Report 02.620

2 October 2002

Report to Environment Committee
from Paul Jolly, Pollution Control Officer

Coastal Structures Inventory for the Wellington Region

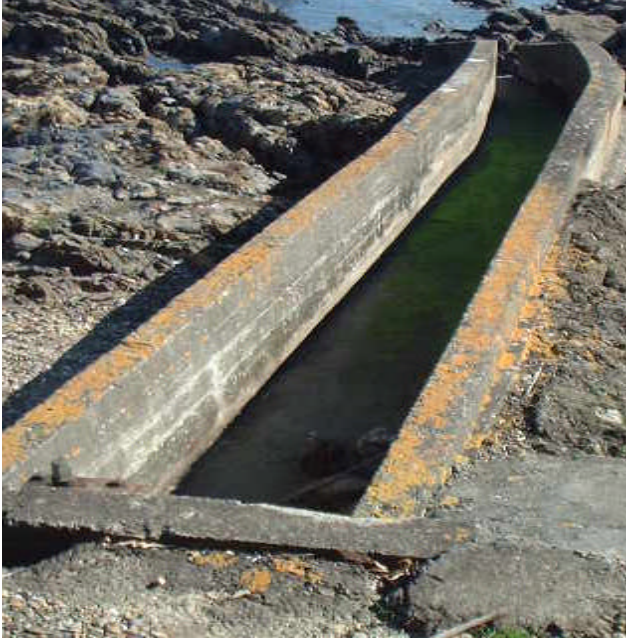
Figure 1 Emergency Sewer Overflow from Sorrento Bay, Eastbourne

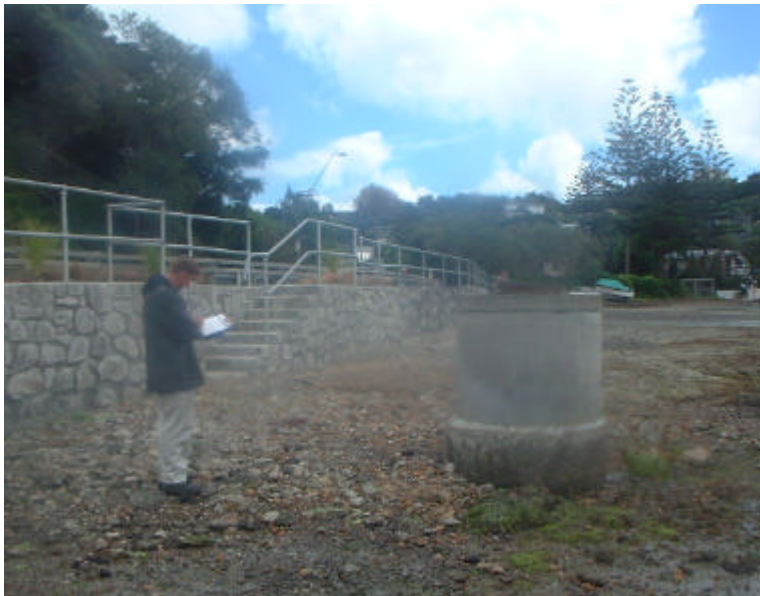
In addition to outfalls and overflows, there are 10 sewer inspection points along the Golden Gate in the Pauatahanui Inlet area. These are 1 metre diameter cylindrical concrete structures, which may overflow to the coastal marine area in the event of sewer blockage. All are in reasonable condition.

Figure 2 Sewer Inspection Point Located along the Pauatahanui Inlet

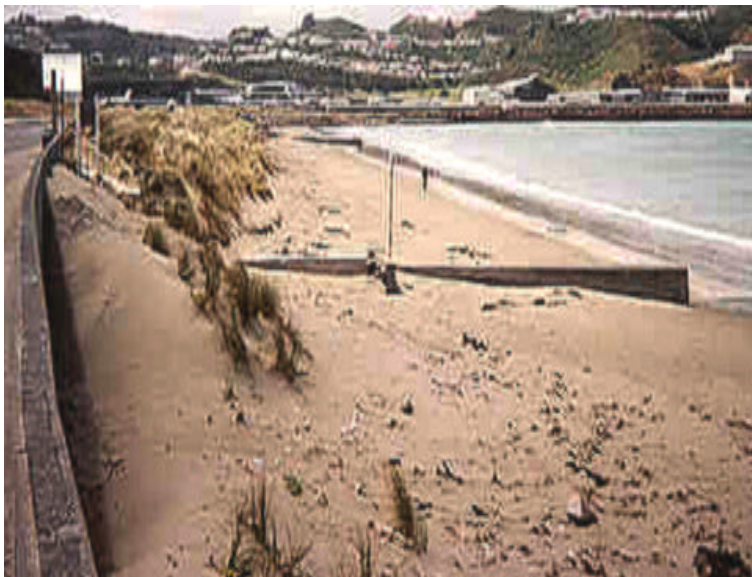
Figure 3 Stormwater Outfall at Lyall Bay, Wellington

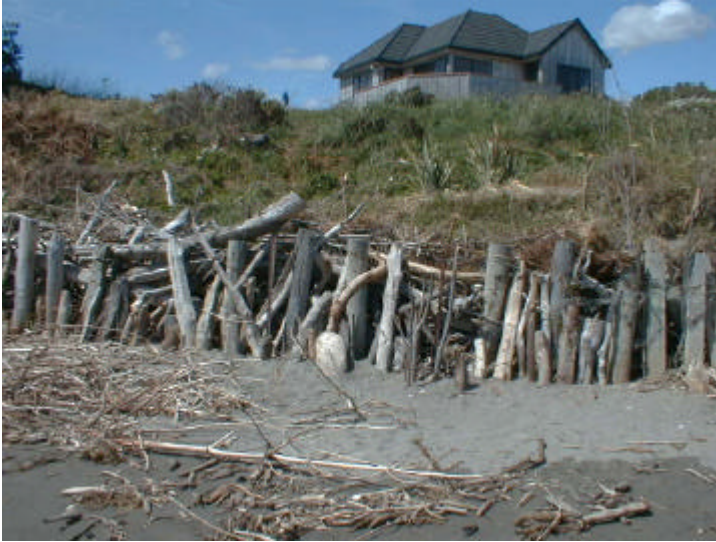
Region are along Oriental Parade and the Wellington Motorway, and the seawall between Pukerua Bay and Paekakariki. There are also a large number of smaller structures at Raumati. The condition of seawalls was generally good.

Figure 4 Seawall at Raumati

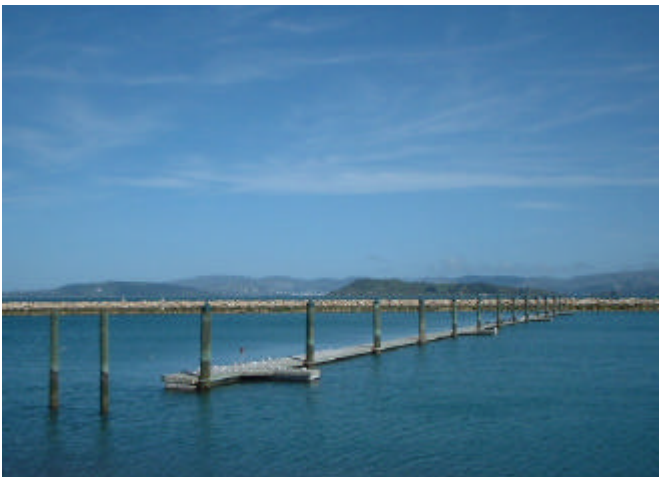
Pile moorings are structures in the seabed to which boats can be moored. They are principally found in the Region's marinas, Porirua Harbour, Motungarara Island and Mana Island. The majority of pile moorings are of average condition.

Figure 5 Pile Mooring at Seaview Marina

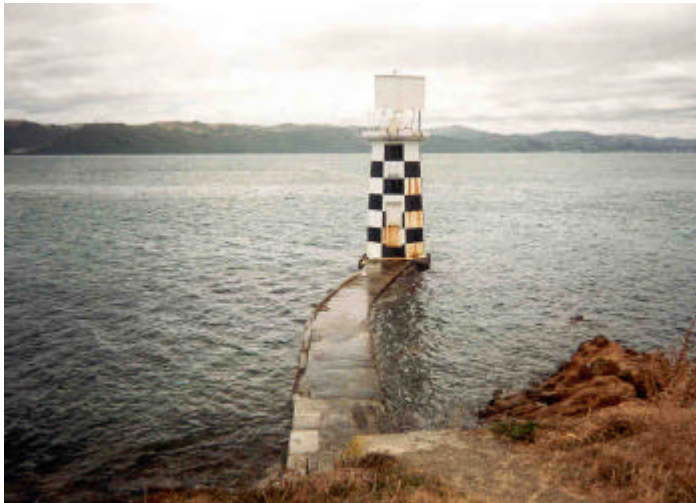
Navigational aid structures include lights, lighthouses and signs, and are used to warn vessels of navigational hazards. There are 14 navigational aids situated within the Region's coastal marine area. Navigational aids in the coastal marine area are maintained by the Harbours department of Wellington Regional Council. All were all found to be structurally sound although some showed evidence of corrosion.

Figure 6 Lighthouse at Point Halswell

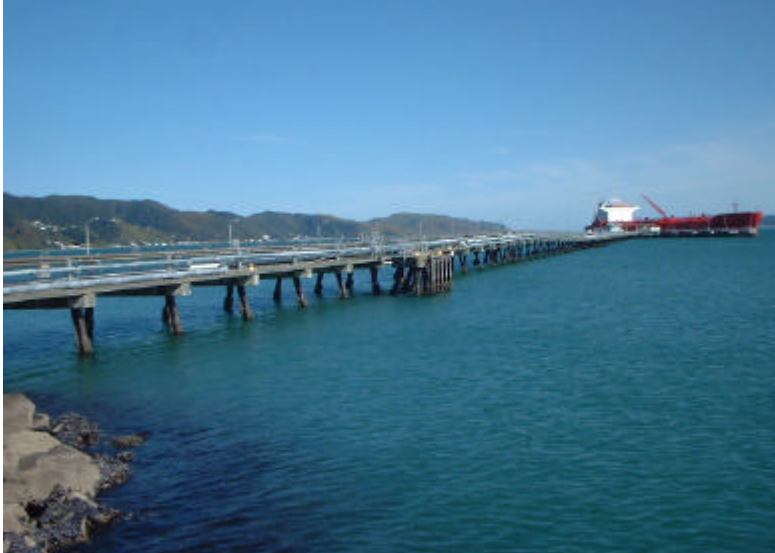
The condition of the wharves, marinas and jetties throughout the Region was generally average, with the exception of Shelly Bay Wharf, which was poor.

Figure 7 Seaview Wharf
