AUGUST 2003

# Wairarapa Peer Review

Annual peer reviews are undertaken of river asset maintenance programmes in the Wairarapa and Wellington areas. The peer reviews provide an audit of maintenance standards and procedures. The reviews are undertaken by inspections of representative sites selected by the peer reviewers. This year's inspection visited several sites on the Lower Wairarapa Valley Development Scheme and the Waiohine Scheme.

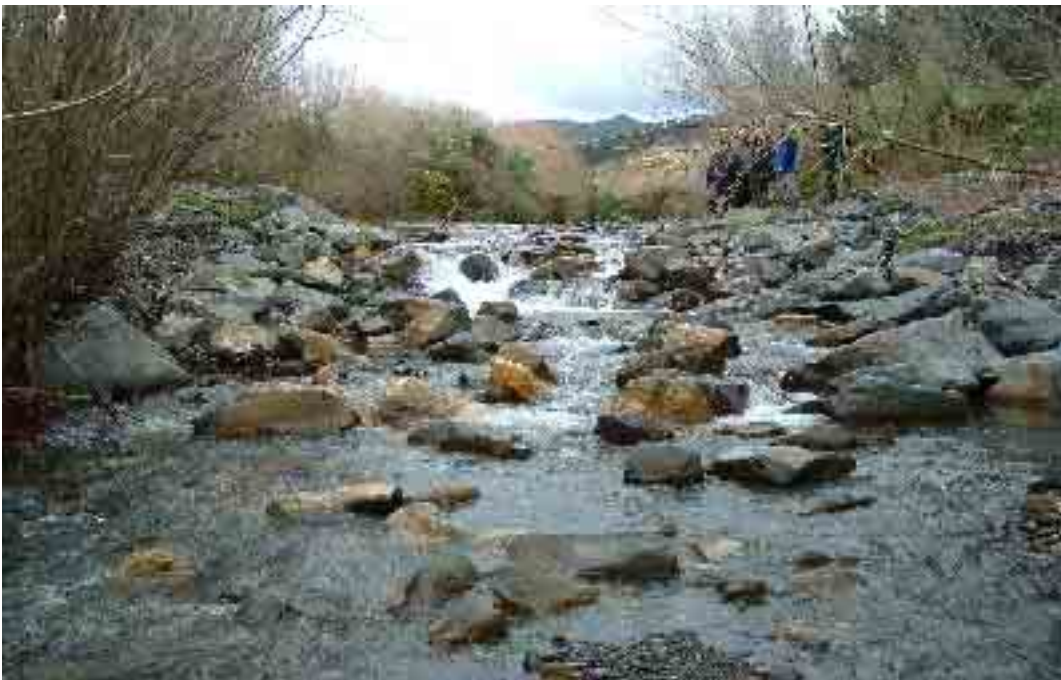
Figure 1: One of the Mongonui weirs, showing steps built to assist fish passage

*Overall the system seemed to be working well, with adequate steps built into all the weirs to allow and assist in fish passage. The reviewers note that regular ongoing maintenance of the weirs is required, and essential for these works to continue to be successful.*

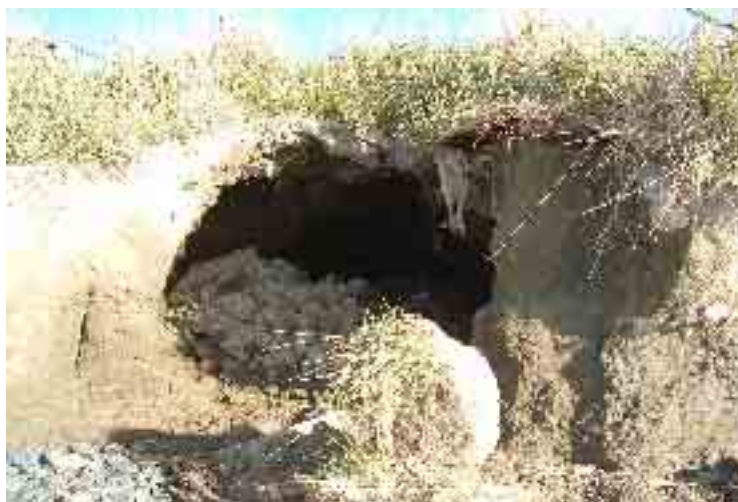
The Onoke stopbanks border the lower reaches of the Ruamahanga River and Lake Onoke. They were constructed in 1964 from dredged riverbed material that was stockpiled, dried and shaped with approximately a 6 metre berm. Due to the locality of the stopbanks they are subject to wind generated wave action and as a result substantial damage along the outer face of the stopbank is occurring. The berm no longer exists in many places and the stopbank is being steadily eroded. In areas, large holes are evident that are undermining the access road that runs along the crest of the stopbank.

Figure 2: A large hole in the outer face of the Onoko Stopbank

*It was apparent to the reviewers that this is a valuable asset that is threatened with wave-lap erosion. The reviewers noted that all erosions areas have already being mapped and prioritised. At present a steering committee has been formed to review the LWVDS with an aim to complete the review process in June 2005. The reviewers also agree with the Scheme managers approach to urgently address this situation through the LWVDS review with a capital works programme put in place.*

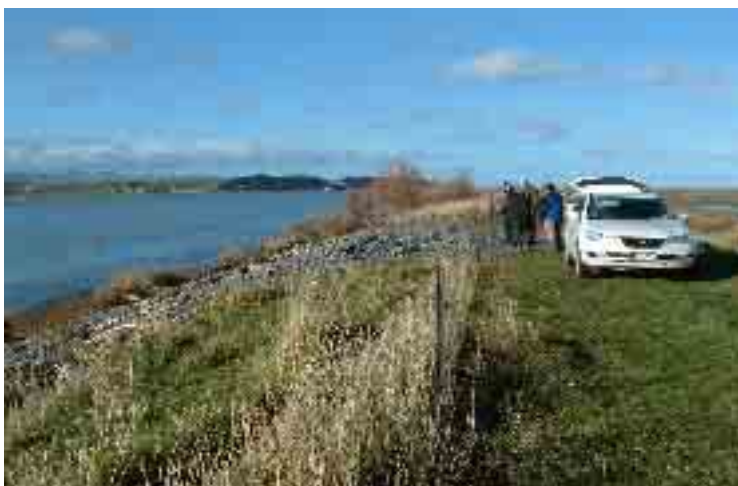
For the reconstruction of the some of the stopbank, gravel screenings have been used to rebuild the partially eroded sections. These are placed in the eroded area and then partially shaped to achieve a natural batter slope.

Figure 3: Reconstructed Stopbank

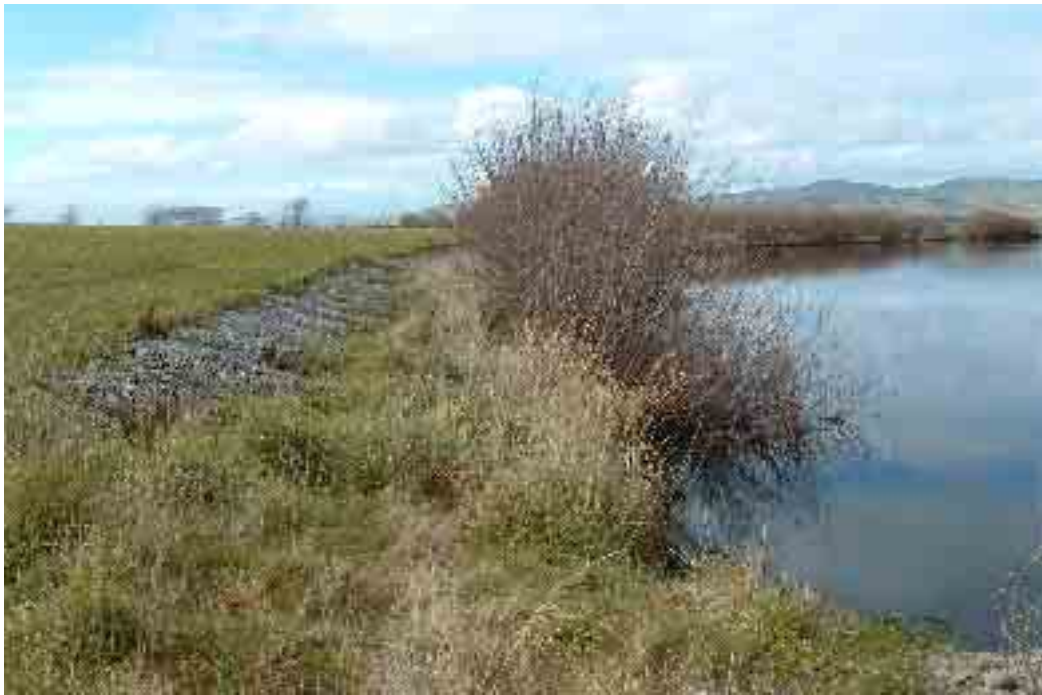
Rather than being grazed, the area is fenced off from the surrounding area and tractor mown. This ensures a healthy grass cover adjacent to the spillover where velocities are high. The channel, drop structure, and surrounds appeared well maintained, with plantings in good health.

Figure 4: Oporua Floodway

*The reviewers were impressed with the standard of maintenance in this area and agree with and reinforce the tractor mowing of the grass sward rather than grazing; this will ensure that grass growth is healthy and adequate.*

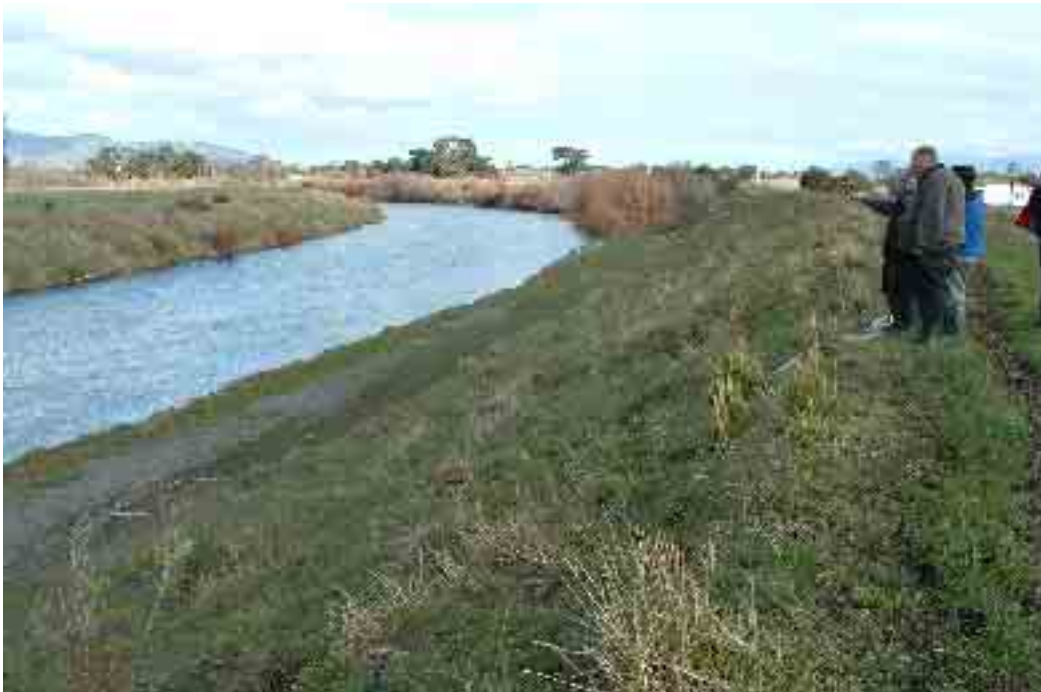
Figure 5: Butcher's stopbank showing silt on the berm and stock damage

During the inspection it was noted that silt build up was evident on the berm; this is periodically scraped off by digger and disposed of. Currently the stopbank is grazed to control growth and it appears that stock are causing considerable damage to the stopbank with grass cover in places being patchy and rutted; this needs to be addressed. The river is also constricted at this point but due to problems with land issues the bend cannot be removed to ease flow.

*The reviewers agree with the approach taken to solve a difficult problem with a limited budget and issues associated with the release and removal of land and willows from the left bank. On the right bank, the reviewers considered the stopbank to be overgrazed. Attention needs to be given to both the management of this grazing to prevent further damage occurring to the stopbank. The development of a grazing plan for particular problem areas may be appropriate.*

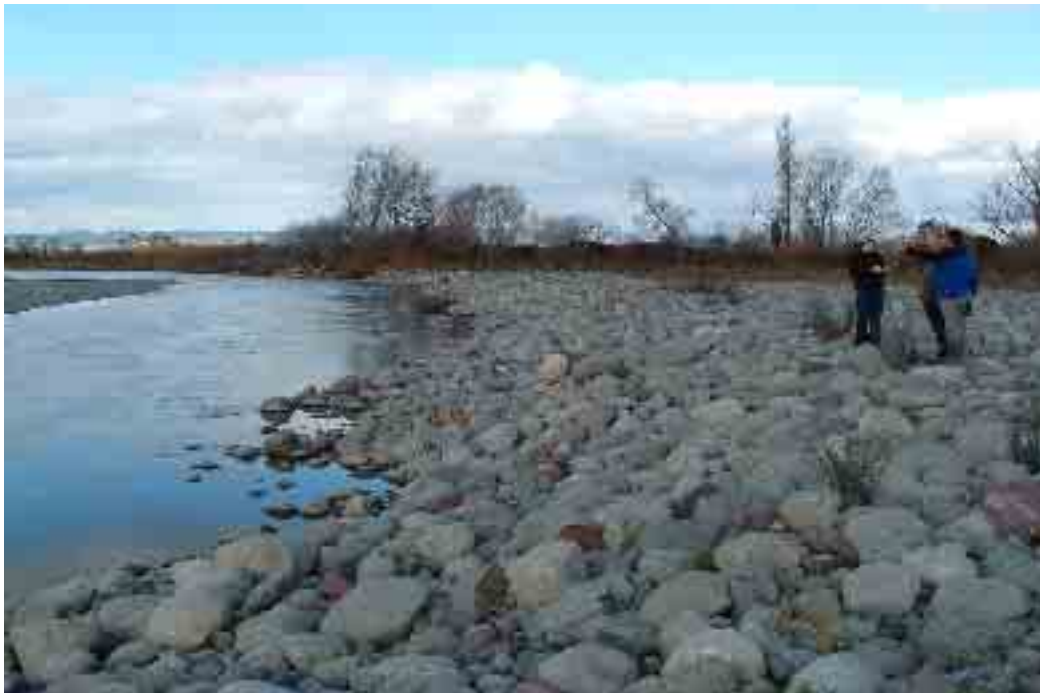
It was noted that there was minimal damage to the backside of the armouring however there were some depressions in the toe of the rip-rap bank; this may mean some form of toe protection will be required in the future.

Figure 7: Boulder rip-rap bank protection

*The reviewers consider the significant works constructed to deal with a difficult problem in an aggressive river appropriate and successful.*

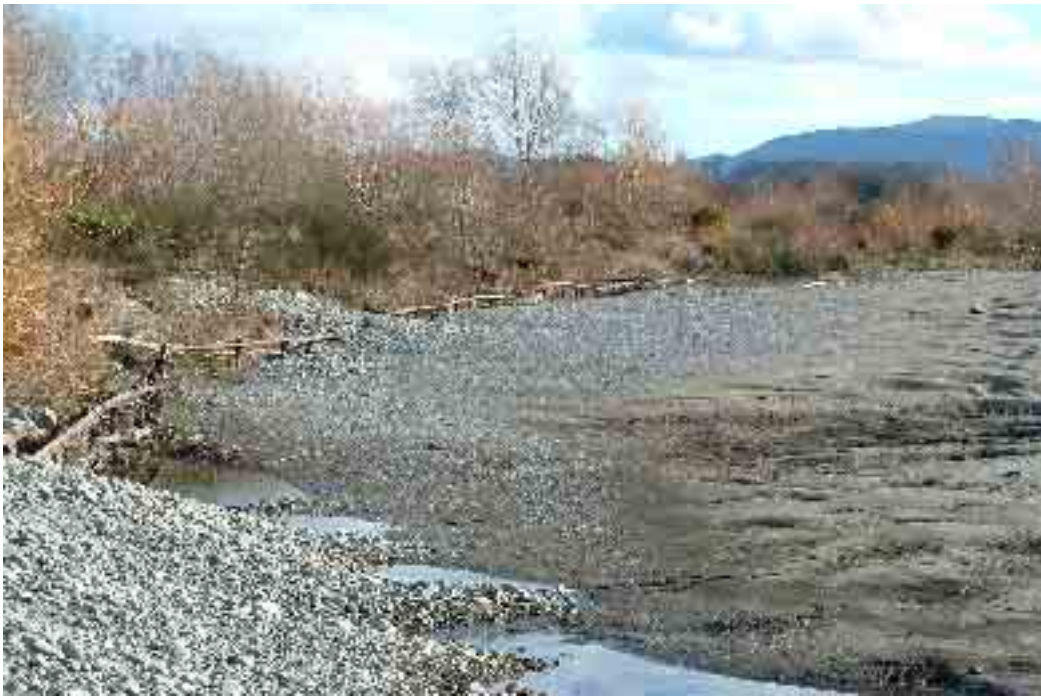
Figure 8: Gravel bank and linear iron training fence

The initial works for the berm reconstruction consisted of the construction of a gravel bank by pushing up the existing gravel beach, shaping of the batter, then armouring this with small ‘paperweight’ concrete blocks. The upstream works consisted of an existing linear iron training fence.

*The new stopbank appeared well constructed, and was generally in good condition. The overall improvement works were well established and seemed to be working well. As the preferred alignment of the Waiohine River has been established, the reviewers’ recommend that all future works should relate to this.*

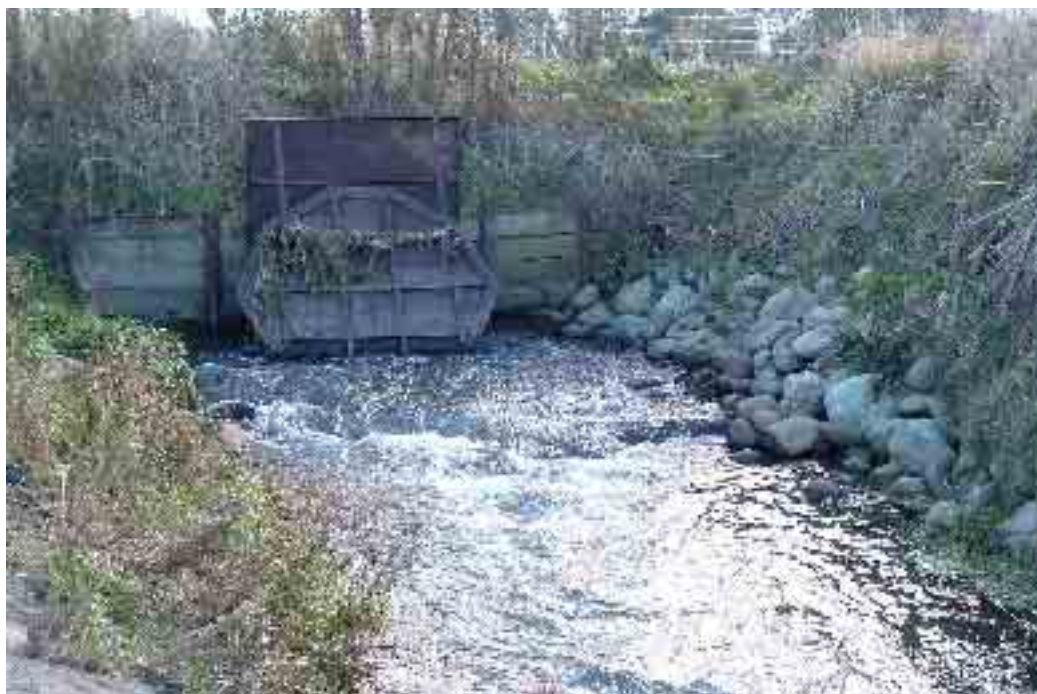
Figure 9: Floodgate from the Muhunua Stream

*The reviewers were impressed with the works constructed in this area to re-establish protection for the landowner.*

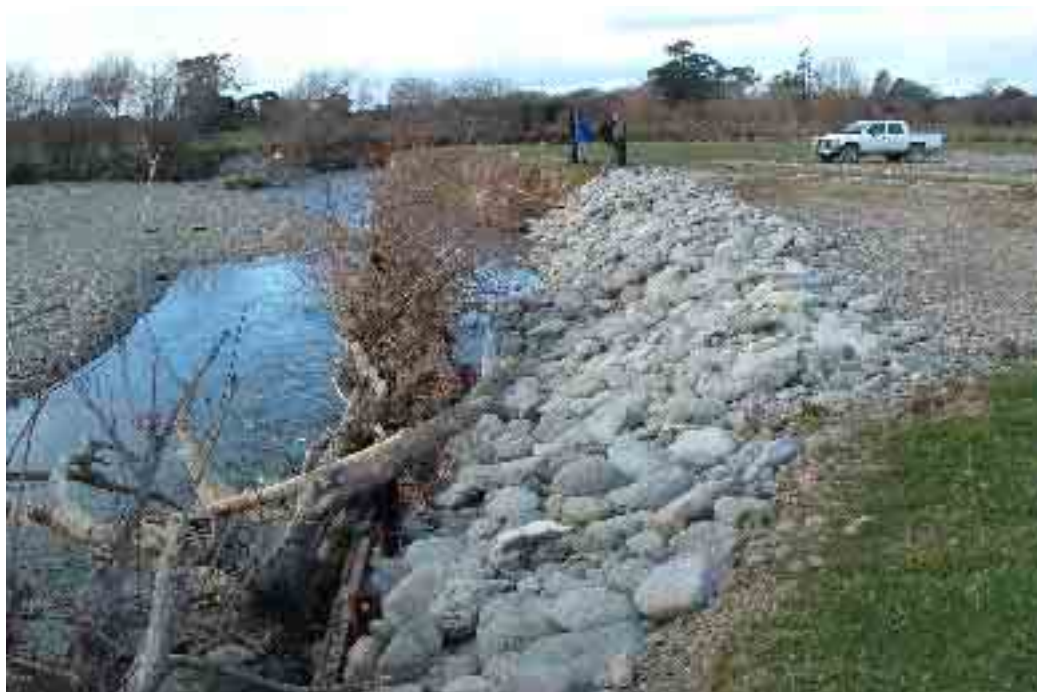
Figure 6: Rail iron deflector fence and newly constructed boulder rip-rap bank protection

The construction of the rip-rap involved gravel from the gravel beach opposite being moved across the channel; boulders sourced from the upper Waiohine were then placed on top to form the rip-rap. At this site there is the potential for the rip-rap bank to be undermined due to the high velocities experienced on the inside of this 'S' bend, however due to the nature of the rip-rap, the boulders will slump accordingly to accommodate any drop in bed levels. This will require an ongoing maintenance program to be developed to 'top up' the boulders as slumping occurs. On the outside downstream bend a series of rock snub groynes have been constructed to provide bank protection.

*The reviewers were impressed with the works constructed to deal with a difficult problem. An ongoing maintenance programme will need to be developed to ensure that the rip-rap bank is kept in good condition until both sufficient grass cover and willows have been established.*
