Wairarapa Municipal Oxidation Ponds

Water Quality Monitoring Report

July 1999 – June 2001

Technical Report No. 01/10

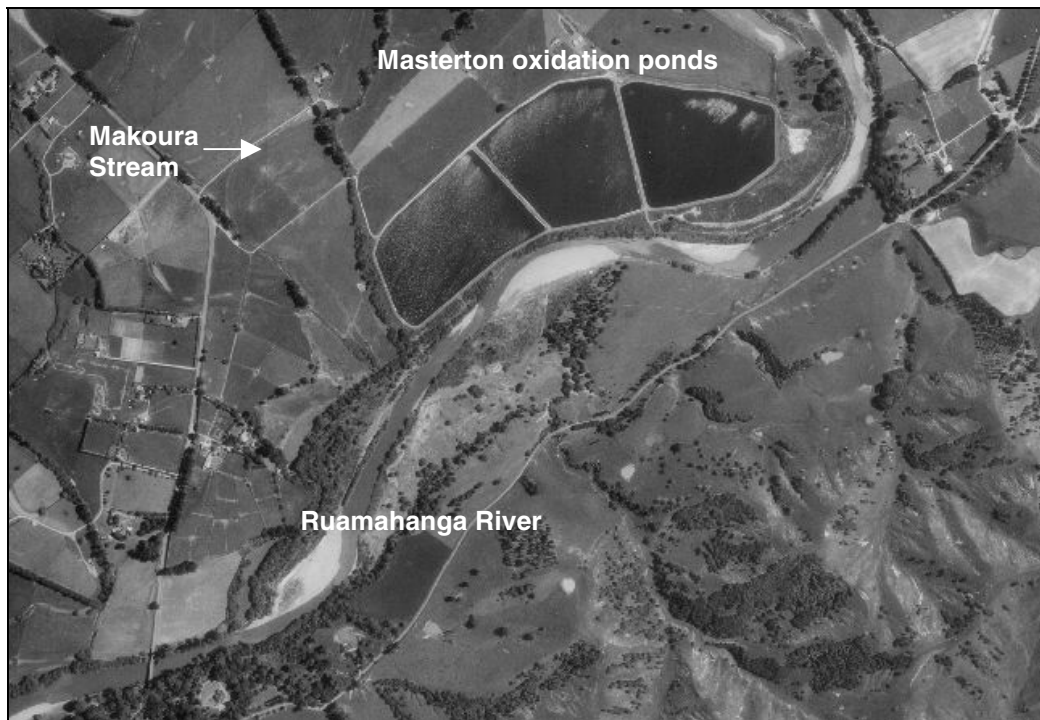
Figure 3-1: Masterton oxidation ponds and receiving environment

Masterton wastewater treatment plant is located about 4km south-east of Masterton, and serves a population of about 19200. The two-stage aerated primary oxidation pond system (Figure 3-1) was upgraded in 1991 to add fine screening and a plant building. Currently investigations are in progress for upgrading and possible improvements to the sewerage reticulation system^[3].

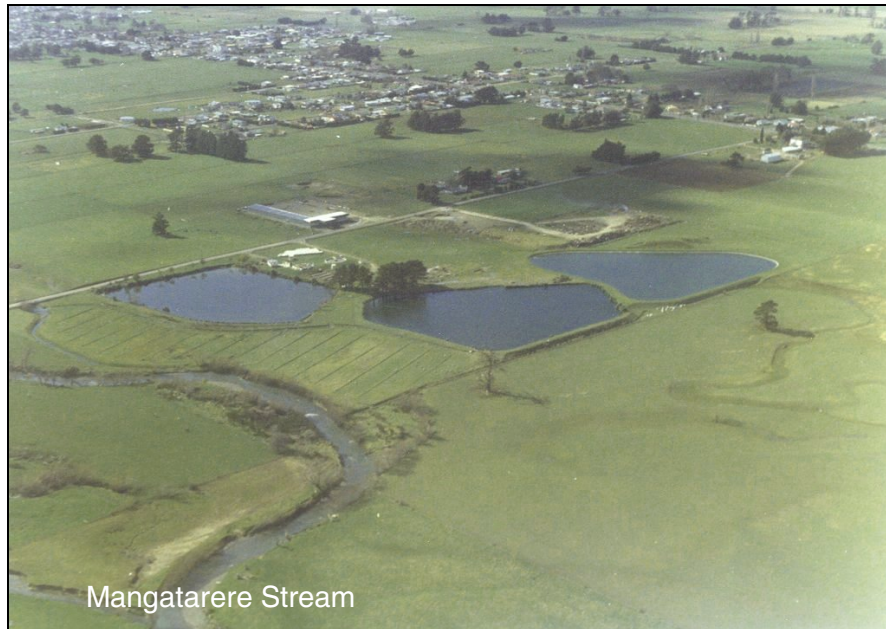
Figure 4-1: Carterton oxidation ponds

Carterton District Council manages a tertiary oxidation pond system to service a population of about 4100 people (Figure 4-1). The system consists of primary sedimentation, a secondary oxidation pond and a single tertiary pond with mechanical aerators. Discharge occurs from the system into the nearby Mangatarere Stream, for which a consent (WAR 950148) was granted in March 1999. This consent specifies, among other conditions, that from 31 December 2002 discharges to the stream will be suspended seasonally, with a land-based disposal system used over summer.
