Inanga spawning habitats in the Wellington

Wellington Regional Council

NIWA Client Report: CHC01/67
Project No.: WRC01501
July 2001

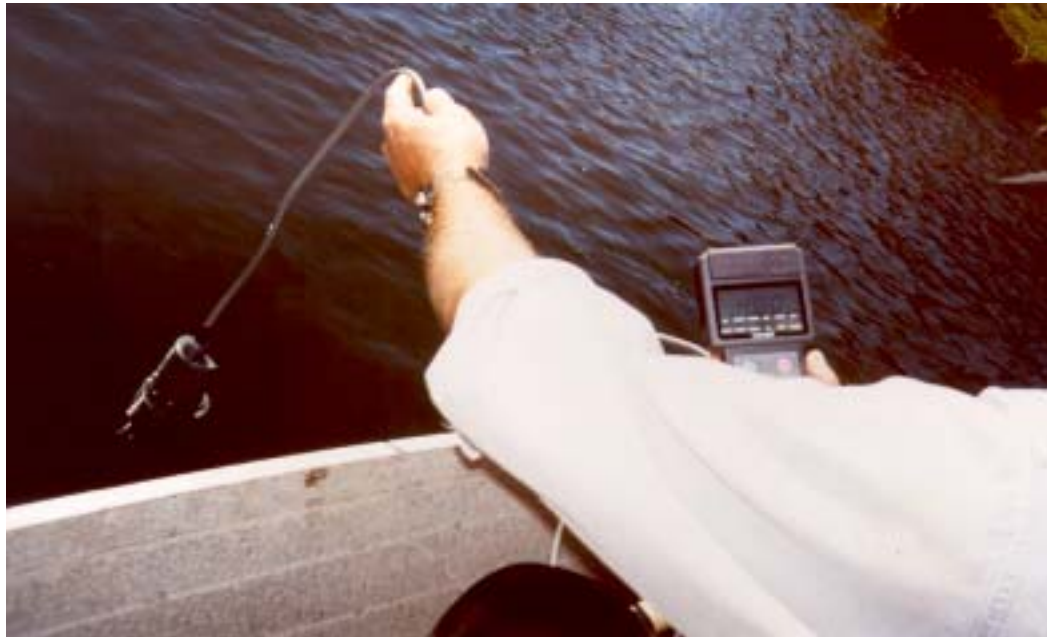
Figure 2: The multi-parameter probe in use. The transducer is slowly lowered into the water to known depths, and water conductivity (viz. salinity) is recorded from the LCD display readout.

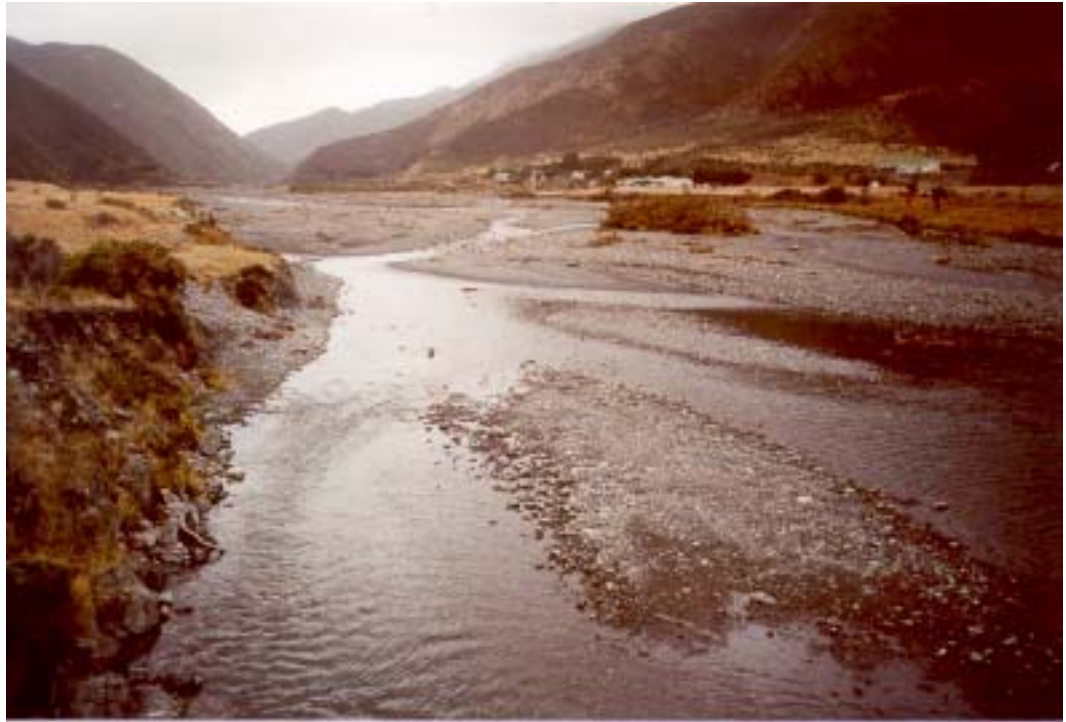
Figure 3: Orongorongo River. Looking upstream from the bridge.

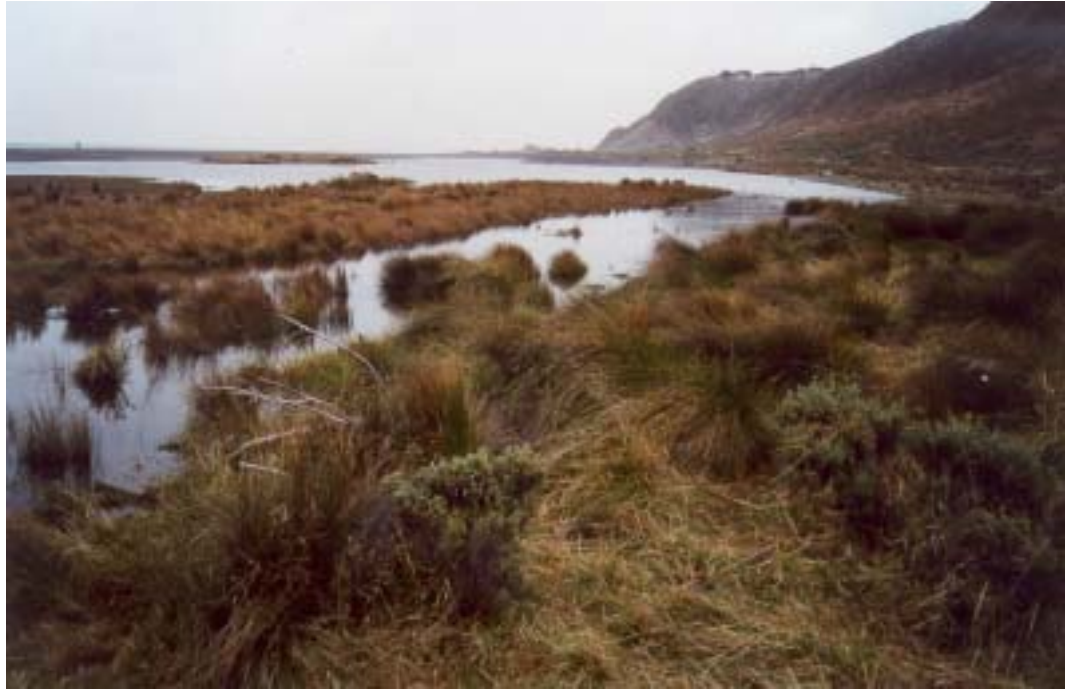
recorded an extensive area suitable for inanga spawning (Fig. 5). Vegetation consisted of the introduced grasses creeping bent, tall fescue, and wiwi. The grasses, particularly, would not tolerate a high degree of saltwater exposure, so presumably the sea intrusion into the catchment is minor. This may be the case if the mouth is closed by Southerly wind conditions for protracted periods. The underlying soil was surprisingly moisture retentive, with a high proportion of clay particulates recorded.

Figure 5: Looking downstream towards the mouth of the Wainuiomata River on full tide. Good spawning habitat is in the foreground.

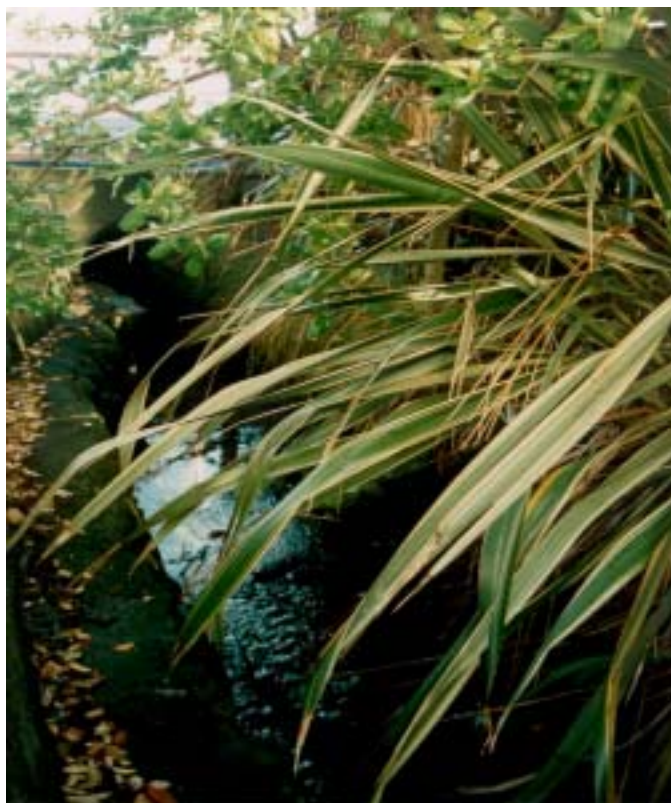
Lowry Bay Stream is a small heavily-shaded stream (Fig. 6) which is culverted under Eastern Bays Marine Drive. The steep, bush-vegetated nature of the catchment is more suitable for whitebait species other than inanga, particularly banded kokopu (*Galaxias*

Figure 6: The heavily-shaded Lowry Bay Stream. The pool upstream of the culvert mouth was occupied by approximately 10 banded kokopu, up to a length of 220 mm.

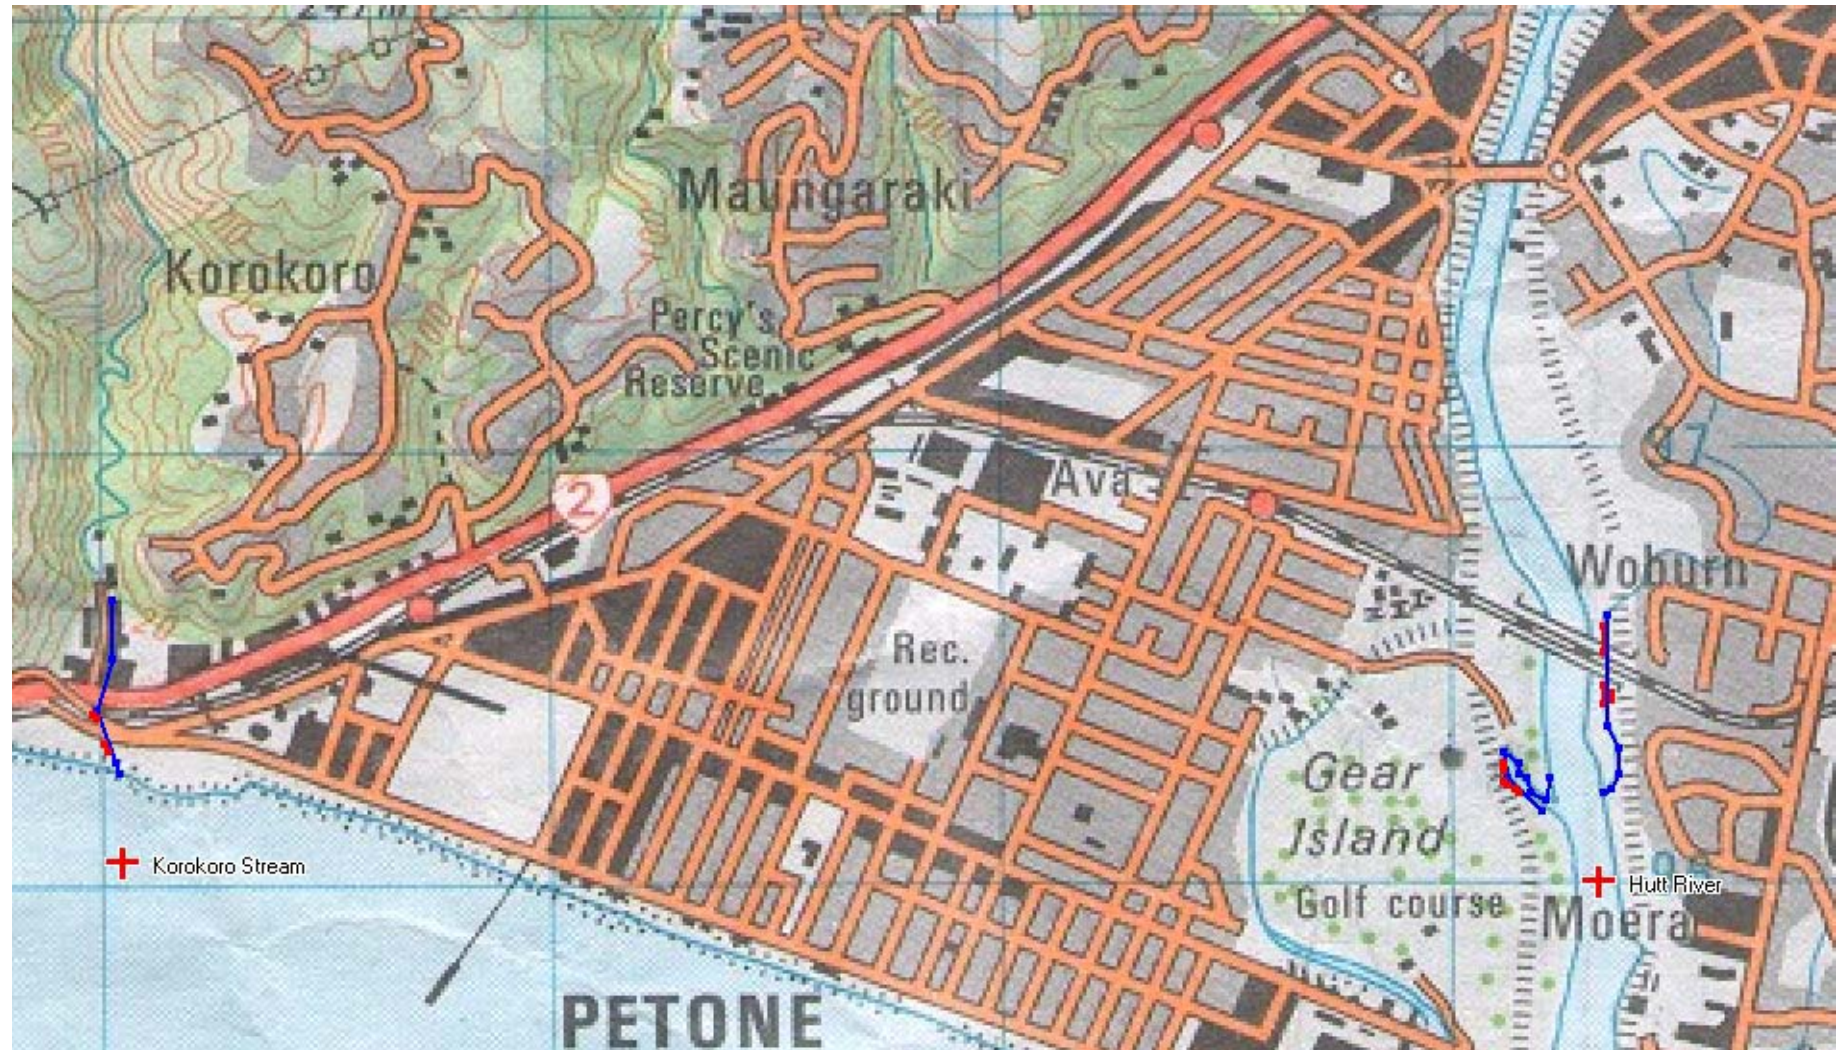
Figure 7: Suitable spawning habitats on the Hutt River and Korokoro Stream. The blue track shows the extent of spawning surveys, whereas the red track indicates the location of suitable spawning vegetation.

The Korokoro Stream was foot-surveyed from the walkway bridge (Cornish Place) to the sea (Fig. 7). The tidally-influenced reaches of Korokoro stream is a heavily industrialised area of the Korokoro valley, but despite this, there were limited areas suitable for inanga spawning. The best location was downstream of a weir (Fig. 12), between the train track and the Esplanade turnoff, along both banks of the waterway for a distance of approximately 5 m (Fig. 13). Grasses here were largely constituted of tall fescue, and Yorkshire fog, with water-emergent herbs (cow parsley and musk) also common. Normal tidal range appeared to be of a low magnitude at this point.

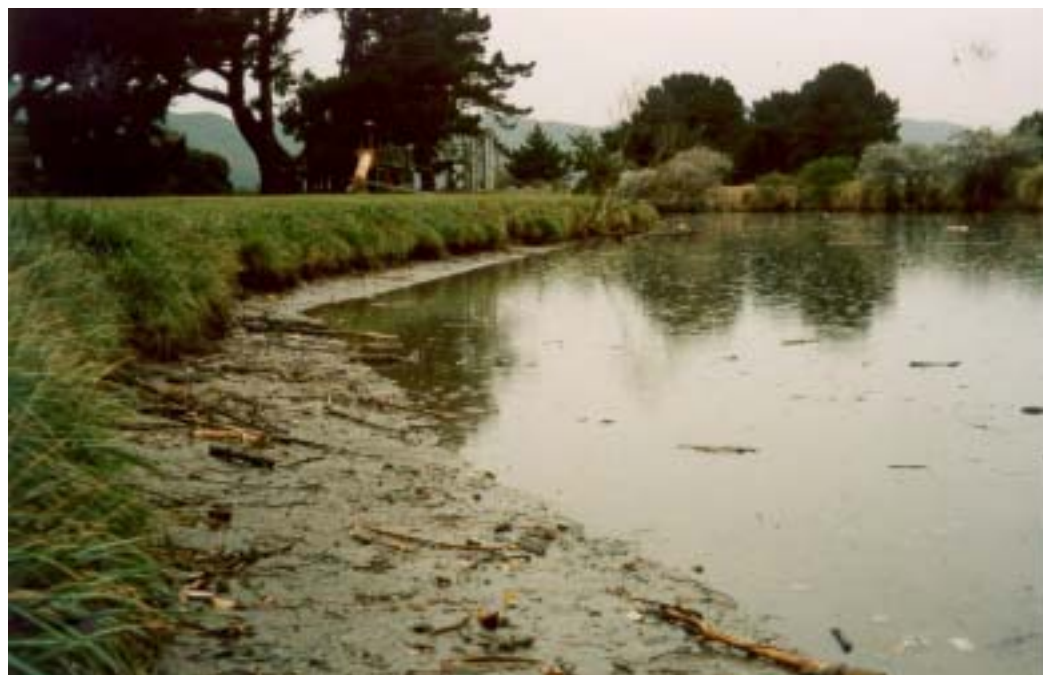
habitats on the south bank bordering the golf course. The north bank profile was unsuitable because it was nearly vertical, and collapsing in many areas around the playground (Fig. 8). Aside from the steep bank profile, the grass along this bank was insufficiently thick to maintain high soil surface humidity, although the presence of amphipods indicate some soil moisture.

Figure 8: Sladden Park on Gear Island, Petone. There were records of inanga spawning along this reach in 1996.

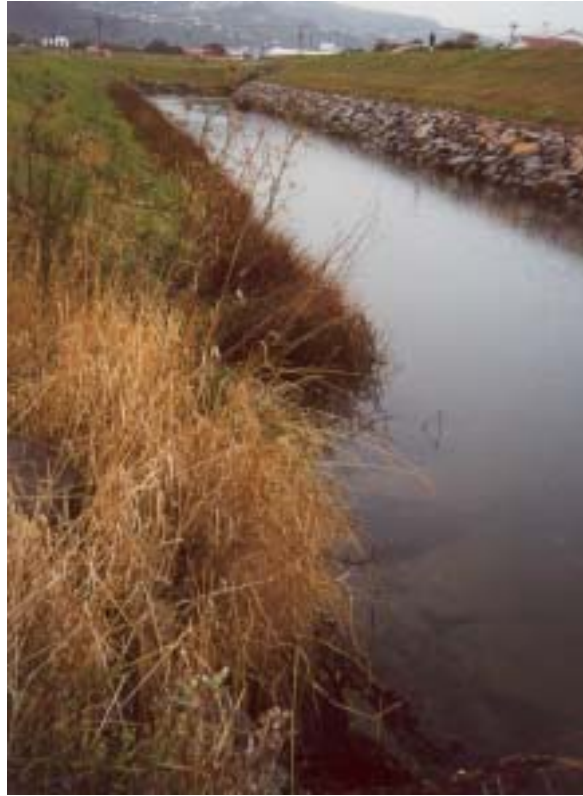
Stone cladding was predominant upstream of the train-bridge, except on the true right bank immediately upstream. At this location, a 40m stretch of native rushes and long tall fescue grass provided excellent spawning habitat (Fig. 9). The survey ceased at the tidegates (Fig. 10), because inanga are known not to spawn upstream of such structures. It is thought that spawning behaviour is inhibited because stream-resident inanga are denied access to salt water during high spring-tide water levels. Patches of good spawning habitat on the true left bank were restricted to unclad banks downstream of the train-bridge (Fig. 11). DoC staff had found inanga eggs along this reach in 1996. Reed sweetgrass was observed growing in isolated stands along this tributary.

Figure 9: Opaahu Stream looking upstream from the railway bridge. Good spawning habitat featured on the left bank, whereas the stone cladding on the right bank is unsuitable.

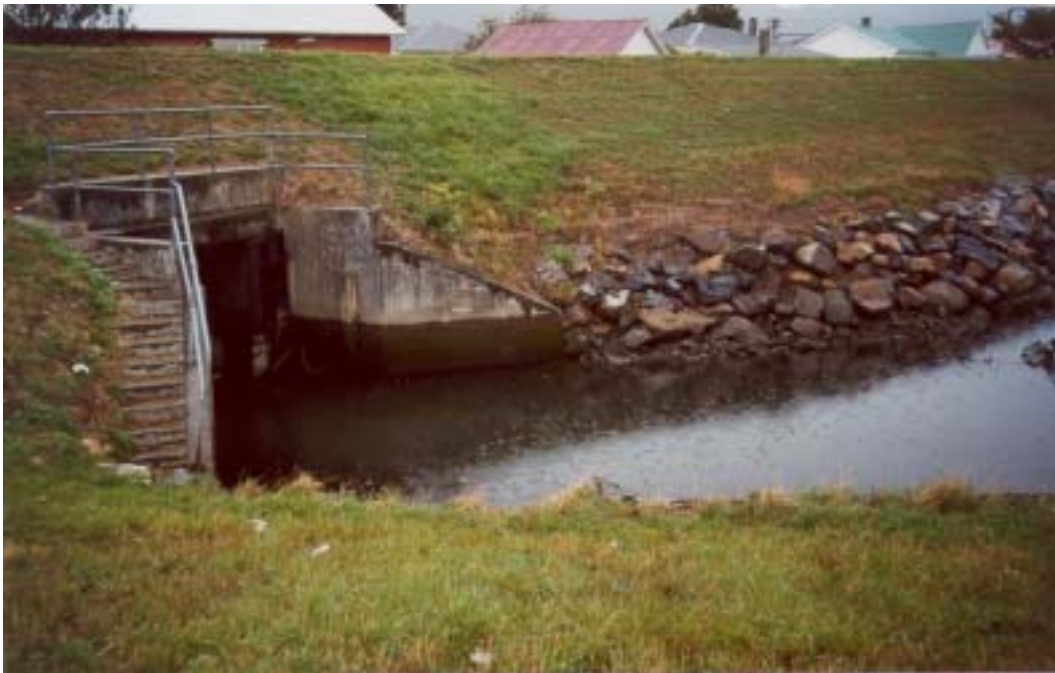
Figure 10: Opaahu Stream tidegates. Such structure have been demonstrated to inhibit inanga spawning upstream of their placement.

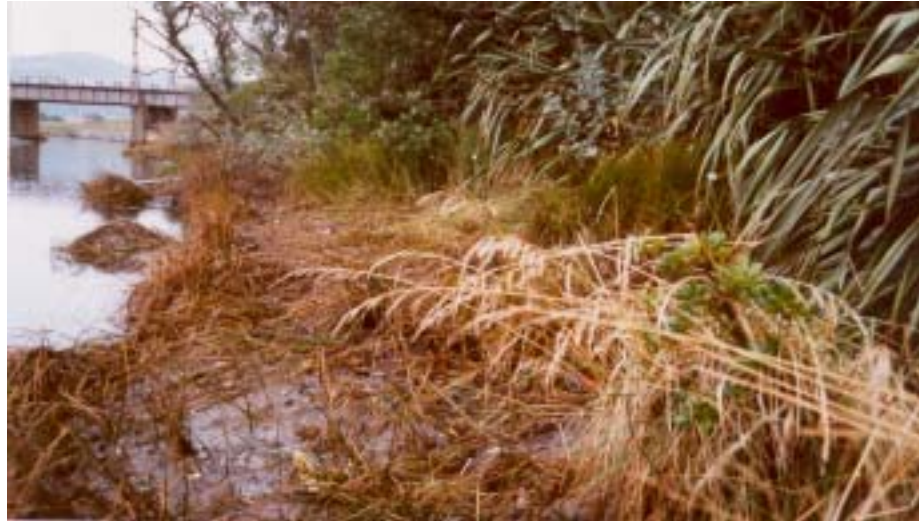
Figure 11: A gently-shelved area suitable for spawning on the true left bank of Opahu Stream downstream of the railway bridge.

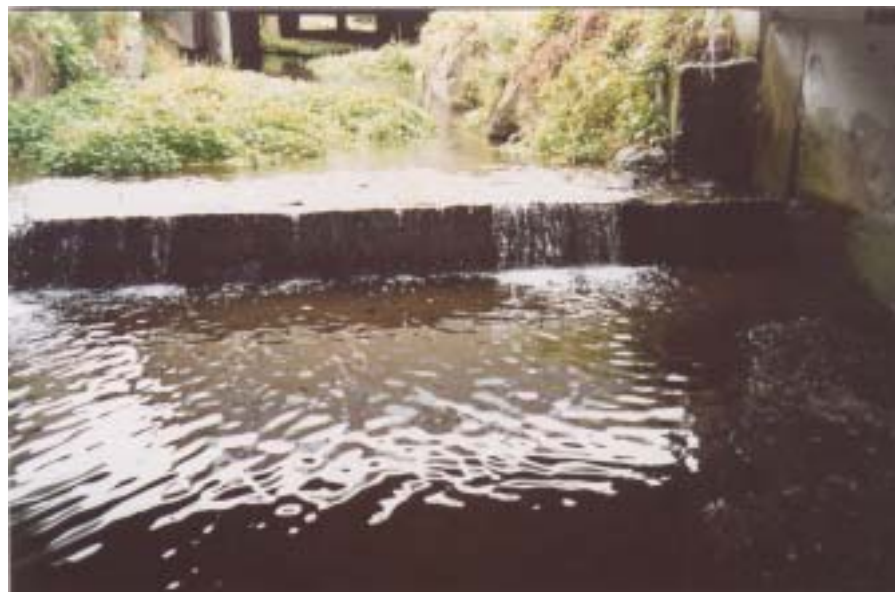
Figure 12: Korokoro Stream. A 0.6 m high weir that would restrict inanga to habitat below this point. Suitable spawning vegetation was downstream of this structure.

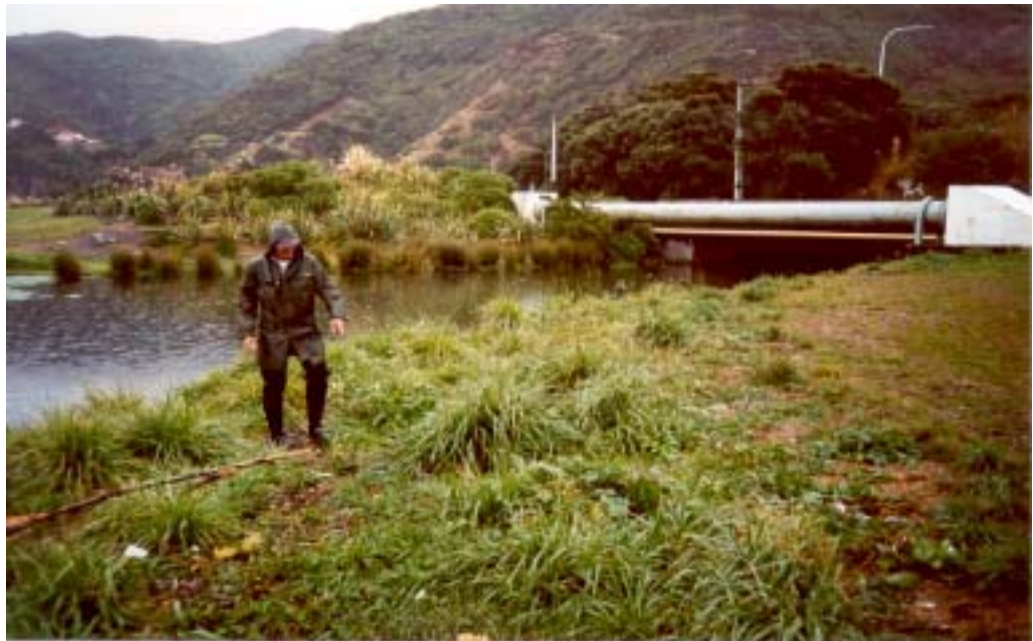
Another small area with some potential for inanga spawning was near the mouth of Korokoro Stream. However grass growth was weak, possibly due to saline influence. The best area, of a somewhat lower standard in terms of moisture retention, was near the large pipeline on the true right bank (Fig. 14).

Figure 14: Korokoro Stream mouth. The better spawning habitat was on the far bank amongst the grass and jointed rush stands.

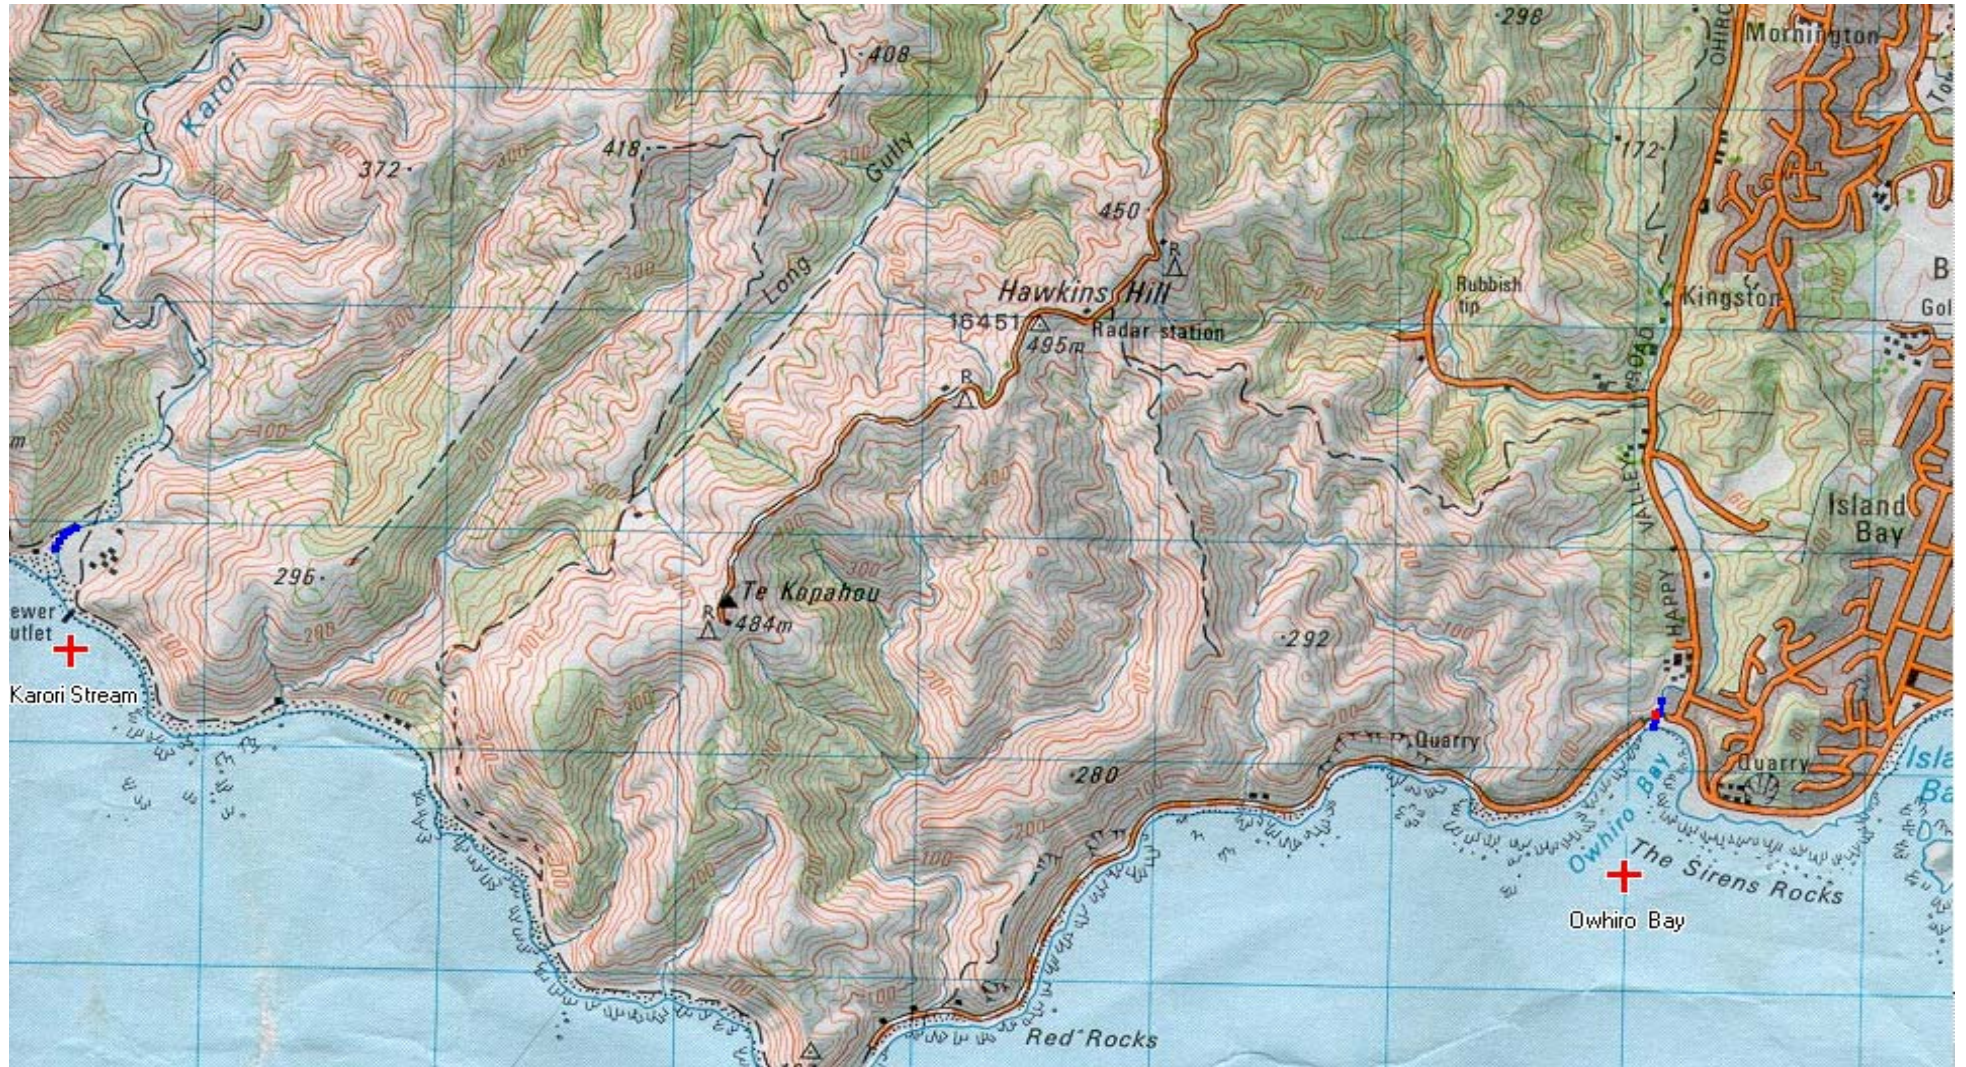
The survey extent is depicted in Fig. 15. This long stream rises in the Wellington suburb of Karori, yet for much of its length, derives flow from rural land. A sewer outfall near the stream mouth discharges into Cook Strait (Fig. 17). The landowner claimed the catchment used to have (brown) trout, but they are now absent, and dead eels have been found in the past.

Figure 15: Survey extents (blue), and the isolated patch on suitable spawning vegetation on Owhiro Bay stream (red). Karori Stream lacked suitable vegetation.

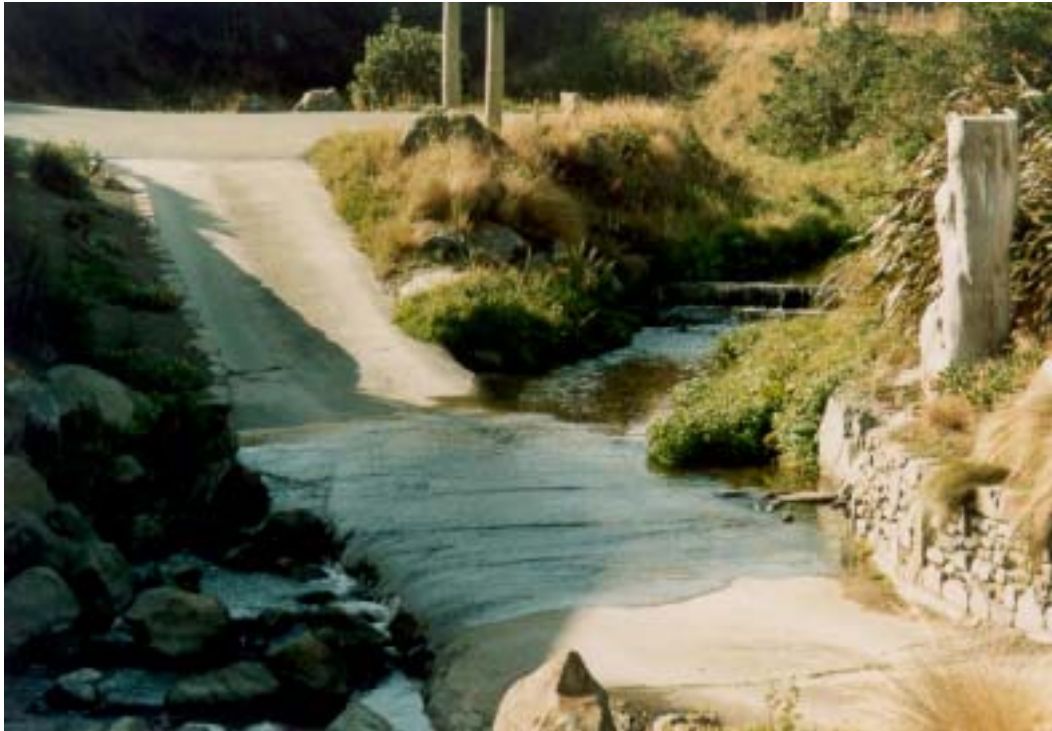
Figure 16: Owhiro Bay Stream. While there was riparian vegetation suitable for spawning, the concrete road ford and weir upstream would inhibit catchment access for inanga.

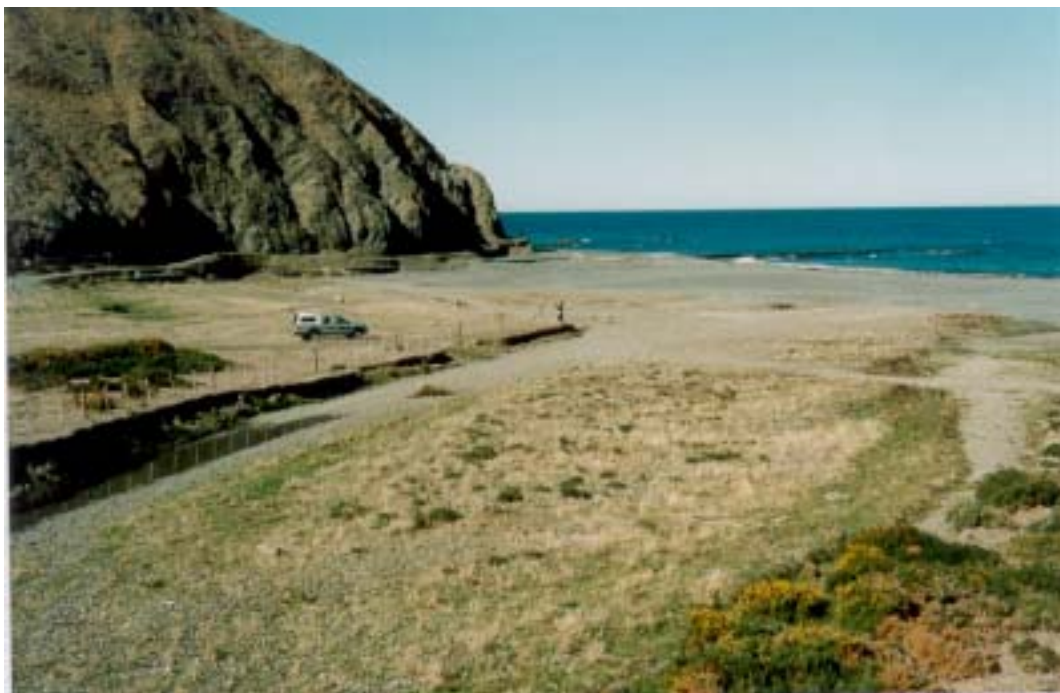
Figure 17: The lower reaches of Karori Stream. The lower reaches were dewatered, and the mouth was closed. The sewer pipe outfall can be seen in the top right of the photo.

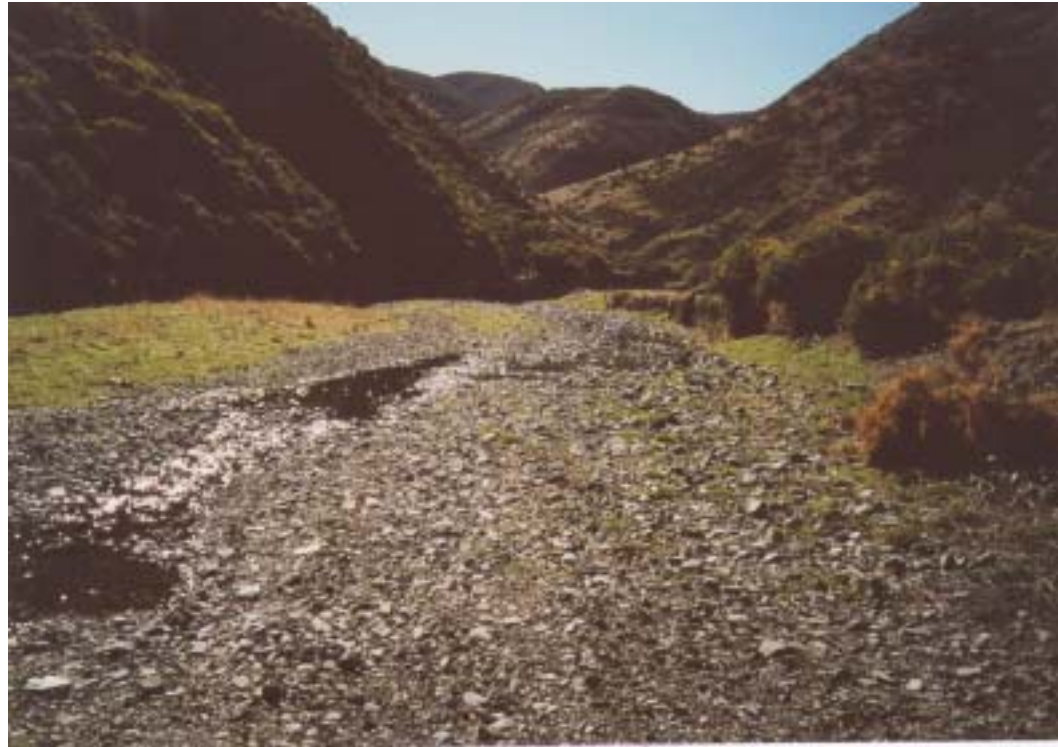
sea. Soil was very thin and grazed, with riparian vegetation composed of a mixture of pasture grass, some weeds (dock, plantain), and buttonweed. Although a seemingly remote area, access to the public by 4WD is possible at low tide around Sinclair Head, and it was clear (from the presence of wheel ruts) that the river course had been used as a road. With these factors considered, and the limited potential for inanga rearing, the enhancement potential for spawning was regarded as quite poor (Fig. 18).

Figure 18: The lower reaches of Karori Stream under the impact of low flows, grazing, and 4WD vehicle traffic

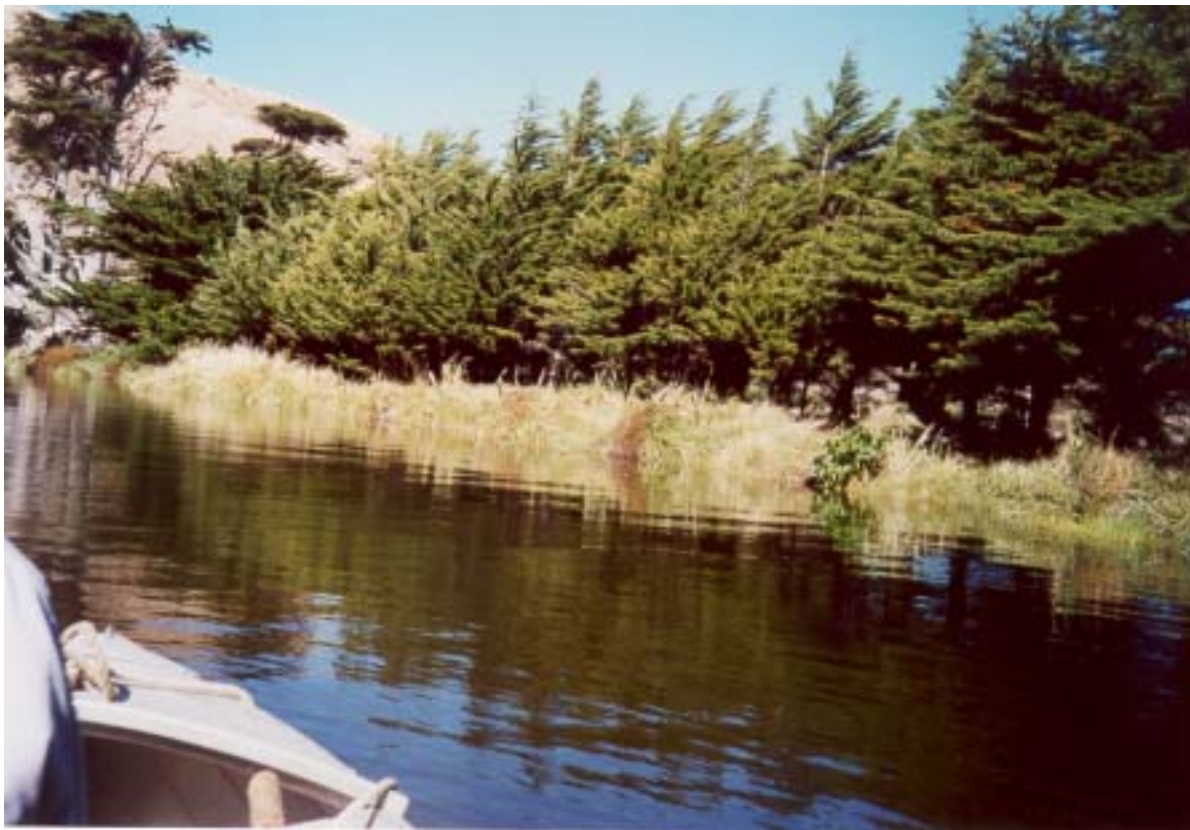
Figure 20: Makara Stream. An 80 m length of suitable spawning ground 200m downstream of the saltwater limit.

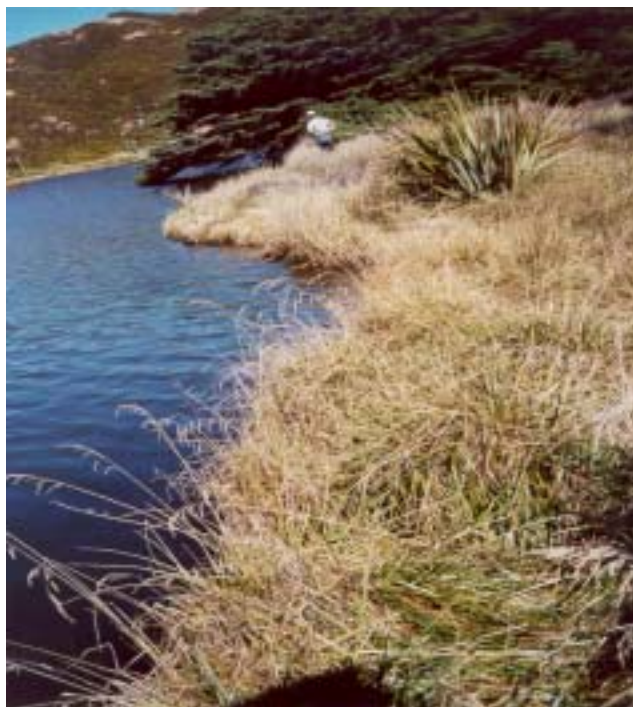
The timing of the field survey coincided with a strong rising tide, so data were collected on the location of the saltwater wedge with upstream distance. On this river the saltwater wedge was terminated by an abrupt shallowing of the channel. We located 2 highly suitable areas, both on the true left bank. The first site was just downstream of the end of the saltwater wedge, and was approximately 80m in length. In this instance, the site was fenced from stock, and appears to have been deliberately stabilised by flax planting (Fig. 20). The second site, equally suitable and with a similar flora, was an island in the lower river with vegetation dominated by ungrazed tall fescue grass, and some flax (Fig. 21).

Figure 21: Suitable spawning habitat on a small island in the Makara River, near the Makara Beach township.

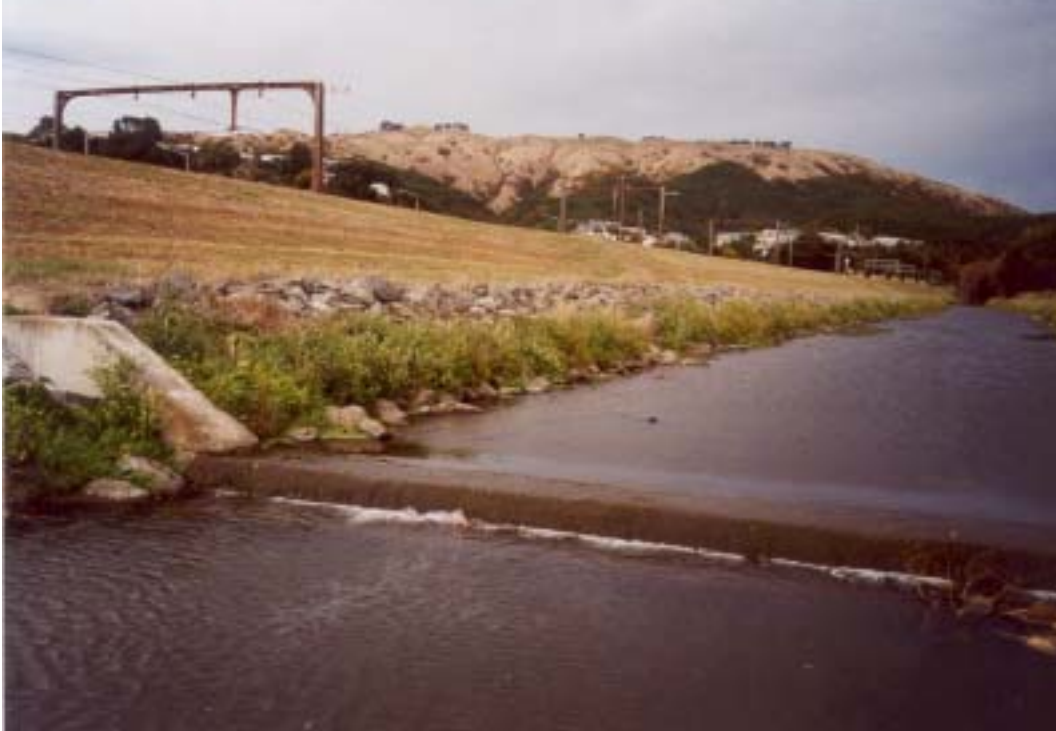
Figure 23: The low weir across the Porirua Stream.

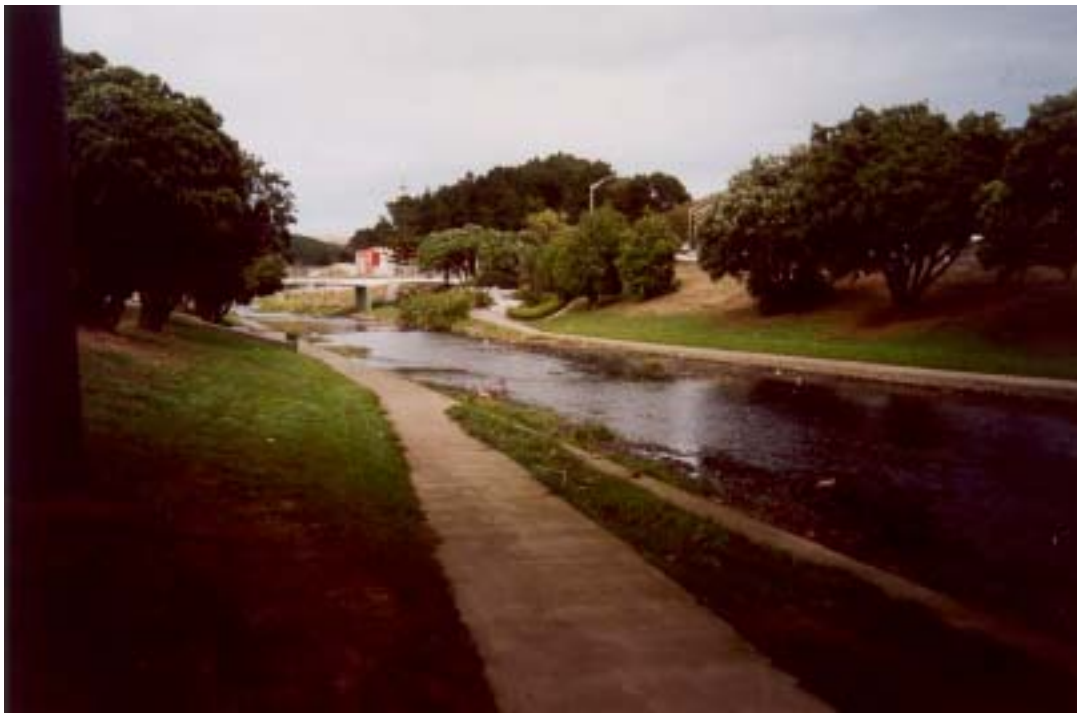
Figure 24: Three large shoals of inanga were observed in the shallow reach of Porirua Stream between the two bridges. Note the vertical concrete-clad banks on each side of the stream.

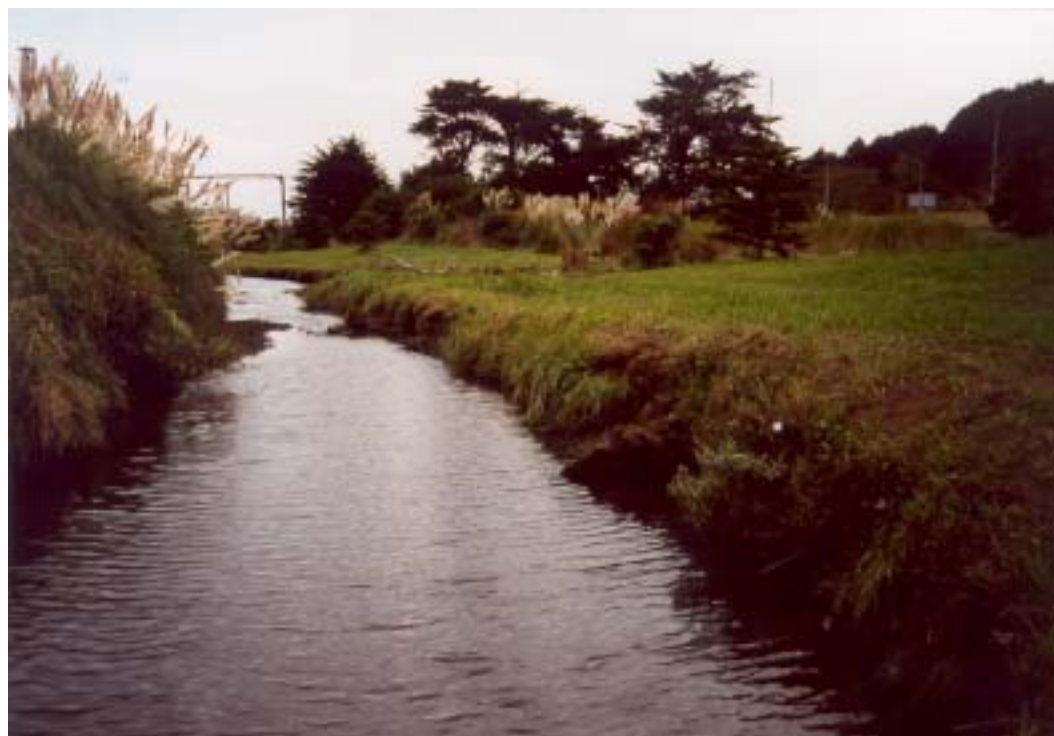
Figure 25: Kenepuru Stream, looking downstream below the weir. The right bank (S.H. 1 side) has the best potential for spawning habitat restoration. It already comprises established toe toe and raupo vegetation.

A number of other catchments also exhibit good potential, which include Porirua Stream. The potential of the Porirua Stream lies less in the value of the mainstem, and more in the Kenepuru Stream tributary. This small tributary does not seem to suffer from the same flow management conflicts as the Porirua Stream mainstem, and would appear to be a good area for some spawning habitat restoration. Some bank regrading would be recommended to reduce the slope of the true right bank between the weir and the railway bridge, and, if the weir serves no present function, we would recommend its removal. This area already contains areas of toetoe and raupo contained in a small wetland, and this would integrate well with the habitat restoration, particularly if it was linked with the stream. Such habitats serve as both rearing habitats for inanga and other fish species, and serves to buffer high flows.

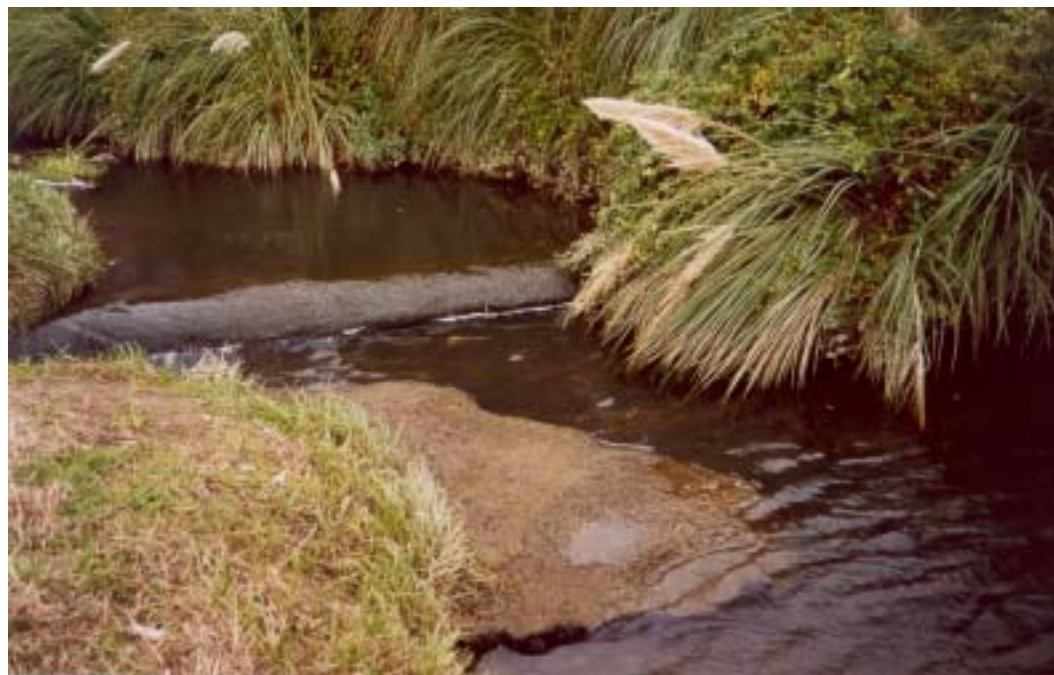
Figure 26: A low weir on Kenepuru Stream that did not appear to serve any perceived purpose. Such structures are best removed, if they are obsolete.

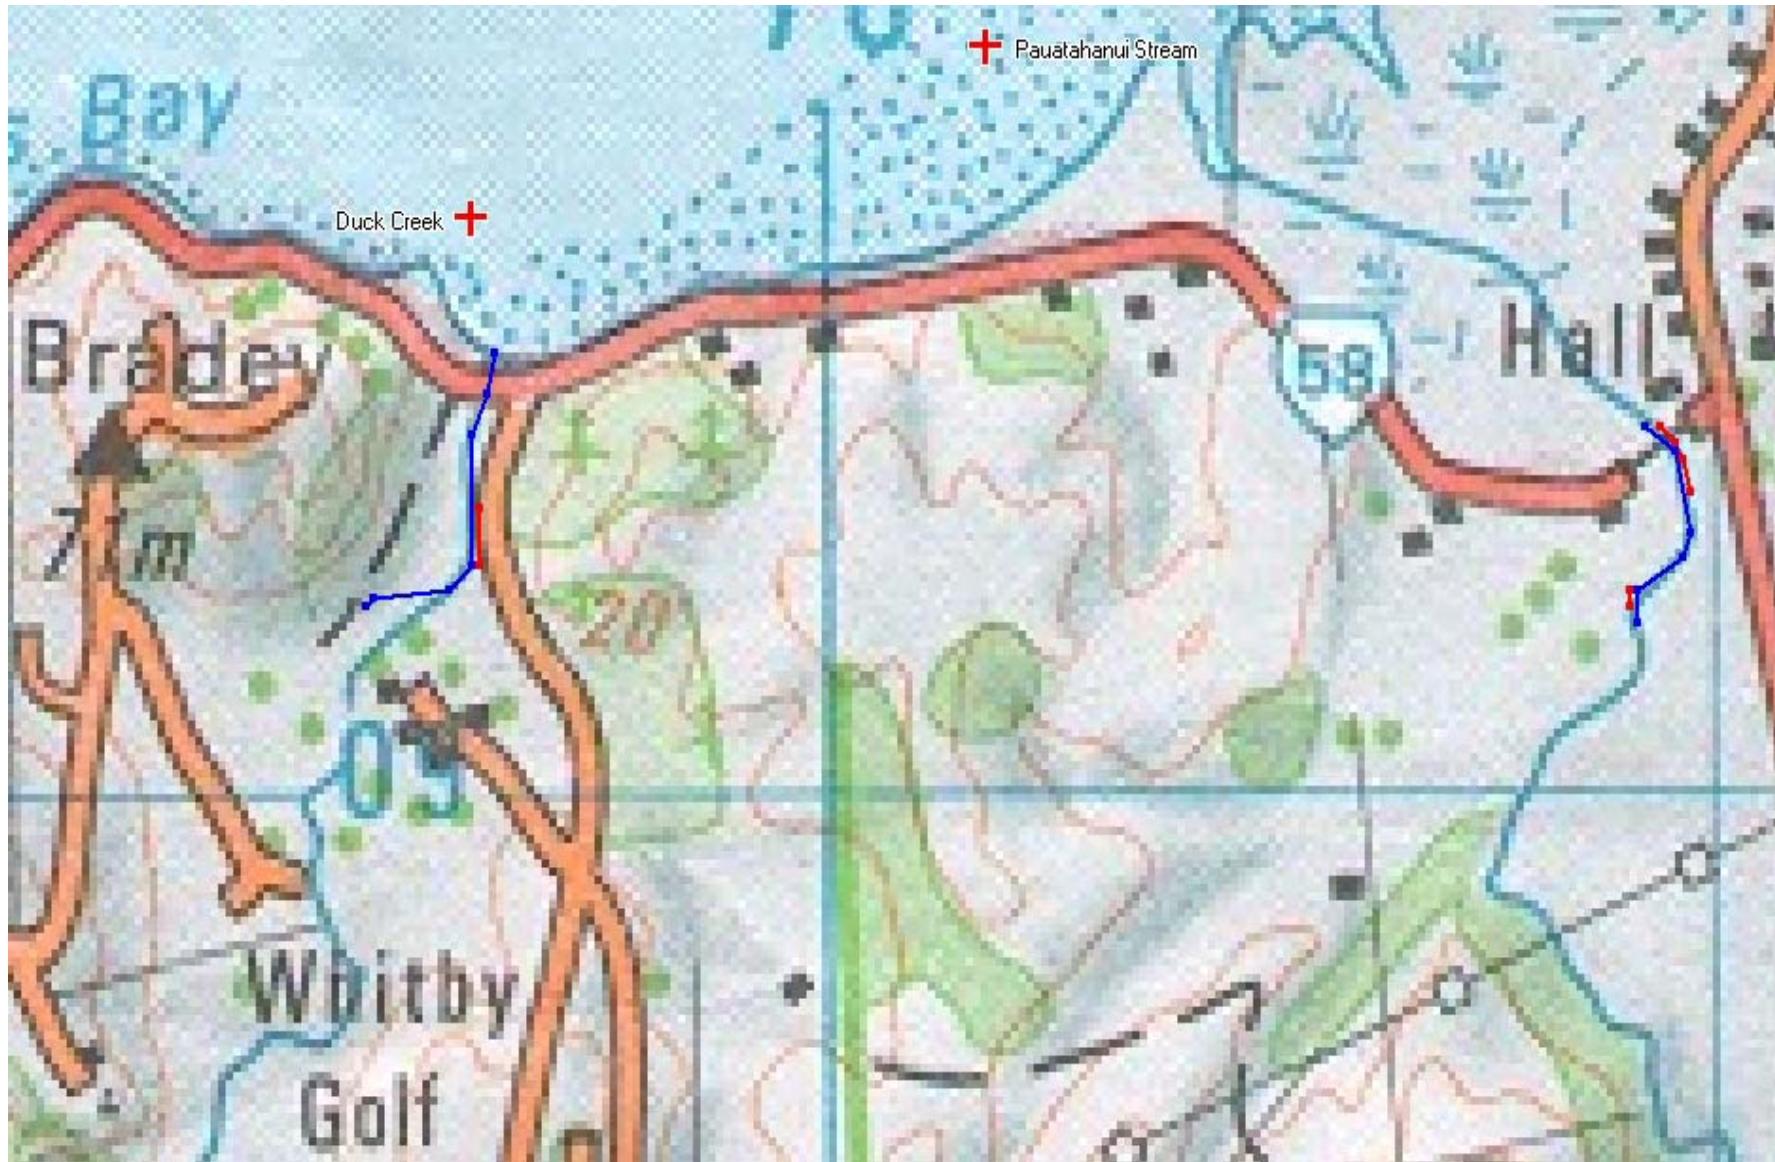
The extent of survey, and suitable spawning areas are depicted in Fig. 27. Duck Creek is a small stream which flows through the Whitby golf course, and then enters a significant saltmarsh (Fig. 28) before discharging into Porirua Harbour. One area of suitable spawning vegetation was found downstream of the golf course, close to the sealed road (Fig. 29). A small school of inanga (10-12 fish) was observed here, where tall fescue grass, toetoe, and flax had been left to flourish. Further upstream, the stream passes through the golf course fairways, and the riparian vegetation had been mowed to an unsuitably short length.

The extent of survey, and suitable spawning areas are depicted in Fig. 27. At the time of the survey, a new bridge was being constructed over the stream. Because the survey coincided with a rising tide, salinity readings were recorded during the upstream excursion. Two suitable spawning areas were found. One, the more extensive, is on the true right bank upstream of the existing SH 58 bridge, and probably on road reserve land (Fig. 30). This site was dominated by tall fescue, but toetoe, blackberry, and mint were also present. Another potential spawning site was upstream of the new bridge site on the true left bank (Fig. 31). At this point the river shallowed to a depth of 0.4m, and no further saltwater intrusion was detected.

Figure 27: Survey extents (blue), and suitable spawning vegetation (red) on Duck Creek, and Pauatahanui Stream.

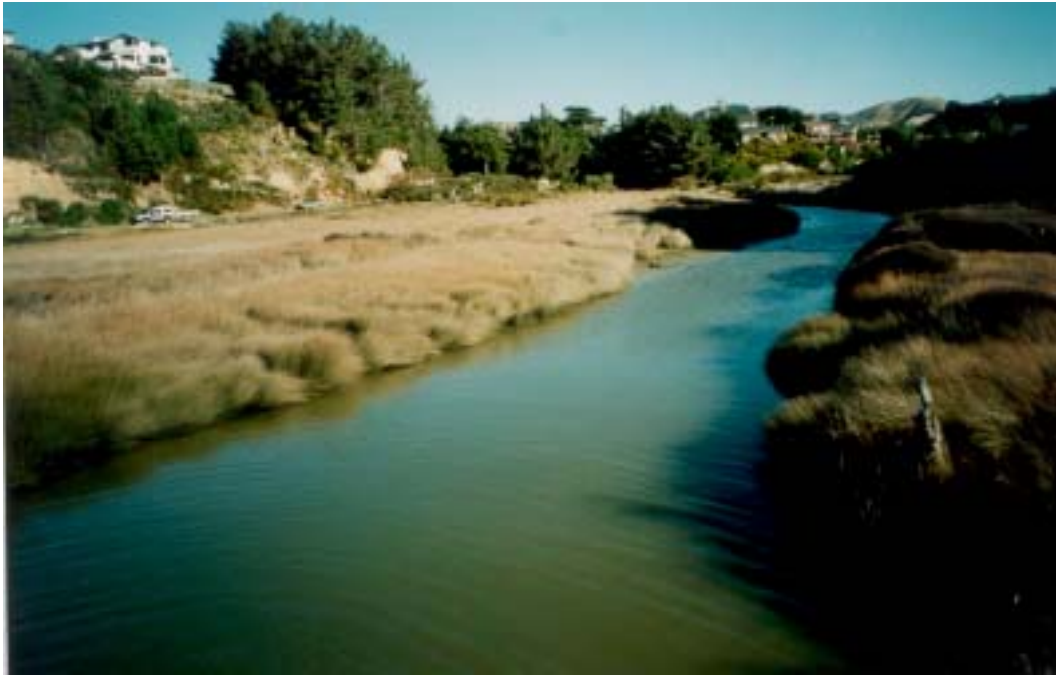
Figure 28: Extensive saltmarsh at the mouth of Duck Creek.
