Inanga spawning habitats in the Wellington

Wellington Regional Council

NIWA Client Report: CHC01/67
Project No.: WRC01501
July 2001

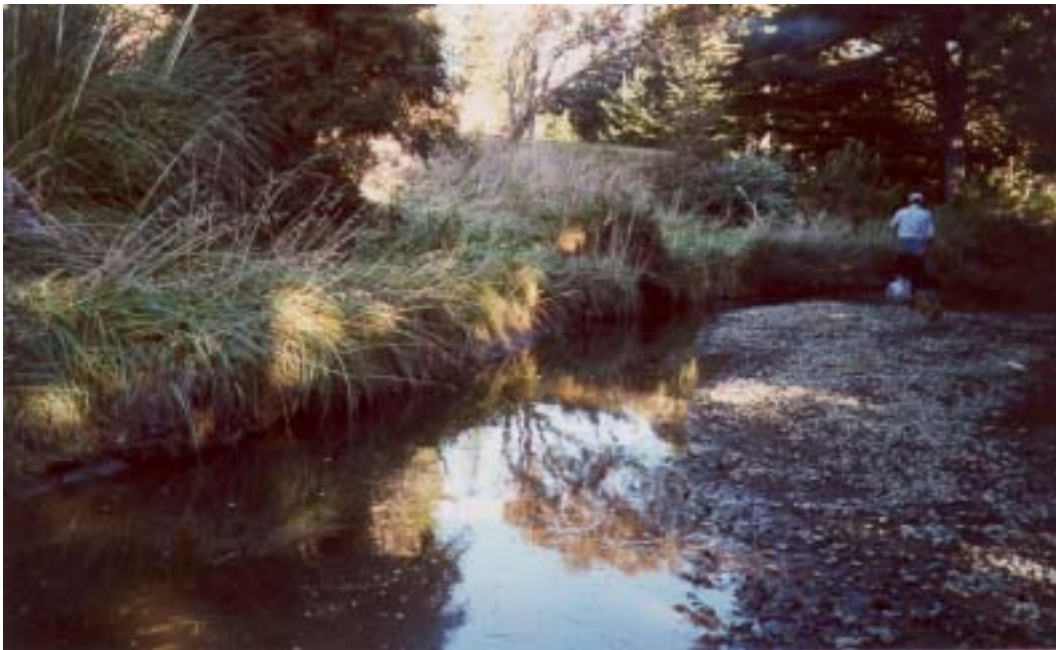
Figure 29: Suitable spawning vegetation downstream of the Whitby golf course on Duck Creek. The plant community comprised a mixture of tall fescue, toetoe and flax.

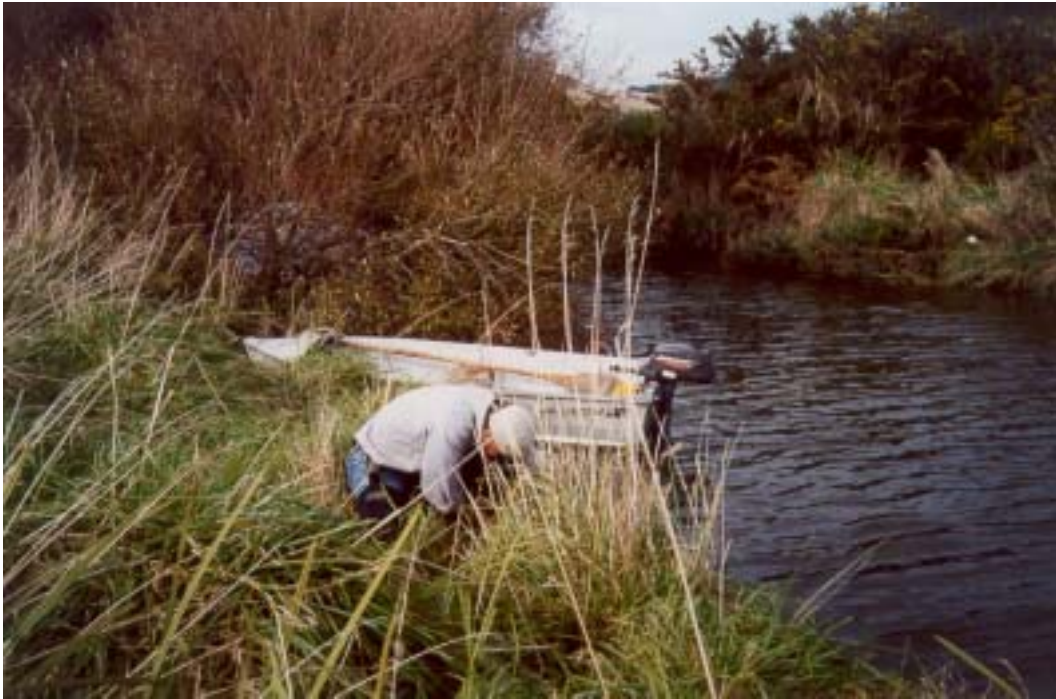
Figure 30: Suitable spawning habitat on the true right bank of the Pauatahanui Stream. This site was upstream of the SH 58 bridge.

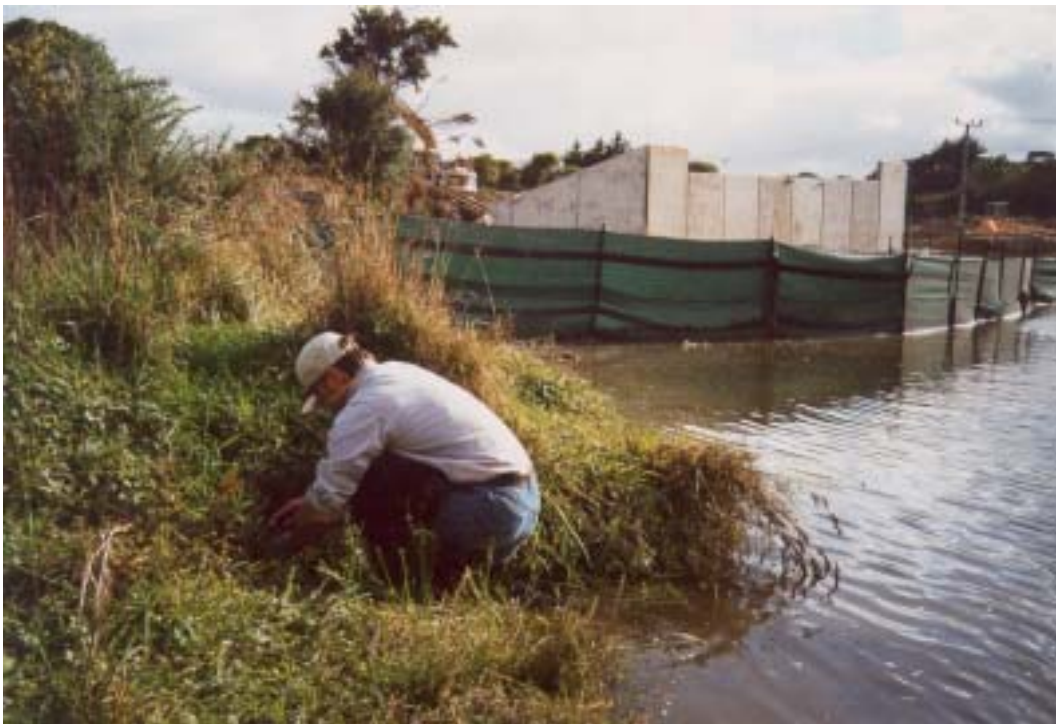
Figure 31: Suitable inanga spawning habitat just upstream of the new bridge over Pauatahanui Stream, on the true left bank. Note the measures to control topsoil runoff around the construction site.

Pauatahanui Stream included suitable habitat for inanga spawning, and prudent sediment control around a major bridge construction site minimised sediment input and bank damage in the vicinity. This precaution proved to be worthwhile, because suitable spawning areas were found very close to the construction area.

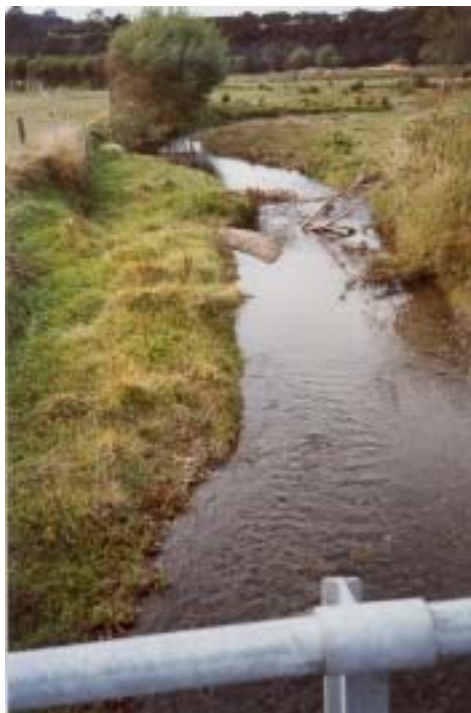
Areas suitable for inanga spawning were confined to areas mainly downstream of the bridge, with the exception of a short upstream section on the true right bank (Fig. 33).

Figure 33: The Horokiwi Stream looking upstream from the road bridge. The best spawning vegetation is the left bank in the photo. Upstream of the fence-line the banks are badly grazed and stock-damaged.

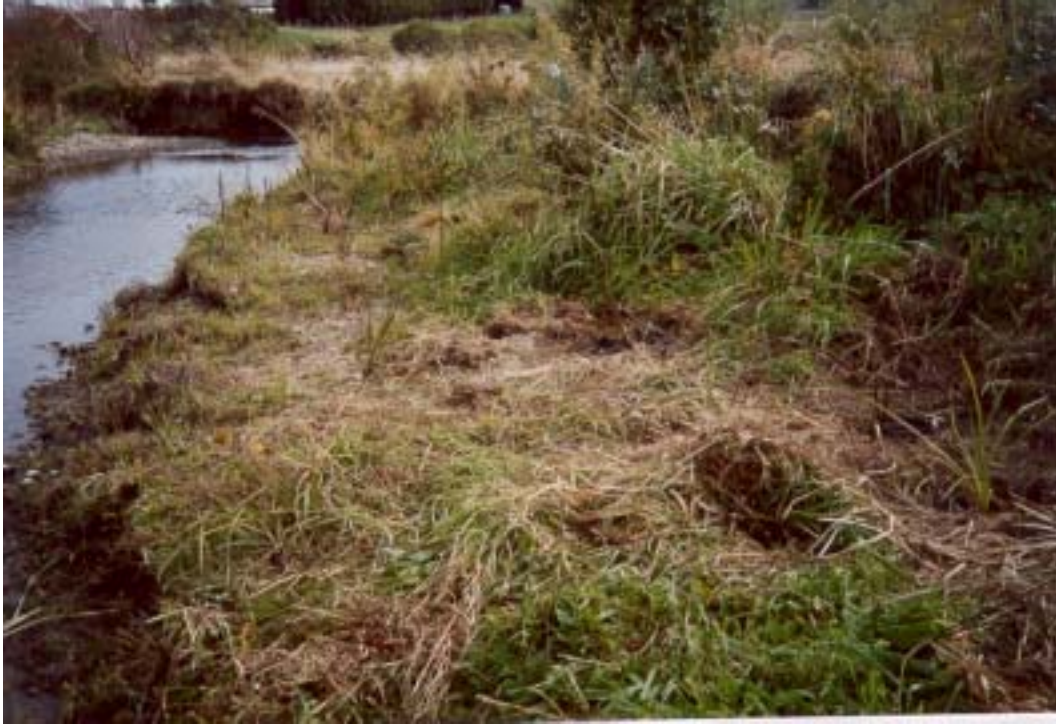
Figure 34: The true right bank of the Horokiwi Stream, downstream of the road bridge. This area, recently planted in flax, was regarded suitable for inanga spawning.

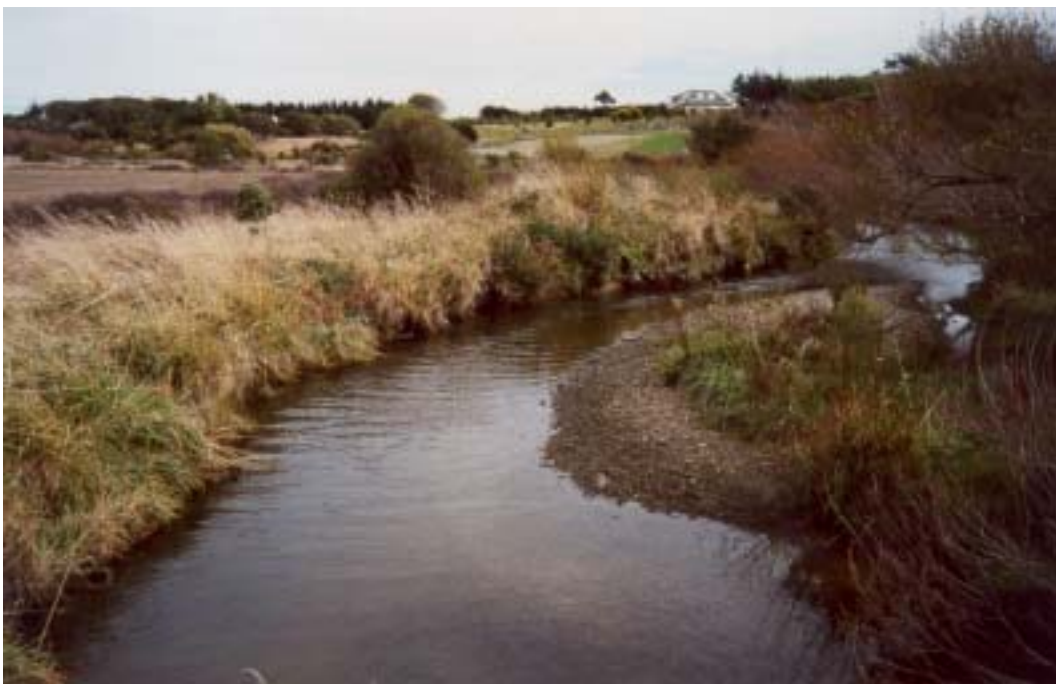
Figure 35: Horokiwi Stream. The steep left bank of tall fescue grass obscures a thick mat of root hairs overhanging the water. This microhabitat is often utilised by spawning inanga.

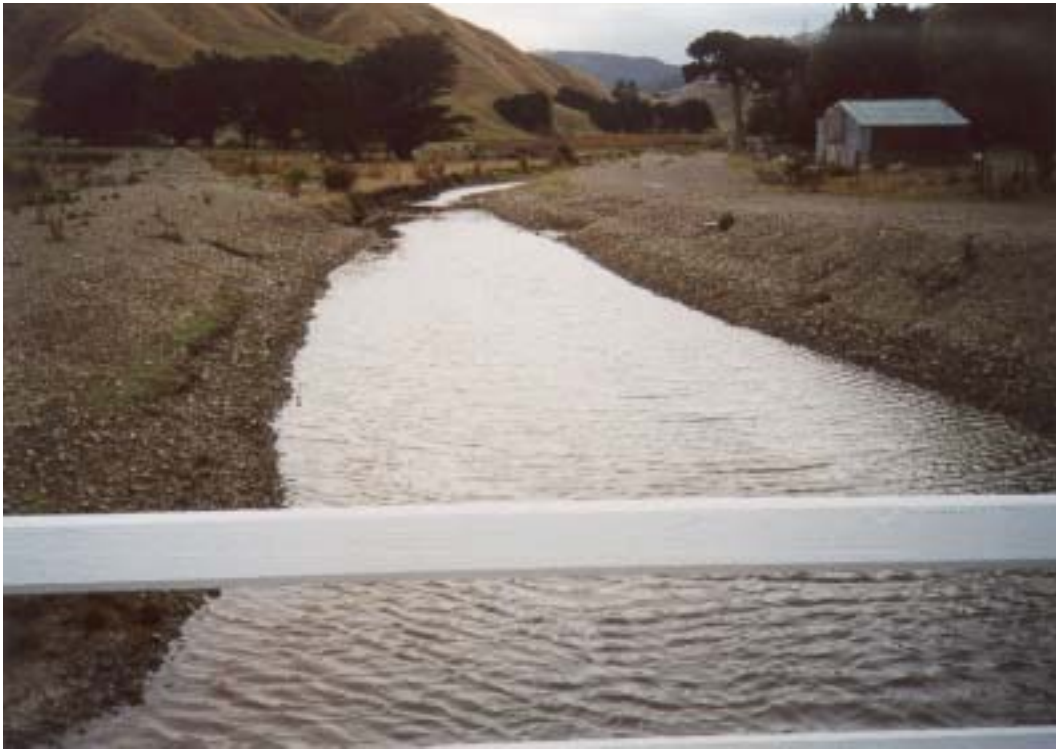
Figure 36: Kakaho Stream, looking upstream from Pauatahanui Road bridge. The banks have been mechanically graded and stripped of vegetation.

This ranking exercise isolates the Kakaho Stream catchment as possessing the best (and realistic) potential for habitat restoration. However, this is as equally due to the severely degraded nature of the riparian habitat, as to its potential. Upstream of the bridge, the potential for spawning had been considerably reduced by both unrestricted stock-grazing practices along the waterway, and some mechanised attempt at watercourse alignment (Figs. 36 & 37). Its potential for inanga was regarded as high firstly because of the significant amount of suitable rearing habitat for adult inanga which extended for 2km inland from Porirua Harbour. Secondly, apart from the fact that the banks were grazed to a stubble, the bank slope for inanga spawning in the tidally-influenced fresh water zone was ideal. It is possible that spawning habitat is better upstream beyond the area surveyed, but this area is too far upstream, as it would be beyond the tidal influence. To restore values in this catchment it is necessary to prevent unrestricted stock access to the lower reaches of the waterway. Ideally, water

troughs should be used, and stock excluded from the waterway's entire length, but failing that, stock should have access only to specific drinking areas.

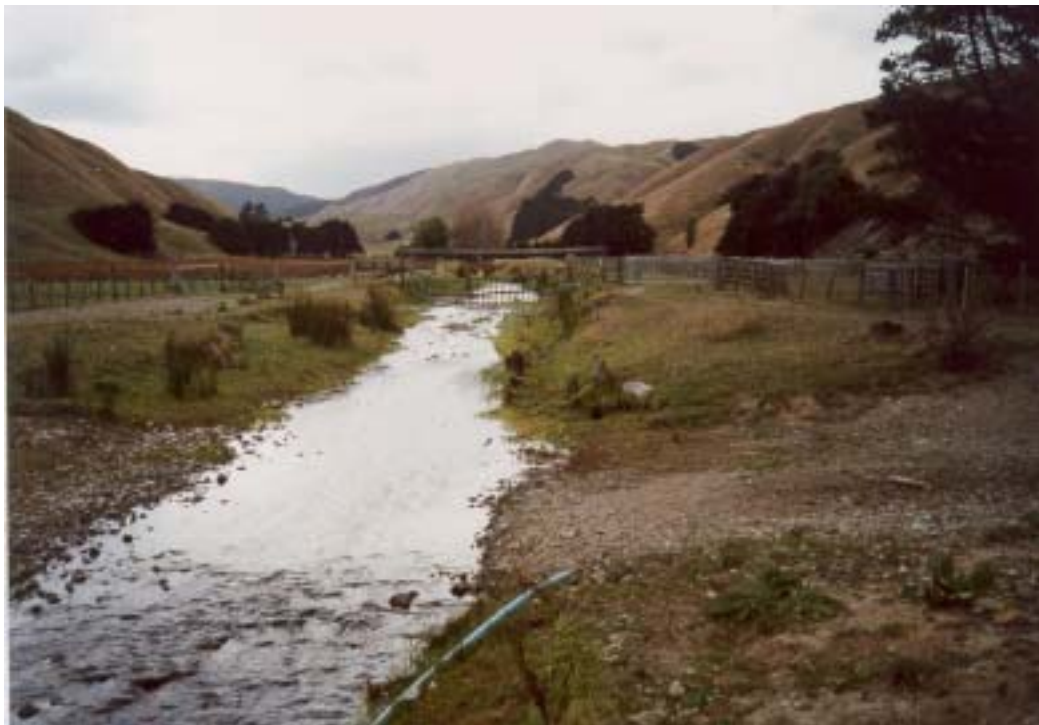
Figure 37: Kakaho Stream upstream from the bridge.

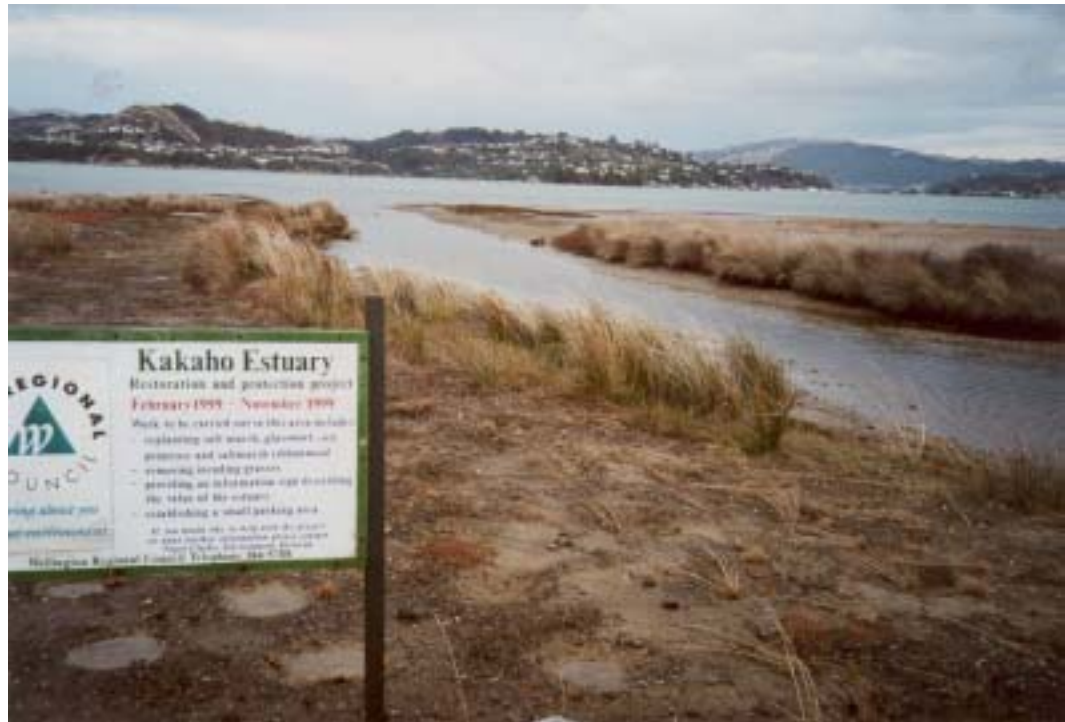
Figure 38: The Kakaho Estuary, looking downstream from Pauatahanui Road, showing the partially completed saltmarsh planting programme.

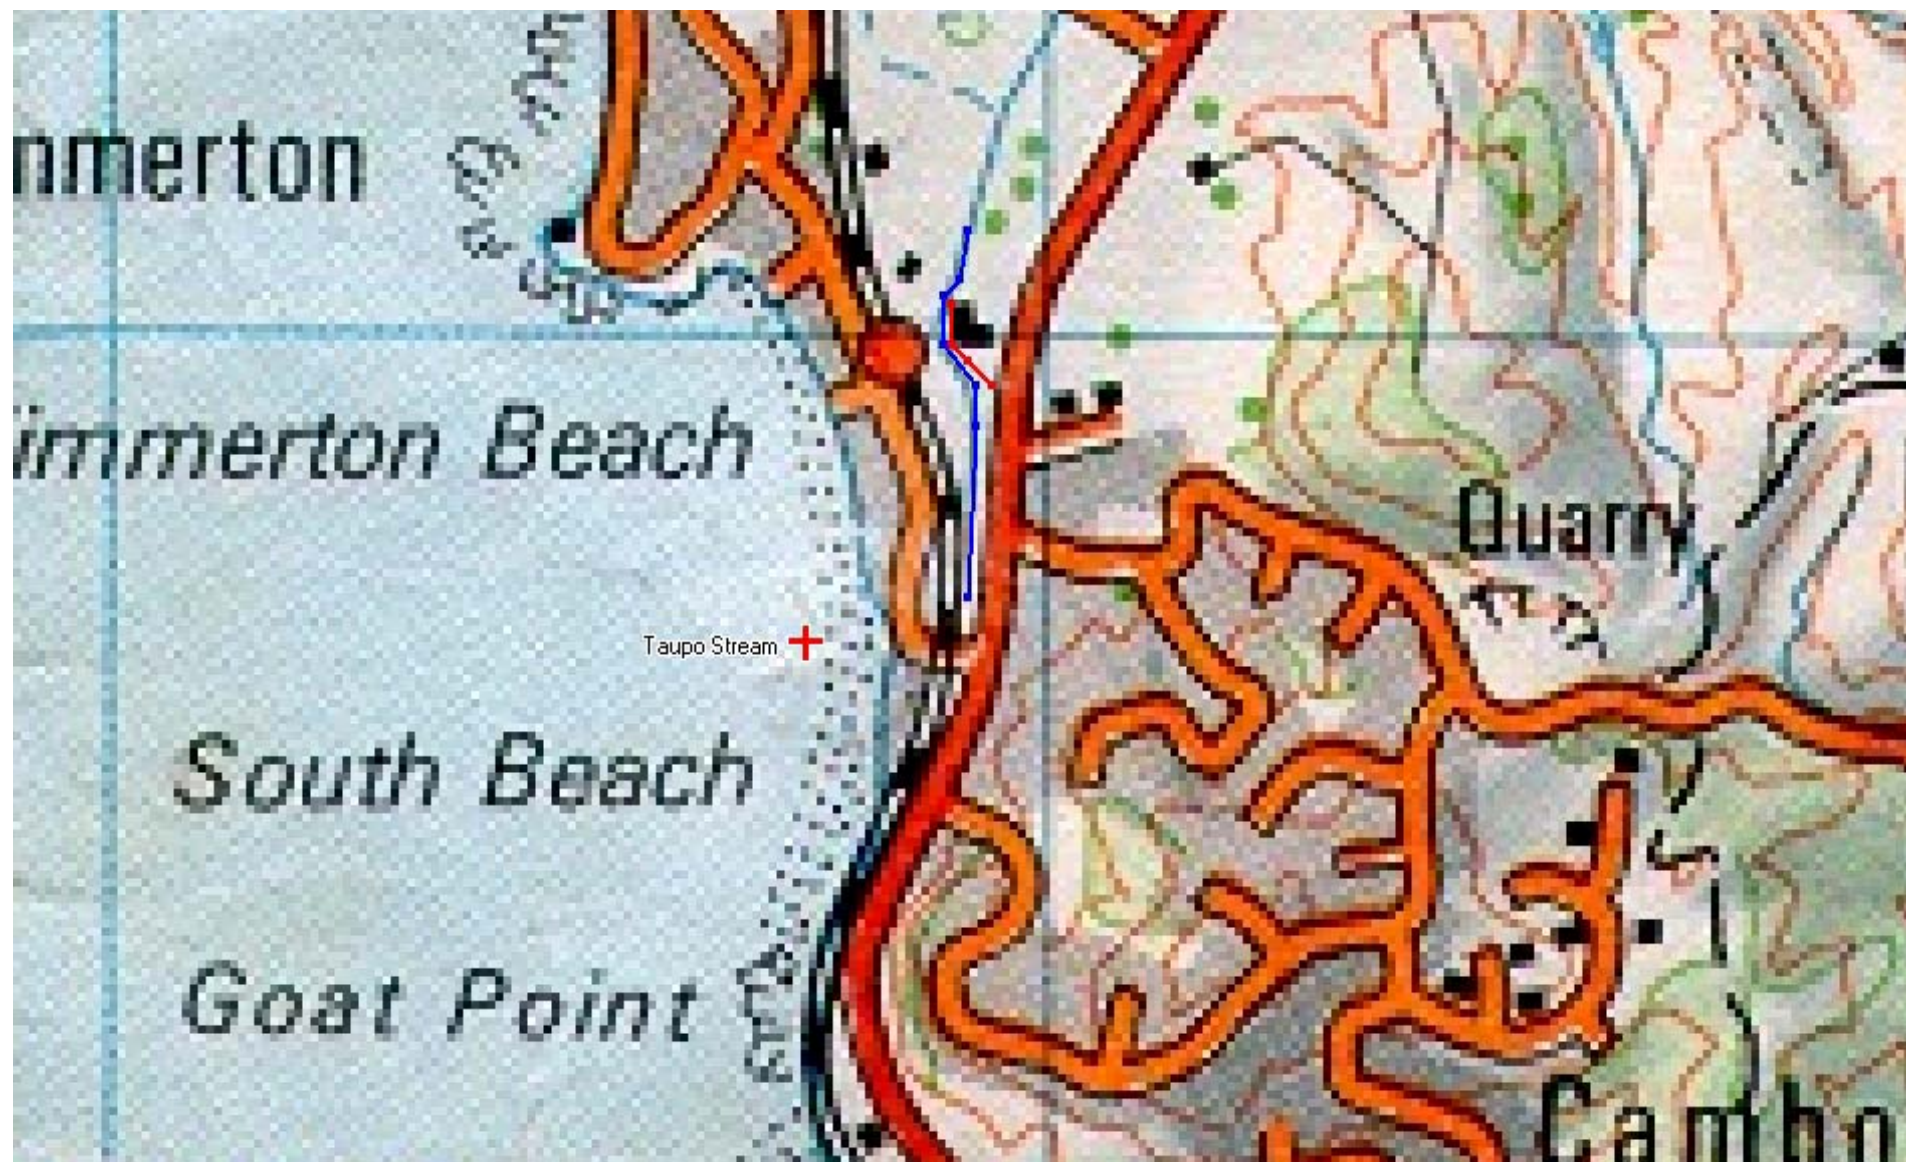
Figure 39: Extent of survey (blue) and potential spawning area (red) on Taupo Stream.

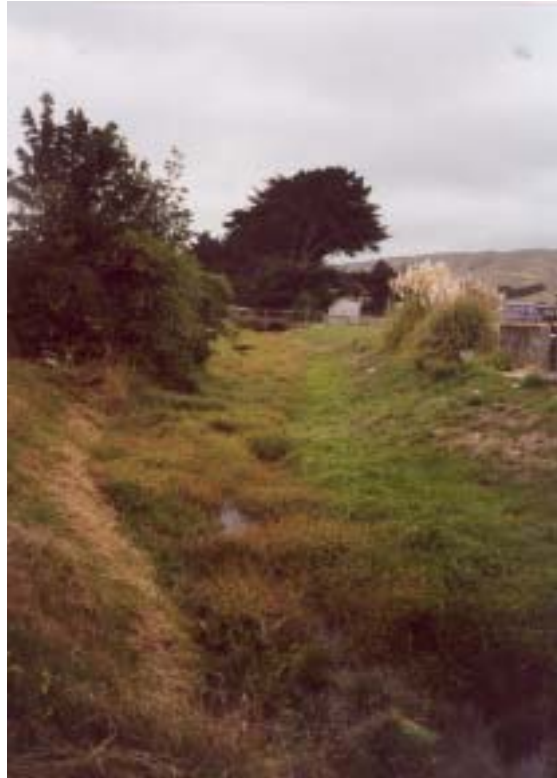
Figure 40: Taupo Stream at the Plimmerton Domain. The channel is partially dewatered, and the banks mown.

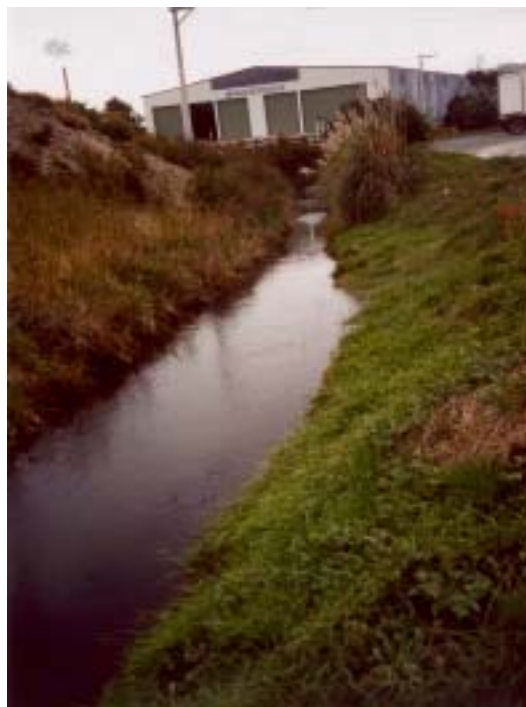
Figure 41: Suitable inanga spawning habitat on Taupo Stream, downstream of the Plimmerton Domain. The right bank (true left) appeared to be the most suitable.

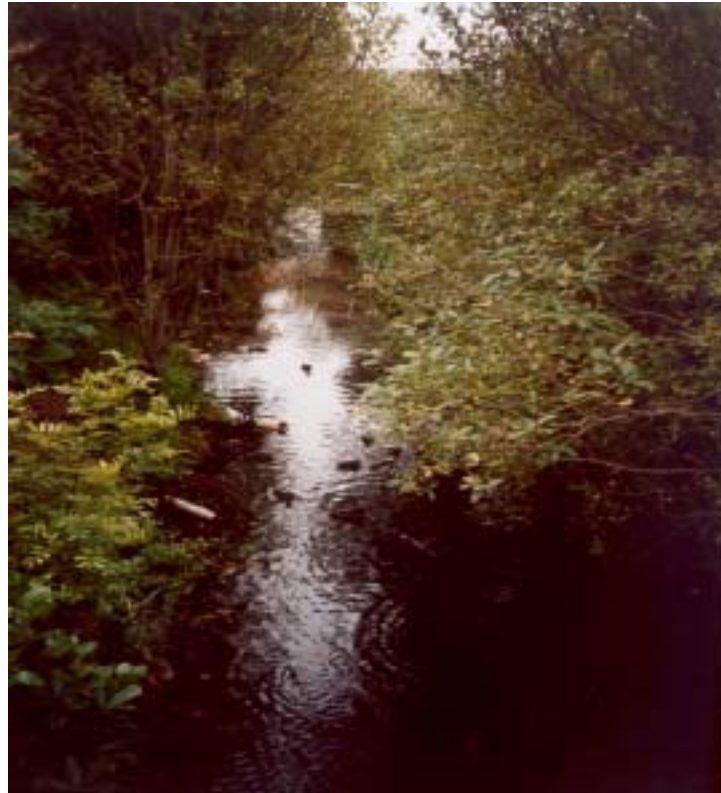
Figure 42: The dark, shaded conditions of the lower reaches of Taupo Stream. While this area would be good for inanga rearing, the paucity of soft vegetation makes it unsuitable for spawning.

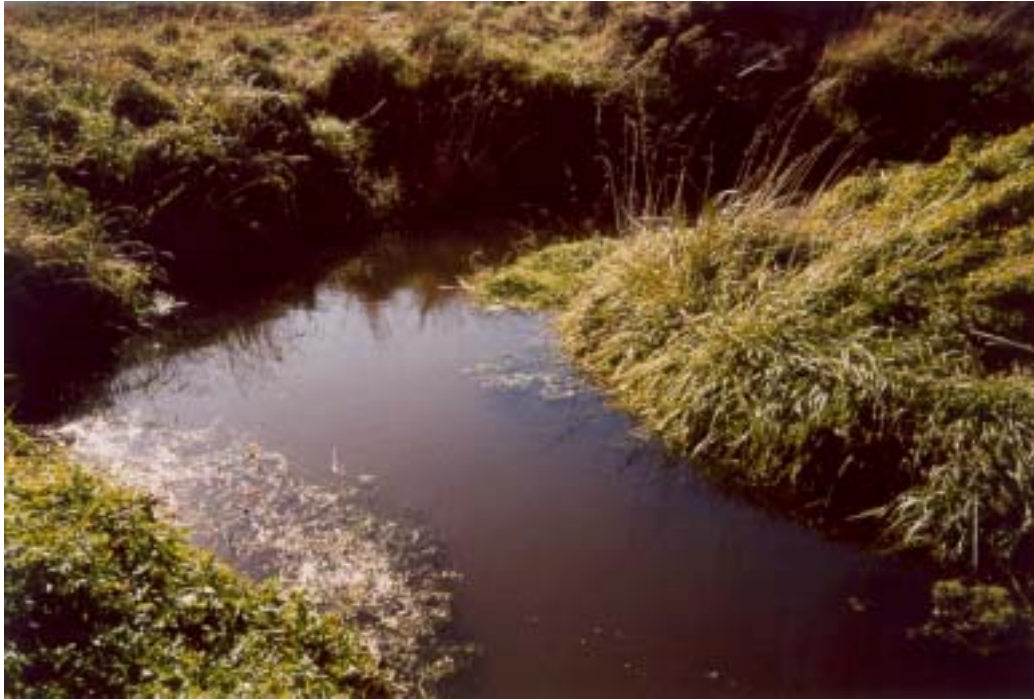
Figure 44: Suitable spawning vegetation on the Whareroa Stream, near the end of the saltwater wedge.

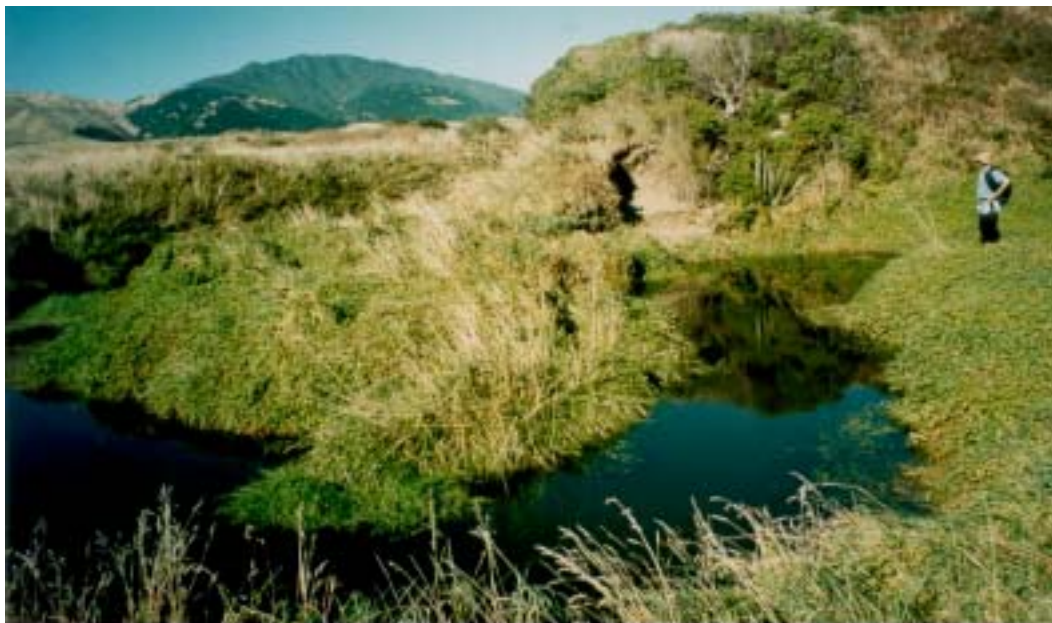
Figure 45: Good spawning habitat near the terminus of Whareroa Stream.

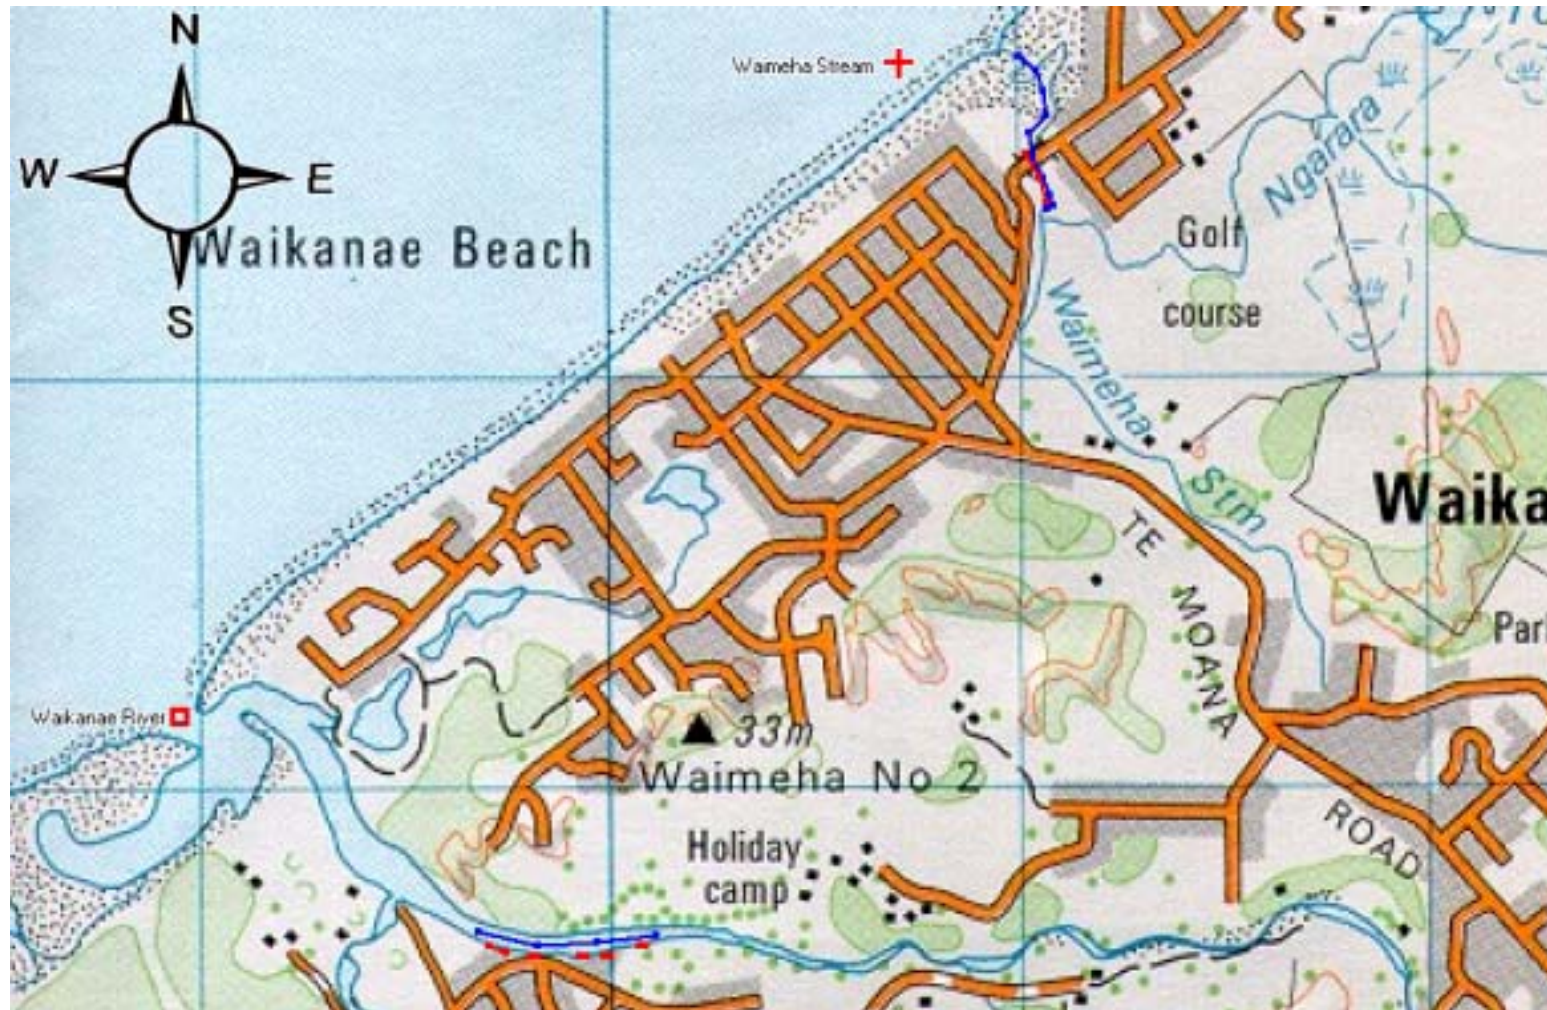
Figure 46. Extent of surveys (blue) and potential spawning areas (red) on Waimeha Stream, and Waikanae River

The extent of survey, and potential spawning grounds are depicted in Fig. 46. As typically found on larger rivers, suitable spawning areas on the Waikanae River were patchy in distribution. A number of small suitable areas were located within and downstream of the Otaihanga Reserve, but predominantly on the true left (south) bank (Fig. 47). While the bank was steep in some places, with some bank stabilisation by willow trees, the north-facing bank aspect meant that underlying grasses were not shaded by tall vegetation in most areas, and therefore grass growth was sufficiently luxuriant to support spawning. These grasses were predominated by tall fescue and creeping bent. At the downstream limit of the Reserve, overgrowths of blackberry and old man's beard on the true left bank may be also reducing potential inanga spawning habitat. At the downstream limit of the reserve on the south bank, the grassy bank slope was more gentle, and thus offering a potentially greater surface area for spawning.

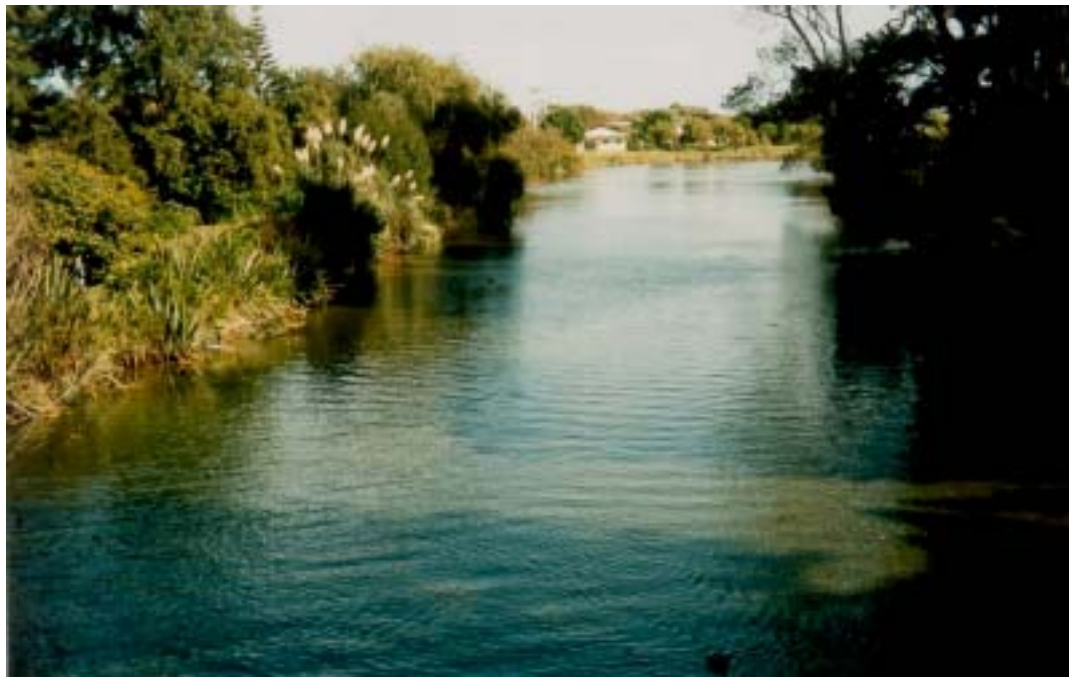
Figure 47: The mainstem of the Waikanae River looking downstream from the Otuhaima Reserve footbridge. The best spawning habitat was on the left bank in between the flaxes and toetoe.

In contrast, the true right bank was heavily shaded by tall pine trees, with an underlying gravel bank with an unsuitably thin layer of soil and tall fescue. Soil moisture retention of this bank would be low in these areas, and utilisation by inanga for spawning would not be expected.

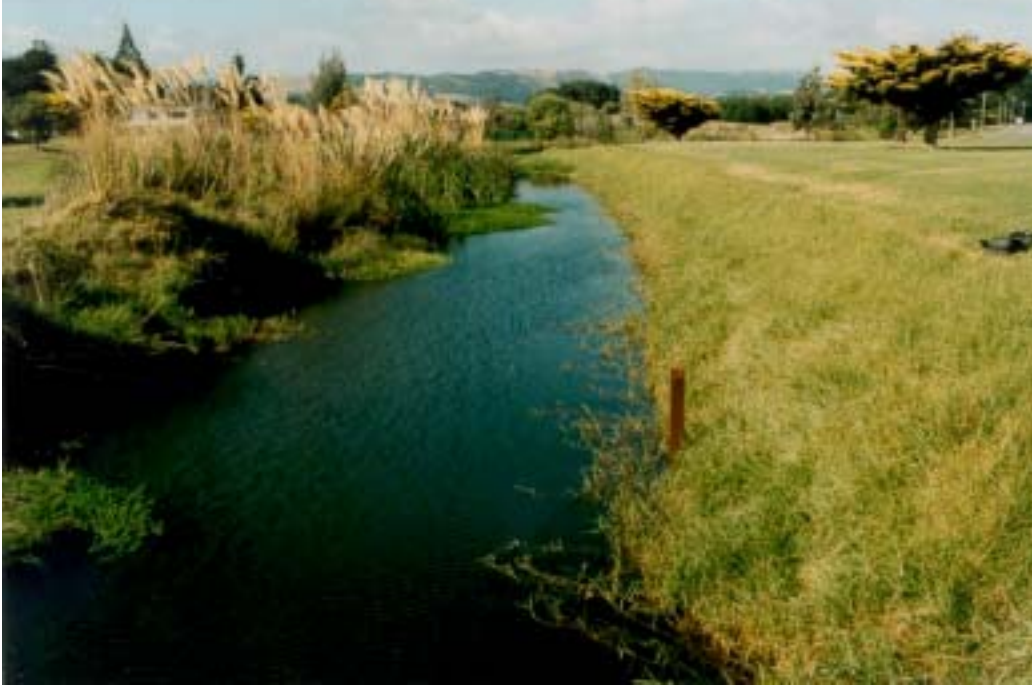
High tide conductivity readings indicated that the stream ran fresh at the time of the survey. The most suitable bank was the true left (south) bank, which, although mown, had uncut grass of sufficient length to support inanga egg development (Fig. 48). In contrast, the true right bank had a sandy soil type, and therefore unlikely to retain sufficient litter-layer humidity.

Figure 48. Waimeha Stream looking upstream from the road bridge. The grass on the right bank, though mown, is of sufficient length and thickness to offer suitable spawning habitat.

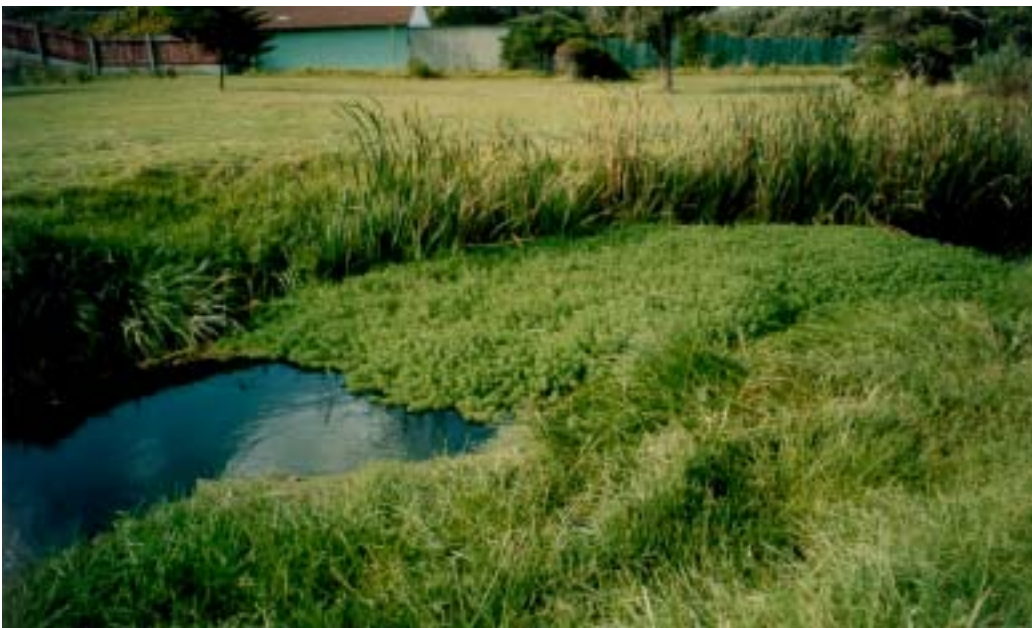
Figure 49: Overgrowth of parrots feather in Waimeha Stream.

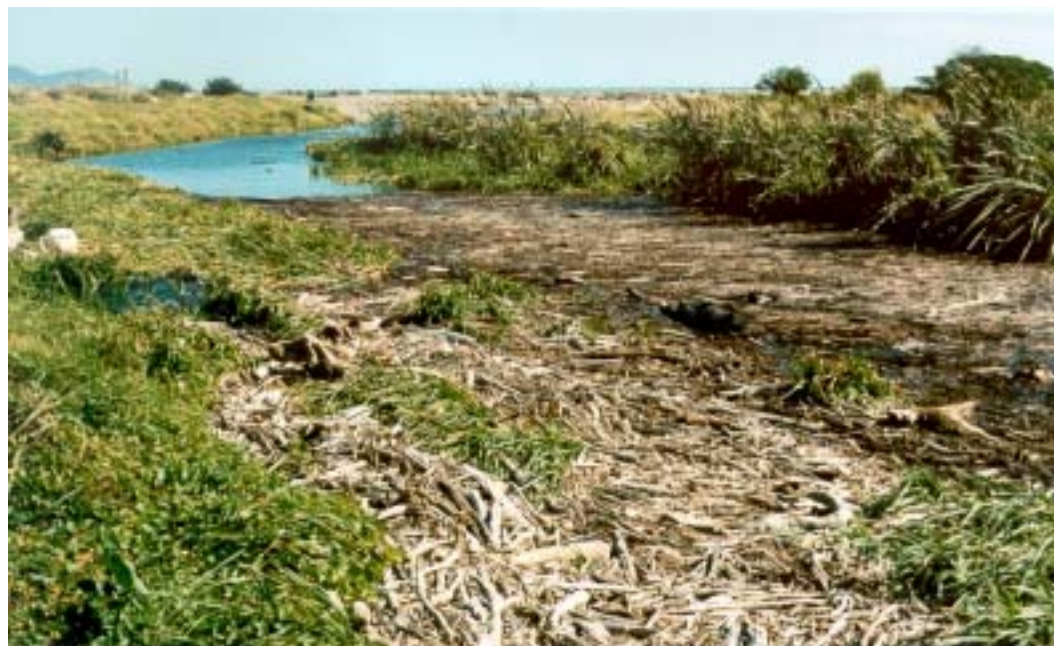
Figure 51: A grass-infested raupo stand which provides good spawning habitat on the lower reaches of the Mangaone River (far bank). Floating beds of reed sweet grass blocked the lower channel on this waterway.

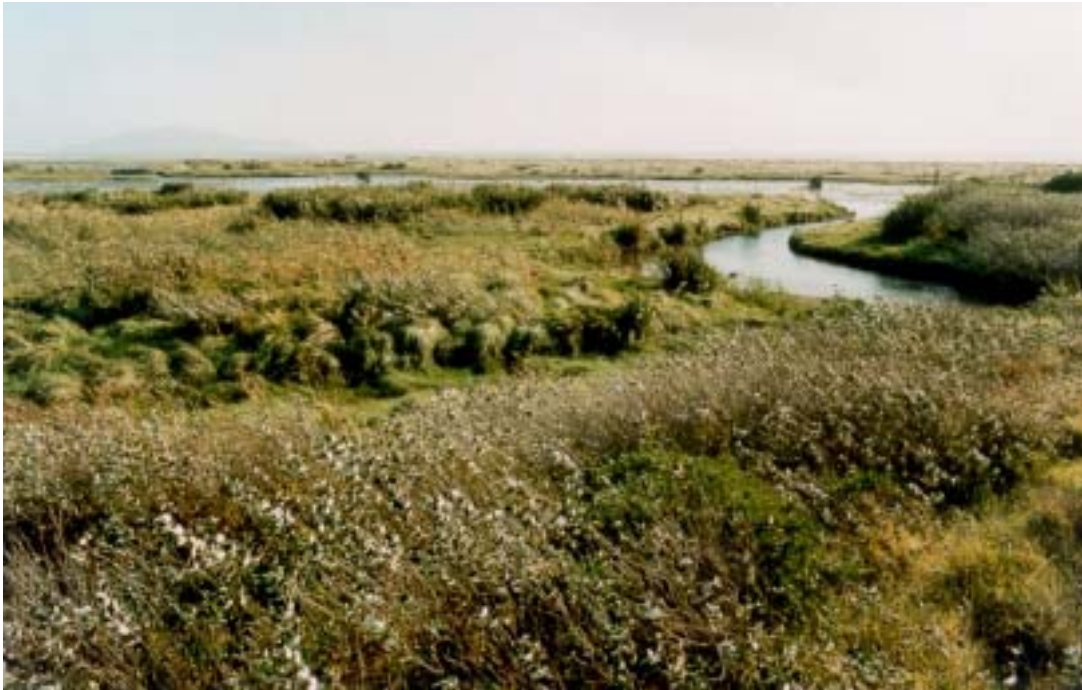
Downstream of the flap-valve tidegates on the north-side tributary (Nga Toko Toko), the system opens out into a broad lagoon, with an extensive area of raupo, flax, and grasses (Figs. 53, 54). It is this raupo and grass plain which offers good habitat for inanga spawning. The normal tidal range in the area was approximately 1m, sufficient to inundate the margins of this area, and the area was quite moist underfoot. While some *Convolvulus* was present here, it appeared to have been sprayed. This area would be available to inanga resident in the lagoon - a shoal of inanga were seen below the tidegates - and upstream-resident inanga that could negotiate the tidegates before they close.

Figure 53: Looking downstream at raupo beds in the lagoon area of the Nga Toko Toki river (Otaki River Catchment).

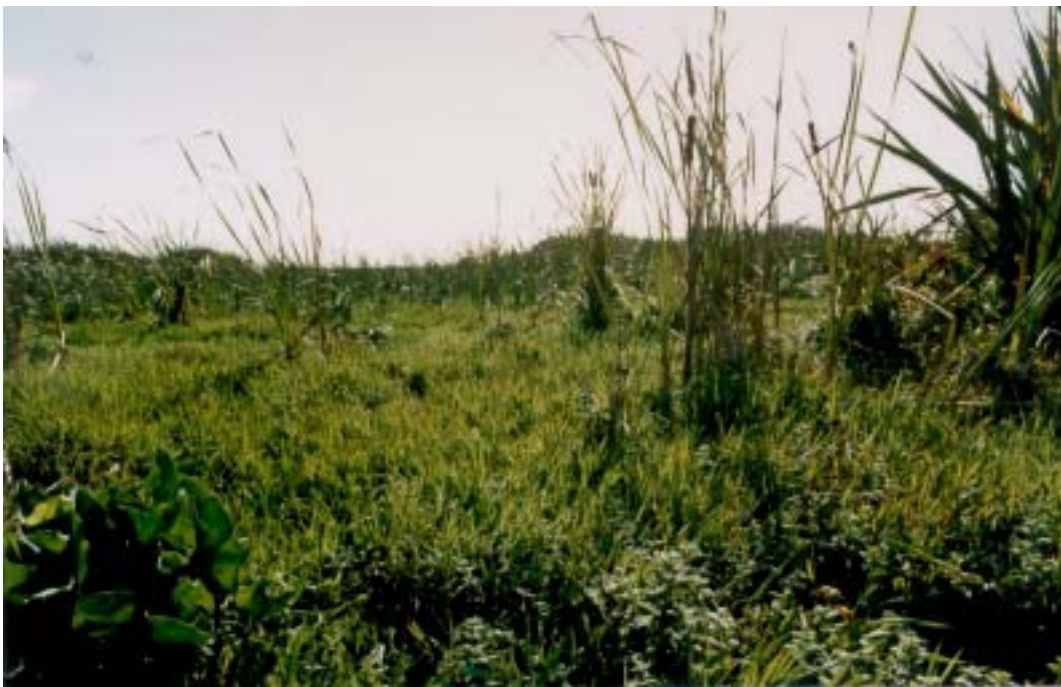
Figure 54: This raupo bed provides good spawning habitat on the lower reaches of the Nga Toko tributary of the Otaki River.

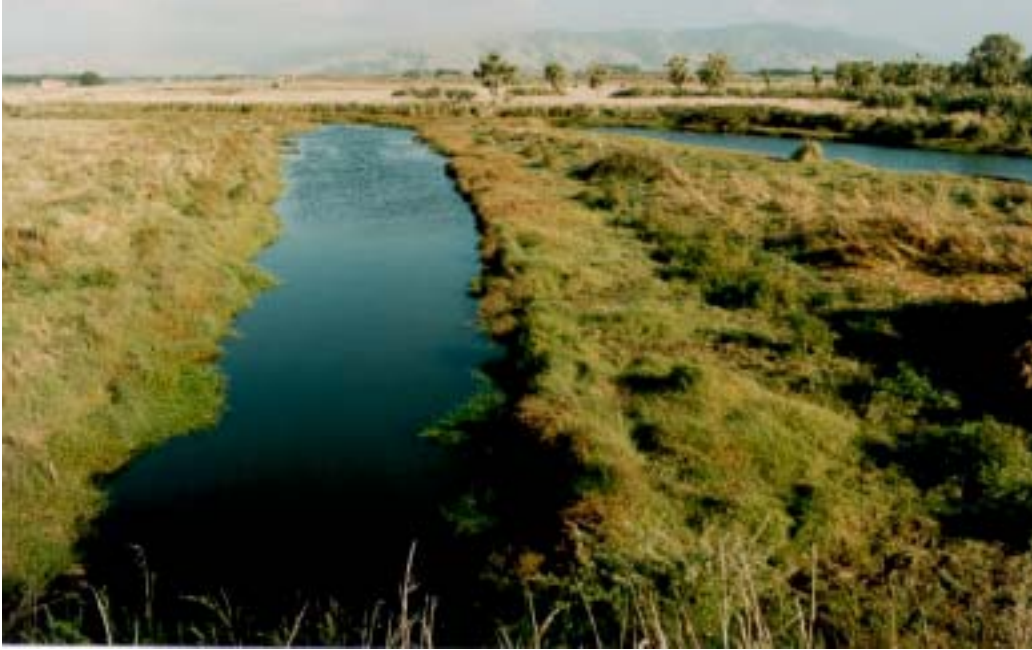
The south-side tributary has been pastoralised with some native vegetation comprising flaxes and cabbage trees. However the riparian zone is dominated by tall fescue downstream of the tidegates with a component of creeping jenny upstream. Both of these grasses are suitable for spawning, but the best habitat (in terms of area, thickness and composition) was found upstream of the tidegates (Fig. 55). The upstream watercourse has formed a second blind-ended branch which also offered good spawning potential. However, despite its suitability, it is unknown to what extent the upstream area would be utilised when the tidegates are shut on the spring tides. There was also suitable habitat, of a slightly lower standard, on the downstream side of the tidegates (Fig. 56).

Figure 55: Looking upstream of the tidegates on the tributary on the south bank of the Otaki River. The vegetation here was highly suitable for inanga.

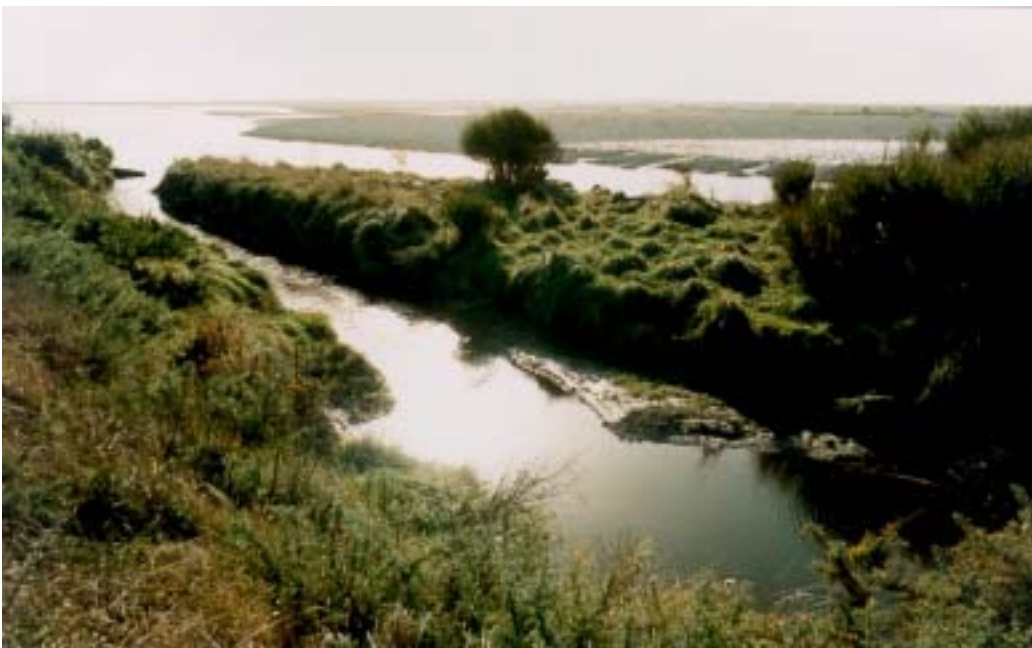
Figure 56: Spawning habitat in an unnamed tributary of the Otaki River (on the south bank), looking downstream of the tidegates.

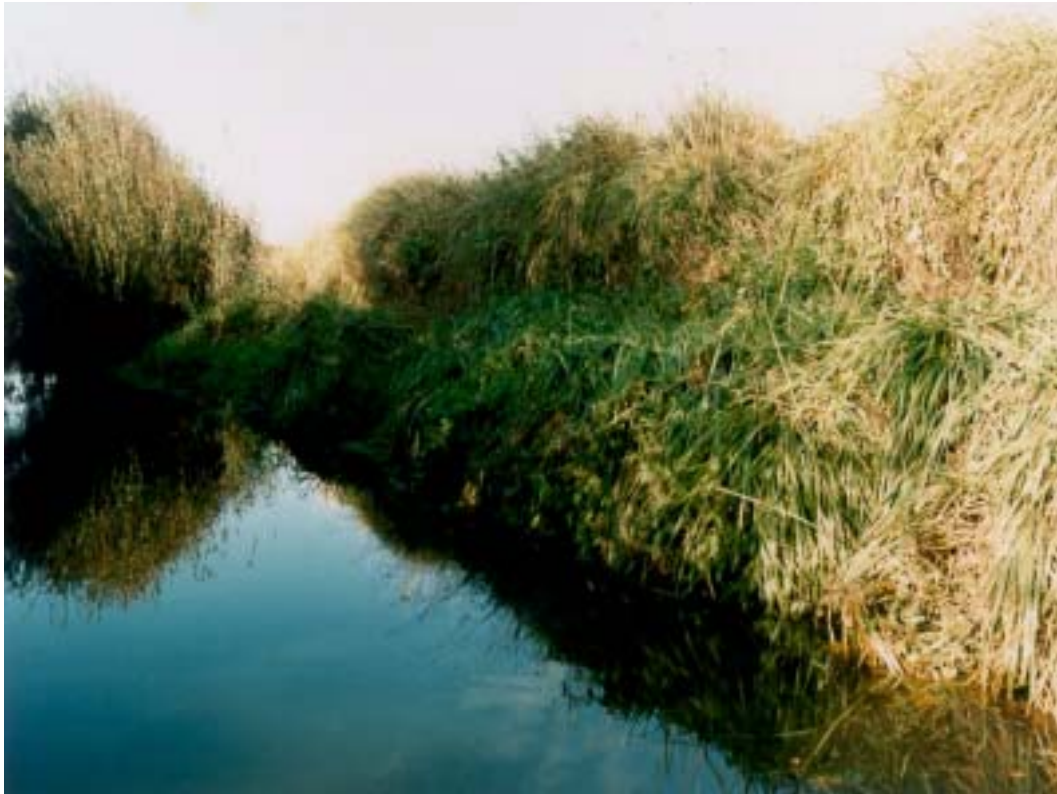
Figure 58: Riparian grassy vegetation on Waitohu Stream. Surprisingly, the vegetative cover at ground level was sparse.

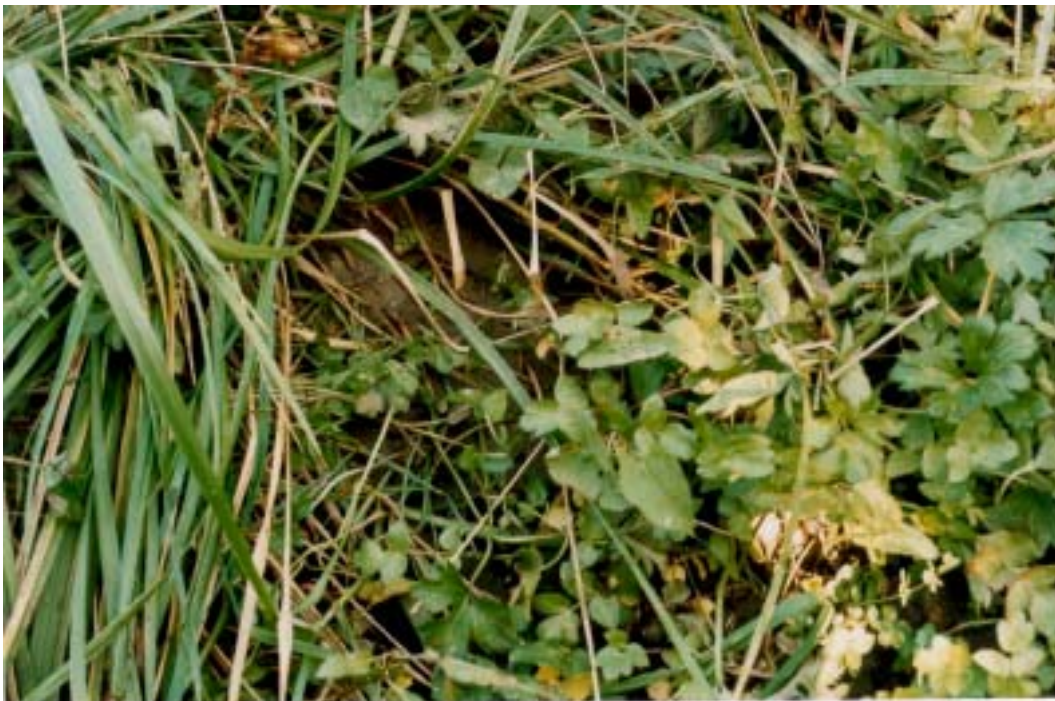
Conductivity readings were taken on the high an rising tide, and the thickness of the saltwater wedge monitored along the water course. Despite several shoals of inanga being observed in the river and the apparent lushness of the riparian grass (Fig. 58) the underlying soil structure (100% sand) was unsuitably sandy for inanga spawning (Fig. 59).

Figure 59: The sandy soil and thin covering of tall fescue grass and herbs in the lower Waitohu stream. This vegetation was regarded as unsuitably sparse for inanga spawning.
