Inanga spawning habitats in the Wellington

Wellington Regional Council

NIWA Client Report: CHC01/67
Project No.: WRC01501
July 2001

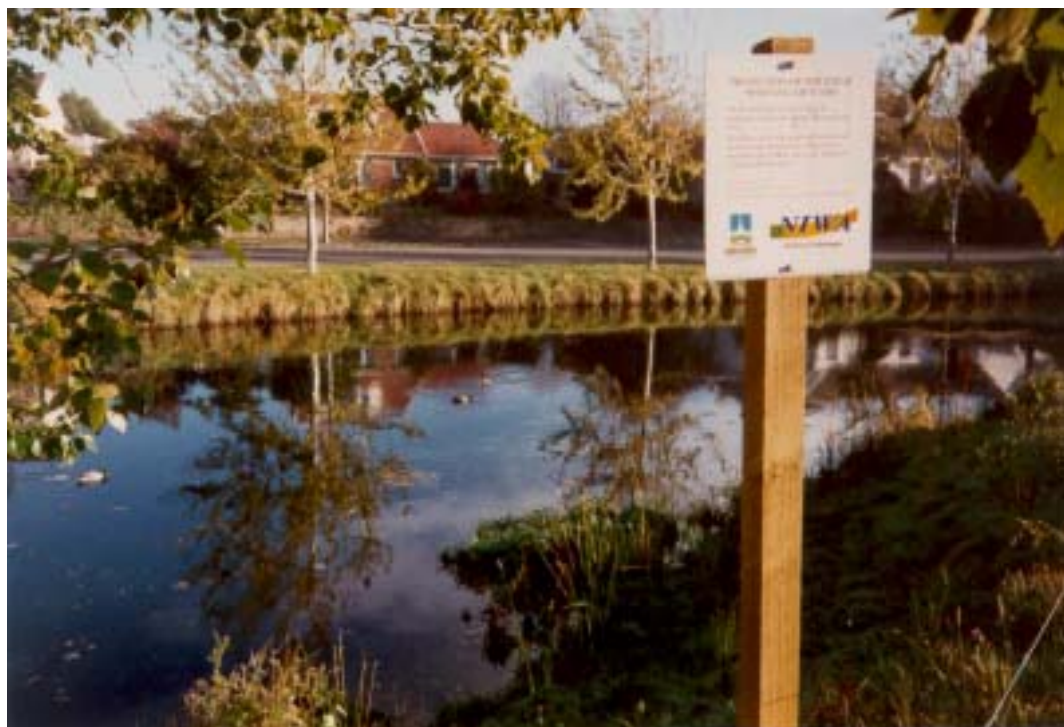
Figure 60: The establishment of native rushes and exotic grasses at the Heathcote River spawning site in Christchurch.
