Riparian rehabilitation to improve aquatic environments in the Wellington region

Results from the riparian management pilot programme, 2002-07

Alton Perrie

GW/EMI-T-08/80

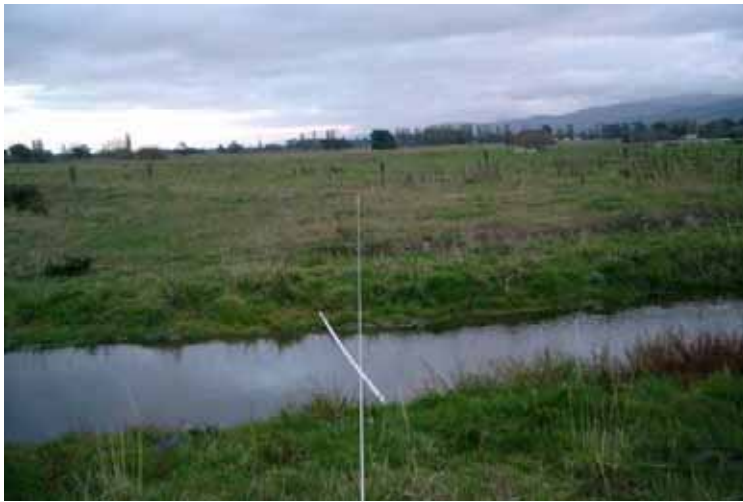
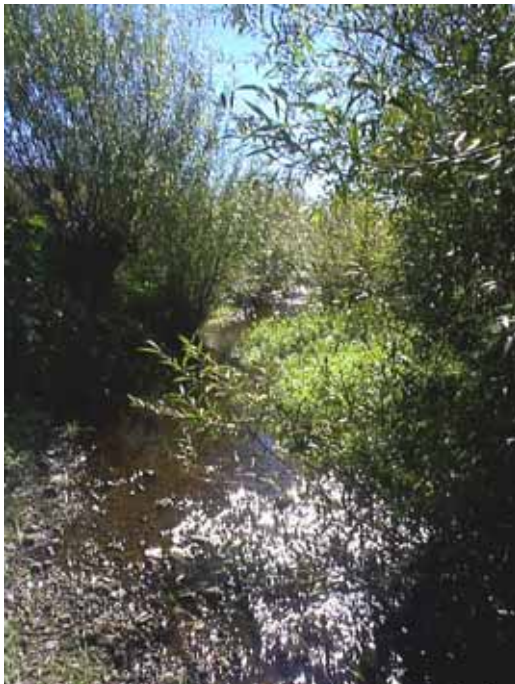
Figure 4.3: Sites upstream (top) of and within the rehabilitation area (downstream) of the Enaki Stream. Photos taken in 2003 and 2005 respectively.

Vegetation cover within the rehabilitation area of the Enaki Stream was significantly greater than that upstream (Figure 4.3). This was more evident in vegetation cover greater than 5 m high (Figure 4.4). Twelve percent cover was provided by vegetation in this height class within the rehabilitation area (consisting of willows and poplars), but there was 0 % cover upstream. Vegetation cover was also higher in the 0.5 m to 5 m height class within the rehabilitation area (32 %), while upstream this height class provided 25 % cover. Composition was similar between reaches for this height class and both sites were dominated by a mixture of broom, willows, poplars and a range of planted natives including flaxes, pittosporums and cabbage trees.

Riparian rehabilitation along a reach of the lower Enaki Stream has resulted in improvements in aesthetics (refer to Figure 4.3), bank stability, streambed shading, instream temperatures, as well as aspects of water quality and habitat quality. The rehabilitation area also appears to buffer against the detrimental effects from extreme environmental conditions; the stream invertebrate community was noticeably healthier within the rehabilitation area compared with that upstream during drought conditions in 2003.

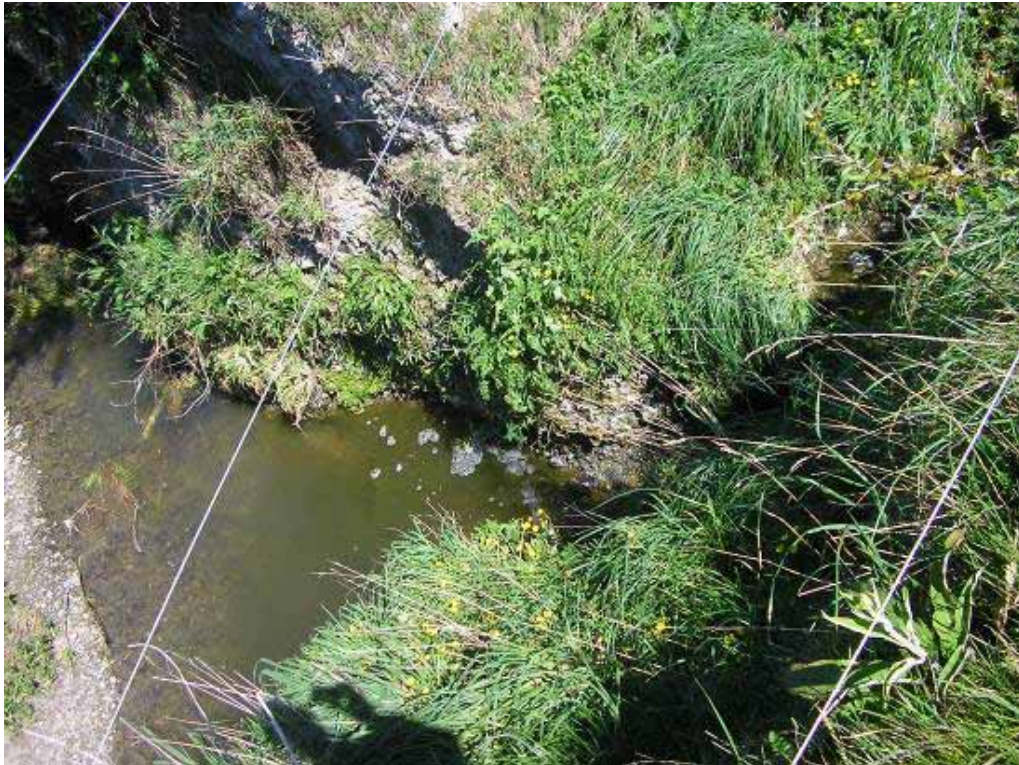
Figure 4.11: Raw dairy shed effluent illegally discharging to a tributary of the Enaki Stream upstream of the rehabilitation area during October 2007.

Poor dairy farming practices in the Enaki Stream catchment are evidenced by the results of Greater Wellington's 2007/08 compliance inspections. Four advisory notices and two infringement notices were issued, all dealing with poor effluent disposal; dairy effluent was either entering a waterway in the catchment (Figure 4.11), or had a high potential to do so (Steven Orr, pers. comm. 2008⁶). In this case, elevated nutrient concentrations probably also reflect subsurface inputs from the shallow unconfined aquifer; Tidswell (2008) reported elevated nitrate-nitrogen concentrations in shallow groundwater around Carterton, attributed to intensive farming (a piggery and dairying) in the area.

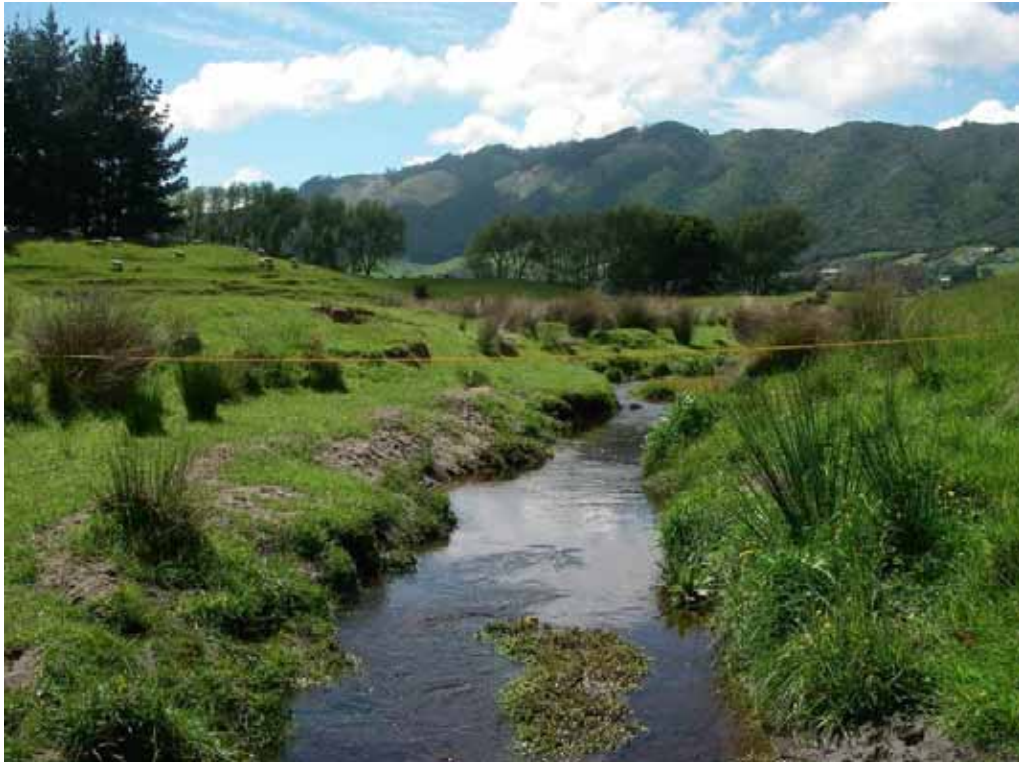
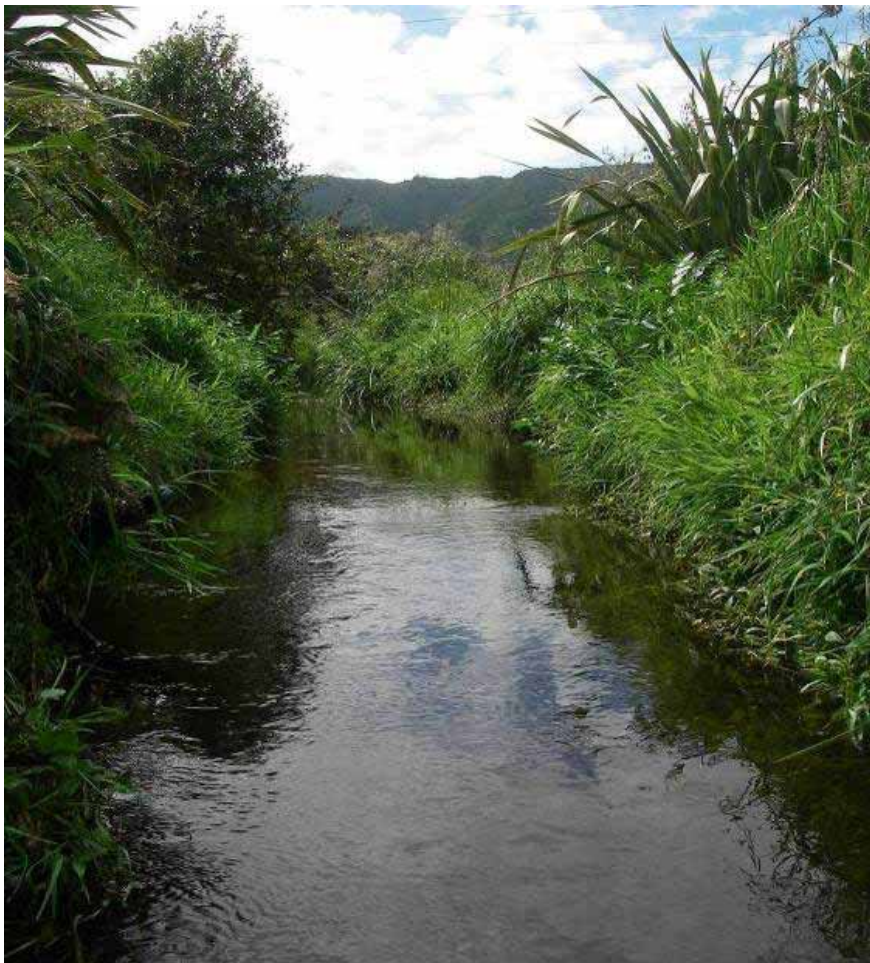
Figure 5.3: Typical stream reaches at the upstream site (top) and within the rehabilitation area (downstream site). Photos taken in 2008.

Estimates of streambed shade within the rehabilitation area were double that of the upstream reach; 19 % and 9 % respectively. However, this is still well below the 84 % streambed shade estimated at the reference site (Figure 5.5). As with vegetation cover, estimates of shade were similar to those previously reported in 2003.

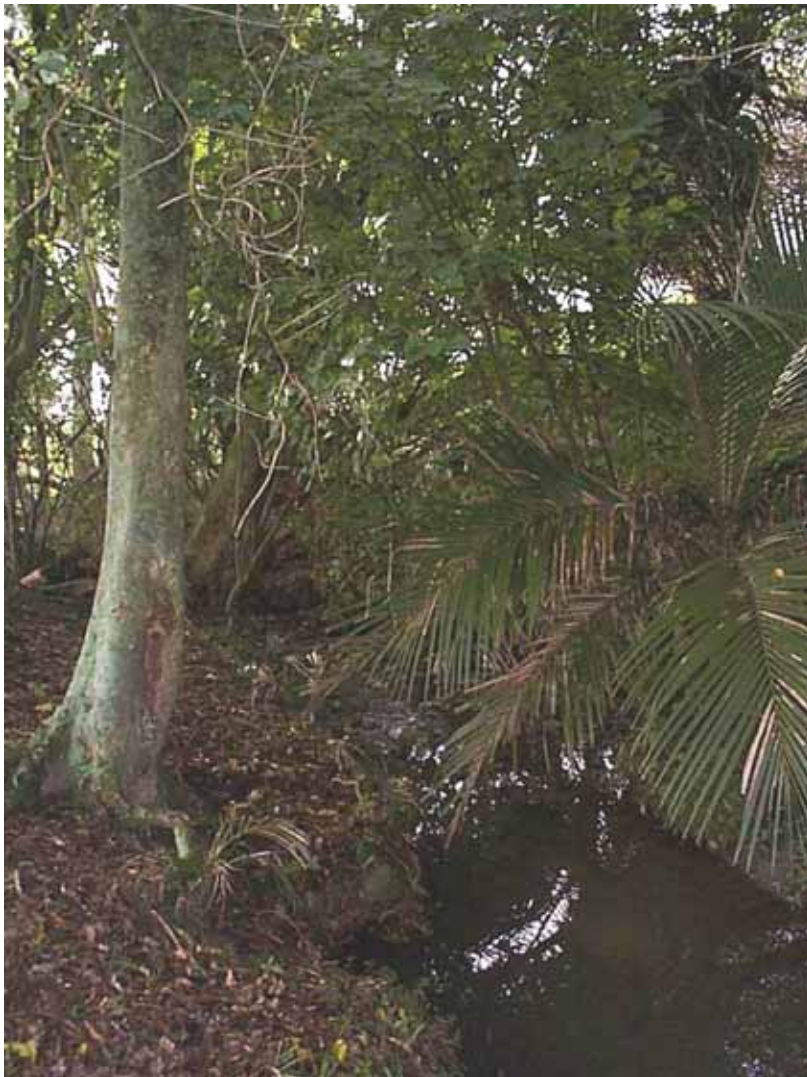
Figure 5.5: Mature canopy cover at the reference site, which provided four times greater streambed shade cover than vegetation at the rehabilitation site.

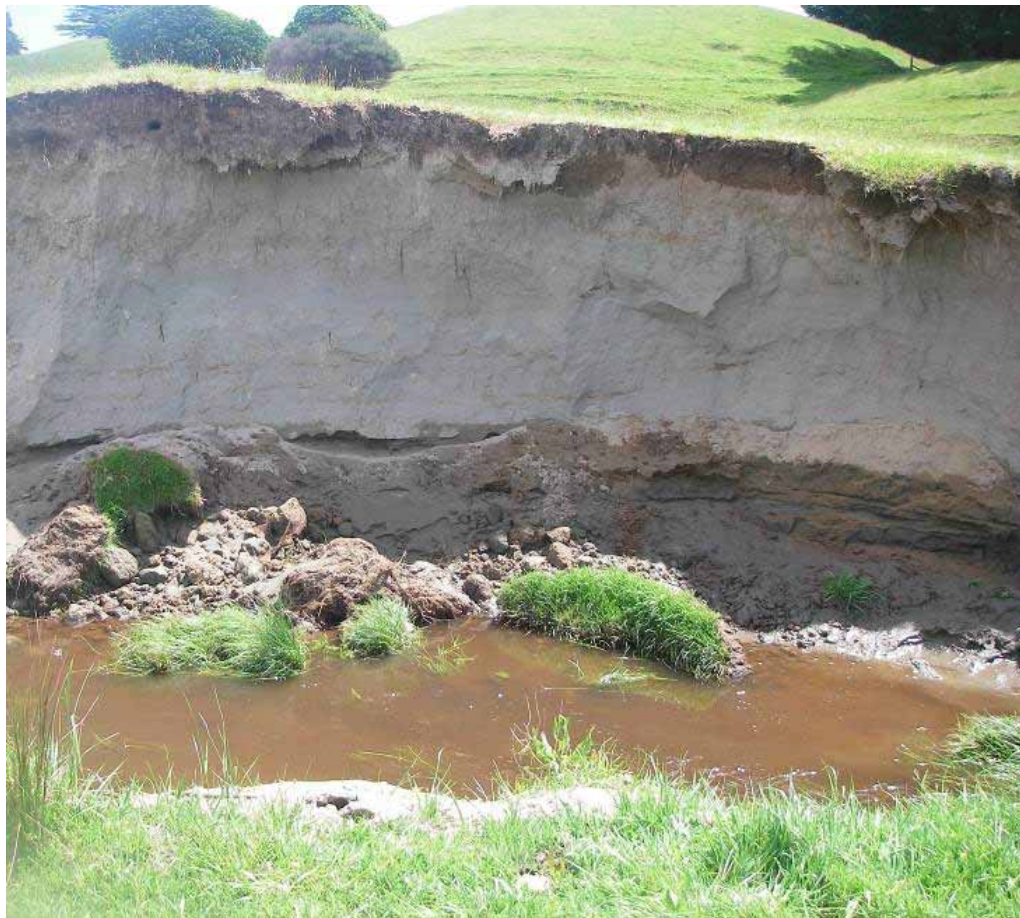
Figure 5.6: Upstream of the rehabilitation area erosion and slumping were common resulting in lower bank stability. Photo taken in 2008.

Bank stability scores improved from poor to fair between the unfenced upstream site and the rehabilitation area, the same as found in 2003. Undercutting and slumping of banks, while still present within the rehabilitation area, were more common upstream (Figure 5.6).

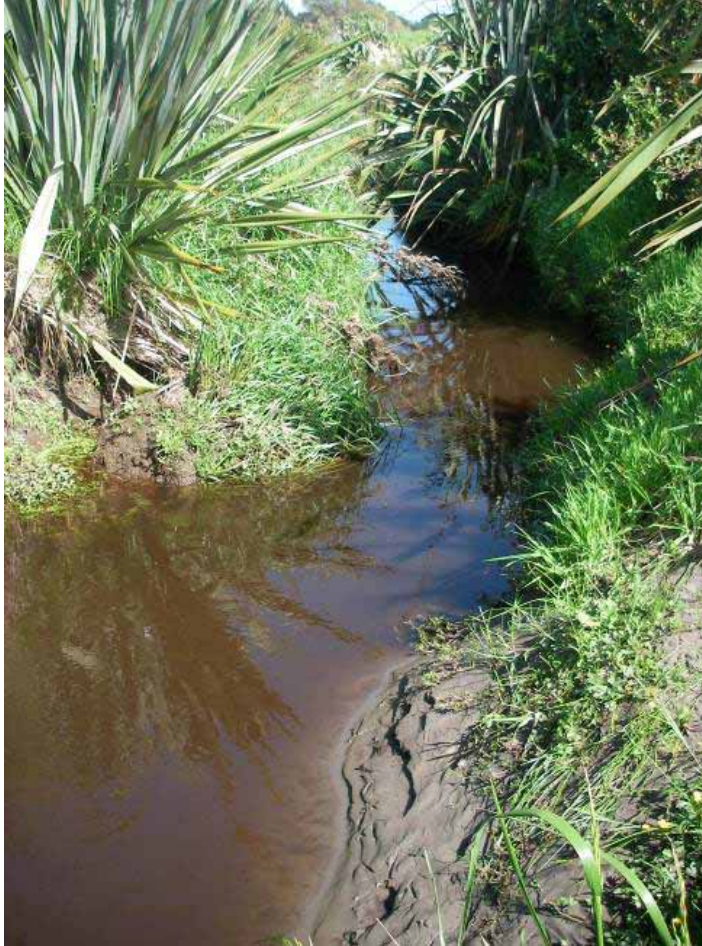
Figure 5.7: Silt substrate along the true right bank within the rehabilitation area. Note the tannin-stained water.

Substrate both within and upstream of the rehabilitation comprised 100 % silt (Figure 5.7). Substrate cover at the nearby reference site was very different and comprised moderate amounts of large and small cobbles as well as large and small gravels.

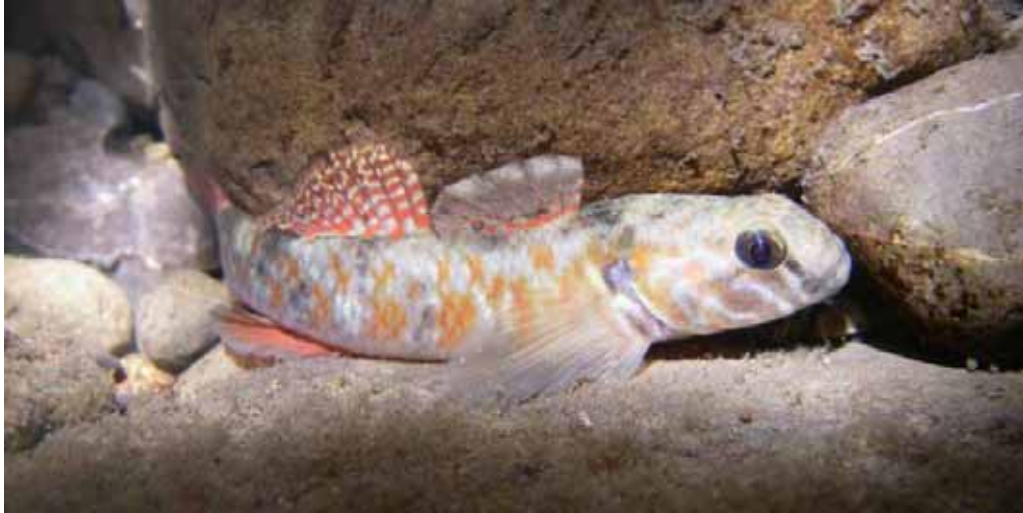
Figure 5.13: In 2007, a redfin bully was caught for the first time within the rehabilitation area of the Kakariki Stream and may be an indication of improving water quality and habitat quality.

Electric fishing in the Kakariki Stream showed that the species and abundances caught varied between sampling years for both sites, with many species recorded as either common or abundant on at least one sampling occasion but absent on another (Table 5.10). Typically, shortfin eels, common bullies and inanga were recorded in reasonable abundances (common or abundant) at both sites. Longfin eels, freshwater shrimp and koura were also caught in good numbers in some years. In 2007, a previously unrecorded species (redfin bully, Figure 5.13) was caught within the rehabilitation area.

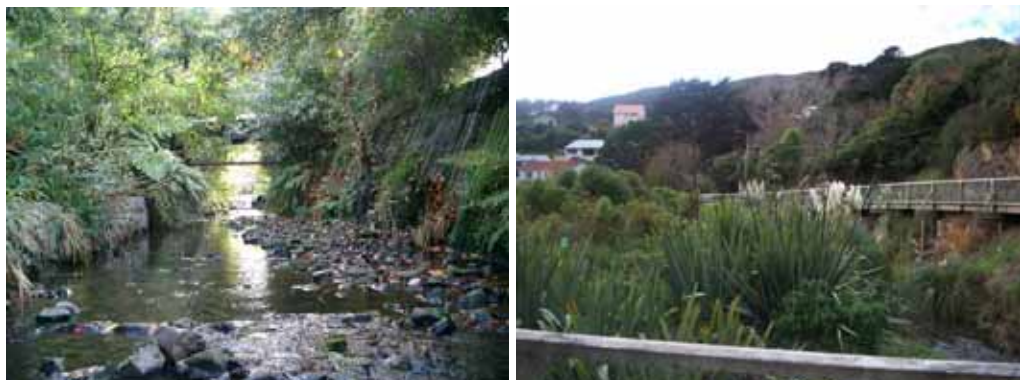
Figure 6.3: Monitoring sites upstream (left) of and within the rehabilitation area (downstream) on the Karori Stream. Photos taken in 2003 and 2006 respectively.

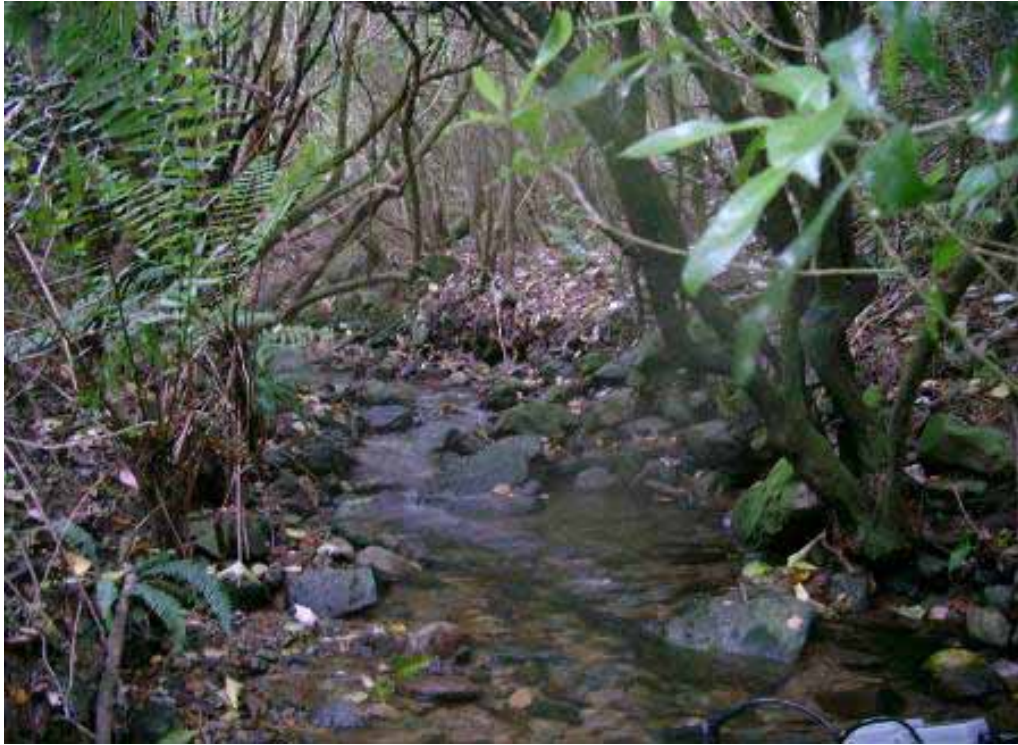
Figure 6.5: The mature canopy cover at the reference site provided significantly more streambed shade than vegetation cover within the rehabilitation area. Photo taken in 2003.

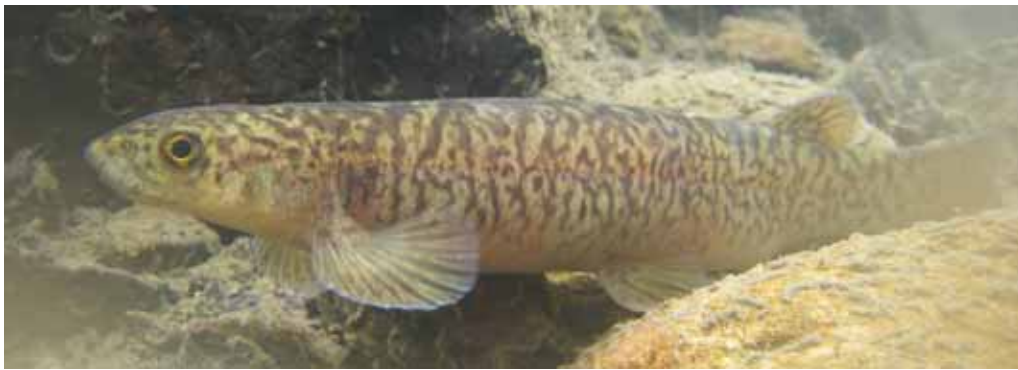
Figure 6.12: Koaro were more abundant within the rehabilitation area but this is thought to be related to instream habitat characteristics rather than riparian rehabilitation.

Fish communities in the Karori Stream were dominated by longfin eels and koaro with shortfin eels, brown trout, upland bullies, and koura found on some sampling occasions but normally in lower numbers (Table 6.6). Koaro (Figure 6.12) were more abundant within the rehabilitation area than the upstream reach on all sampling occasions.

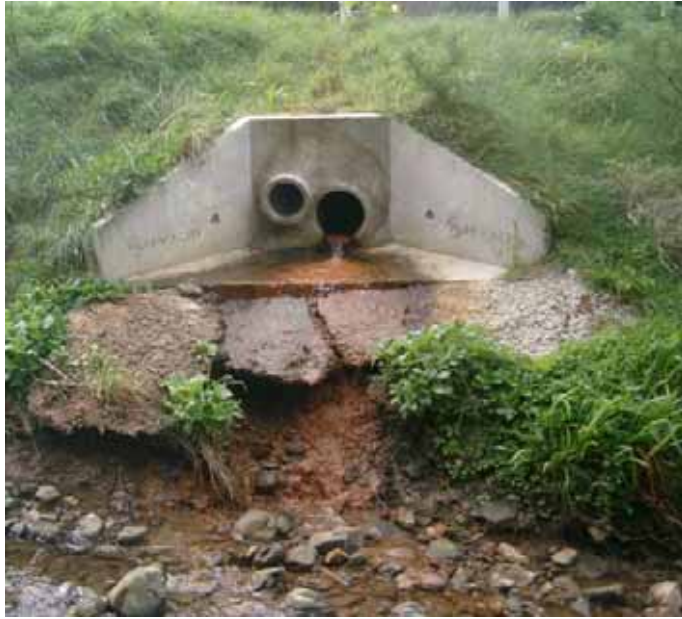
Figure 6.13: Stormwater inputs and runoff from the largely urban catchment upstream of the Karori Stream rehabilitation area will continue to limit improvements in water quality that are expected to occur through riparian rehabilitation
