Waikanae River Estuary

Intertidal Macroalgal Monitoring 2011/12

Prepared
for
**Greater
Wellington
Regional
Council**
June
2012

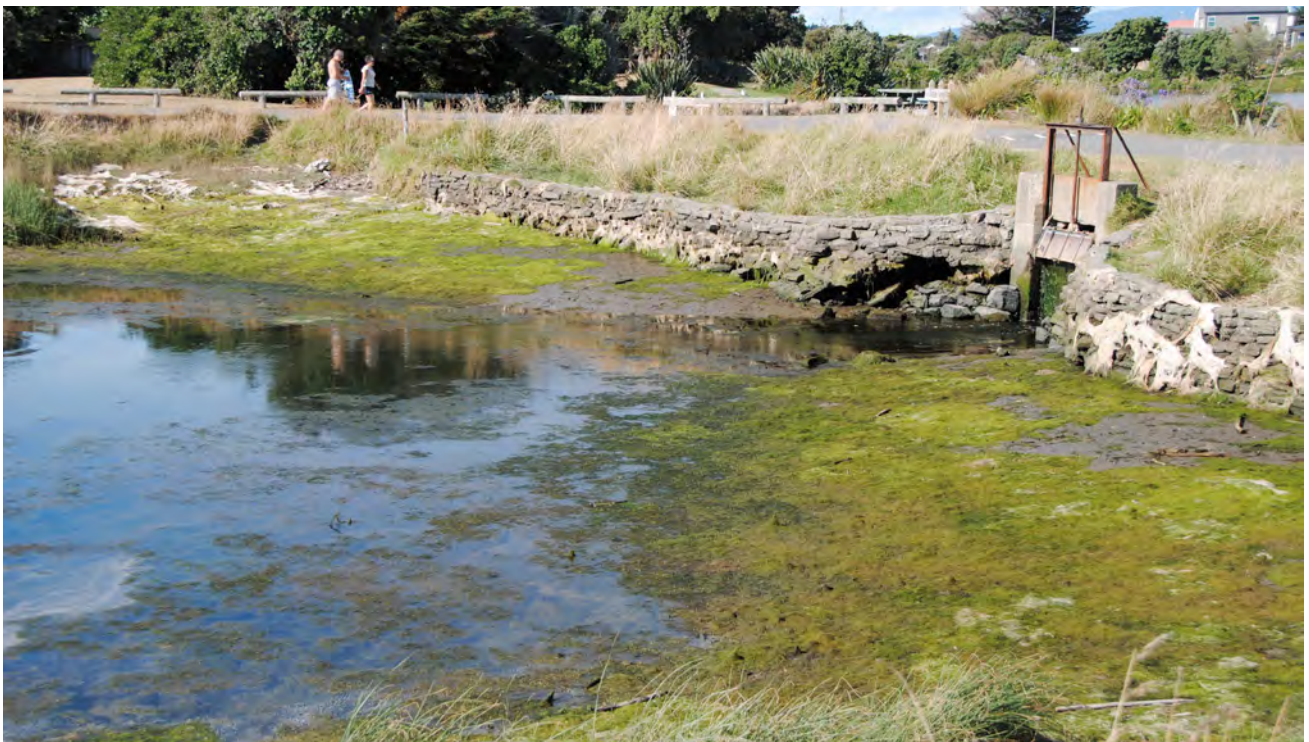
Accumulations of rotting macroalgae adjacent to the flapgate, lower Waikanae River Estuary, Feb. 2012.

This has increased slightly from 2010 and 2011 (see Stevens and Robertson 2010, 2011) due to increased cover and nuisance conditions (e.g. rotting macroalgae and poorly oxygenated and sulphide rich sediments) in the poorly flushed embayment next to the flapgate (see photos on page iv and bottom of this page).

Based on the combined trend of an increasing MC, and the presence of these eutrophication indicators, it is recommended that macroalgae be quickly reassessed in conjunction with sediment rate monitoring in January/February 2013, and thereafter based on the condition ratings.
