## LakeSPI survey of Lake Kohangatera - 2013

Prepared for Greater Wellington Regional Council

June 2013

NIWA Client Report No: HAM2013-052  
Report date: June 2013  
NIWA Project: WRC13206

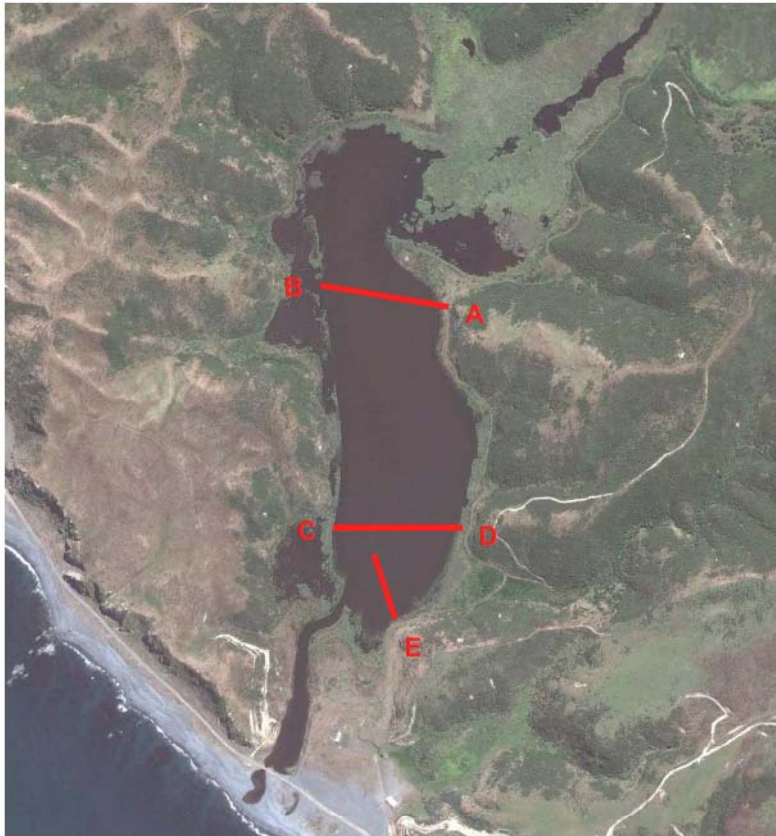
**Figure 2-1: Location of 5 survey sites in Lake Kohangatera.**

The LakeSPI method (Clayton and Edwards 2006, de Winton et al. 2012) was applied at five baseline sites (selected in 2011) in Lake Kohangatera (Figure 2-1, Appendix A) on the 20<sup>th</sup> March 2013. At each site scuba divers scored 11 metrics over a 2 m wide transect from shore to the deepest vegetation limit. Metrics included measures of diversity from the presence of key plant communities, the depth of vegetation growth, and the extent that invasive weeds were represented. A complete description of measured characters is given in the technical report at <http://lakespi.niwa.co.nz/>. An inventory of all plant species encountered was also made (Appendix B).

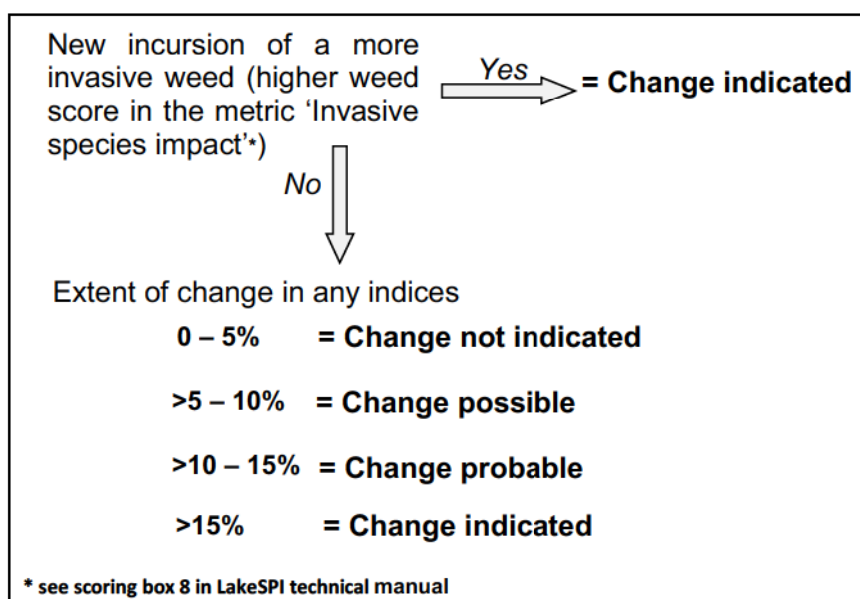
Figure 3-1: Guidelines for assessing the significance of change in LakeSPI Indices over multiple surveys of a lake.

In addition to statistical significance, the ecological significance of change was assessed using the guidelines below (Figure 3-1) which give a scale of probabilities for ecologically significant change in lake condition based on change in averaged LakeSPI indices (LakeSPI units as %) over repeated surveys. These guidelines, based on expert judgment, have considered observer-based variation and the response of LakeSPI scores to major ecological events in lakes (NIWA unpublished data).

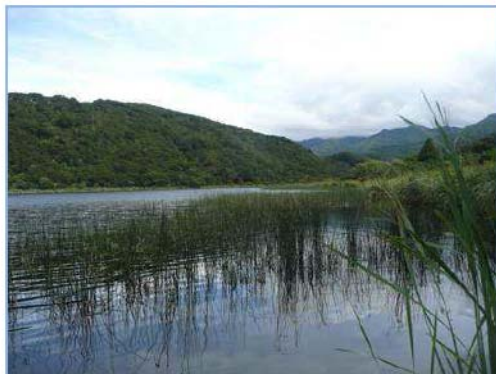
Lake condition:	Excellent
Stability:	Stable
Lake depth:	2.3

In 2013 a LakeSPI Index of 87% showed the lake to be in excellent condition, with no significant ecological change and no statistical difference (paired t-test,  $p > 0.05$ ,  $df = 4$ ) from the previous assessment in 2011 (Table 1). This score was driven by the presence of a diverse, primarily native vegetation (Native Condition Index 83%). A low Invasive Impact Index of 8.1% reflected the lack of development by elodea (*Elodea canadensis*), the only exotic weed species encountered at the surveyed sites.

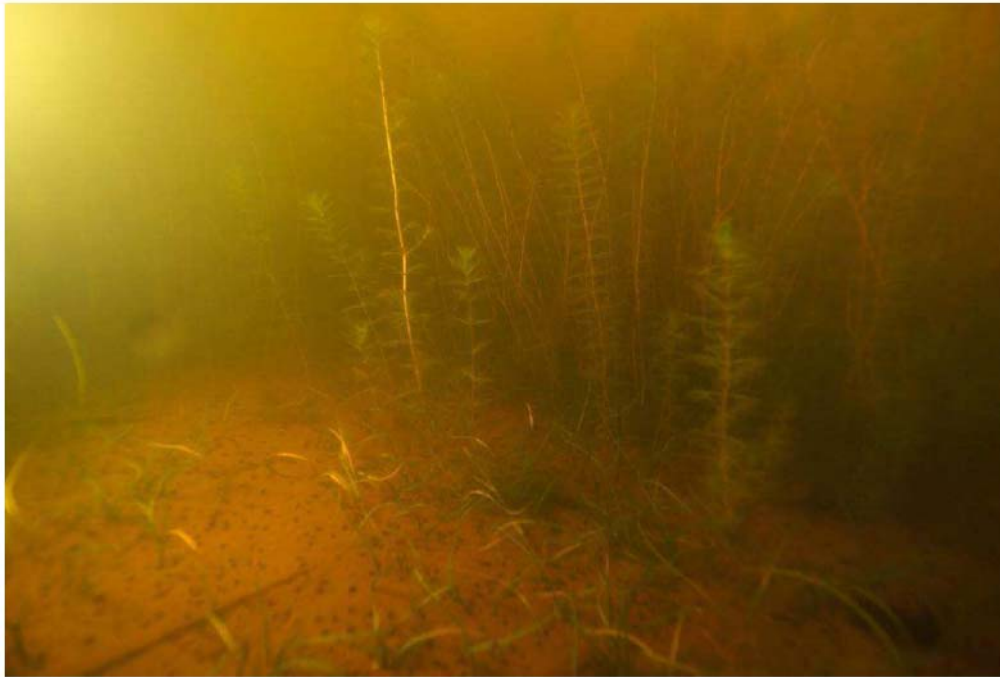
Blunt pondweed (*Potamogeton ochreatus*) dominated the vegetation except for the site closest to the coast (Site E), where sago pondweed (*Stuckenia pectinata*) and horse's mane (*Ruppia polycarpa*) became more abundant. Milfoil (*Myriophyllum triphyllum*) and *Lepilaena bilocularis* commonly co-dominated with blunt pondweed. Elodea was present at Site B (Figure 2-1), in 1.5 to 1.6 m depth, usually at  $\leq 5\%$  cover, but with some patches up to 25% cover and 0.6 m in height. Additional observations suggested this development was typical of the north-western shoreline.

Figure 4-1: Turf plants (*Lilaeopsis*) intergrading to milfoil in 2011 (Photo: R. Wells).

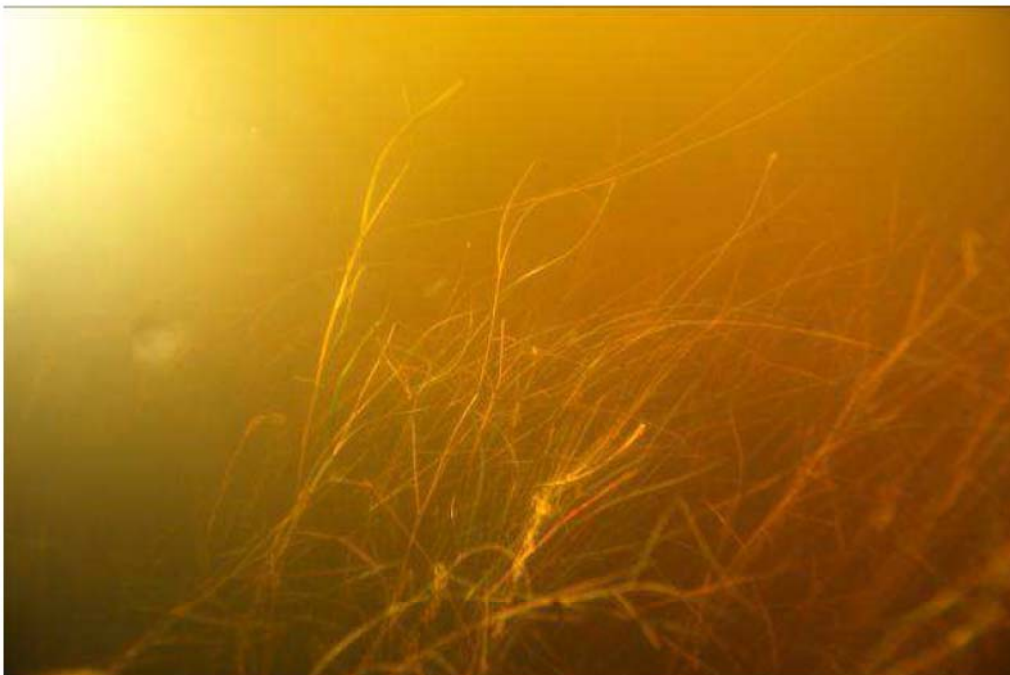
Figure 4-2: *Stuckenia pectinata* and flowering *Ruppia polycarpa* at the southern end of the lake in 2011 (Photo: R. Wells).

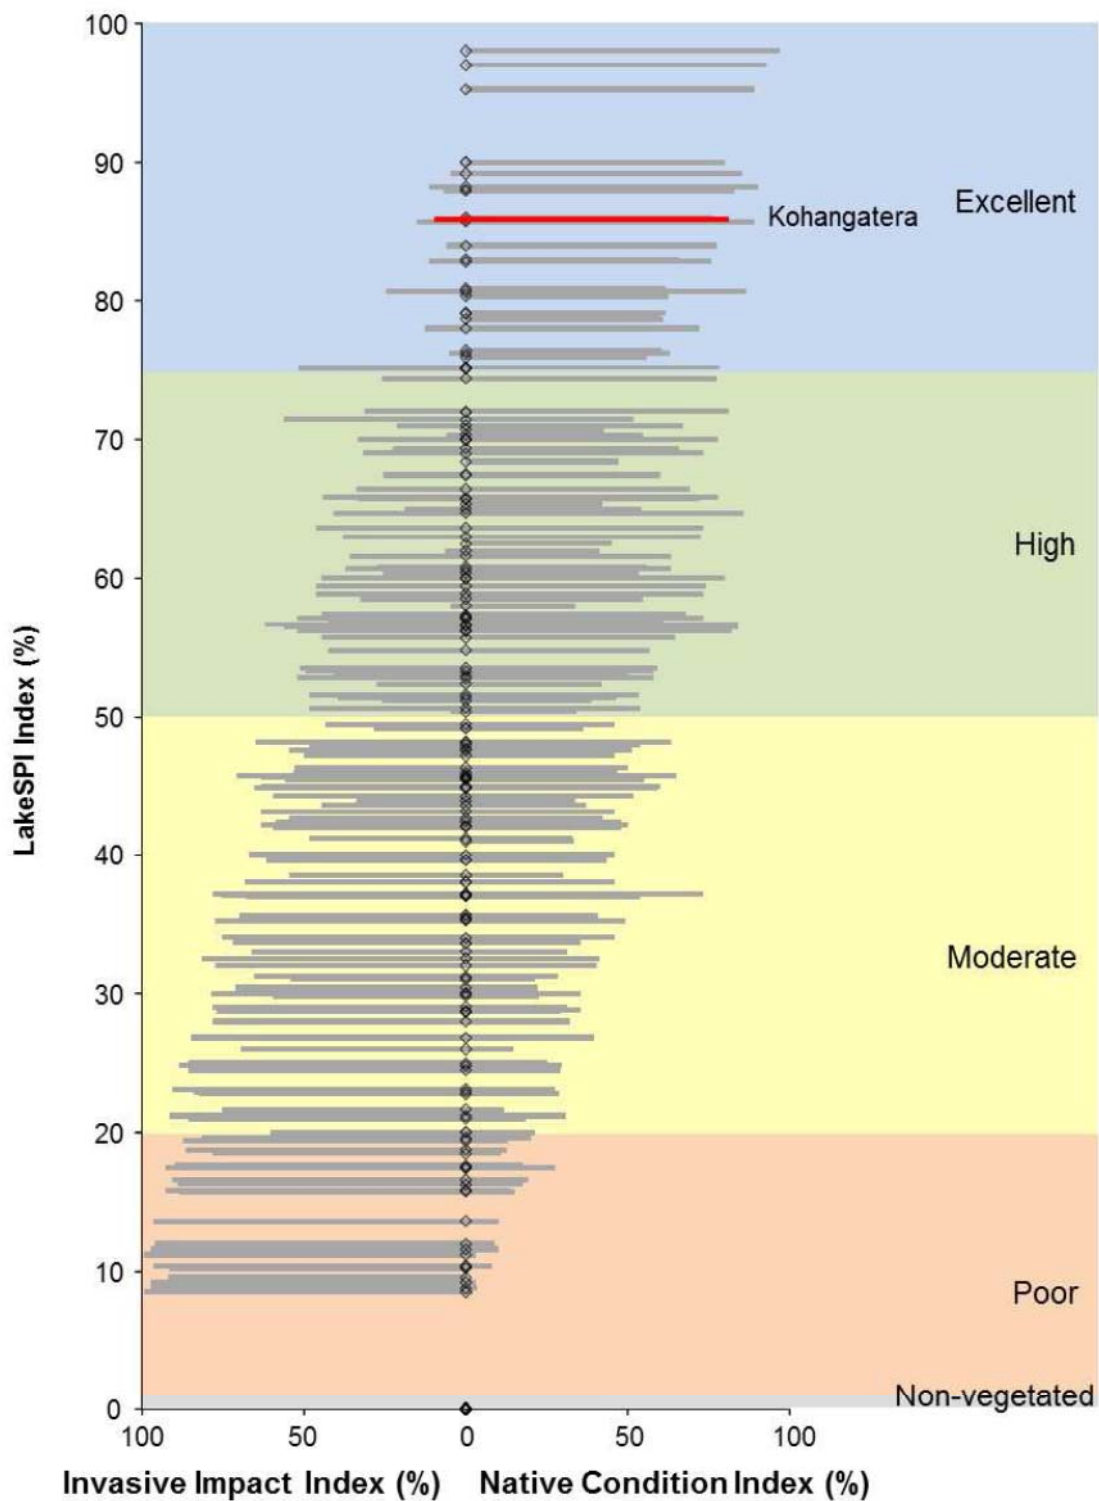
LakeSPI scores from the 2011 and 2013 surveys were not significantly different and indicate that Lake Kohangatera is in an 'excellent' and stable condition. Native submerged vegetation values are still nationally outstanding as identified in de Winton et al. (2011), and the lake provides one of the few examples of a little impacted, lowland coastal waterbody. Compared to 242 lakes assessed nationally using LakeSPI, Lake Kohangatera is ranked 9<sup>th</sup> from top in order of the LakeSPI index (Figure 5-1).

**Figure 5-1: LakeSPI Indices based on the latest results for 242 lakes in grey, showing the score for Lake Kohangatera as a red line.** LakeSPI scores are plotted on the vertical axis, with the Native Condition Index plotted on the right hand horizontal axis, and Invasive Impact Index on the left hand to show the negative influence on LakeSPI scores.
