Report 13.736
Date 21 November 2013
File T/20/22/01

Committee Council
Author Richard Noakes, Senior Fixed Assets Adviser

Kaiwharawhara station overbridge structural report and future use

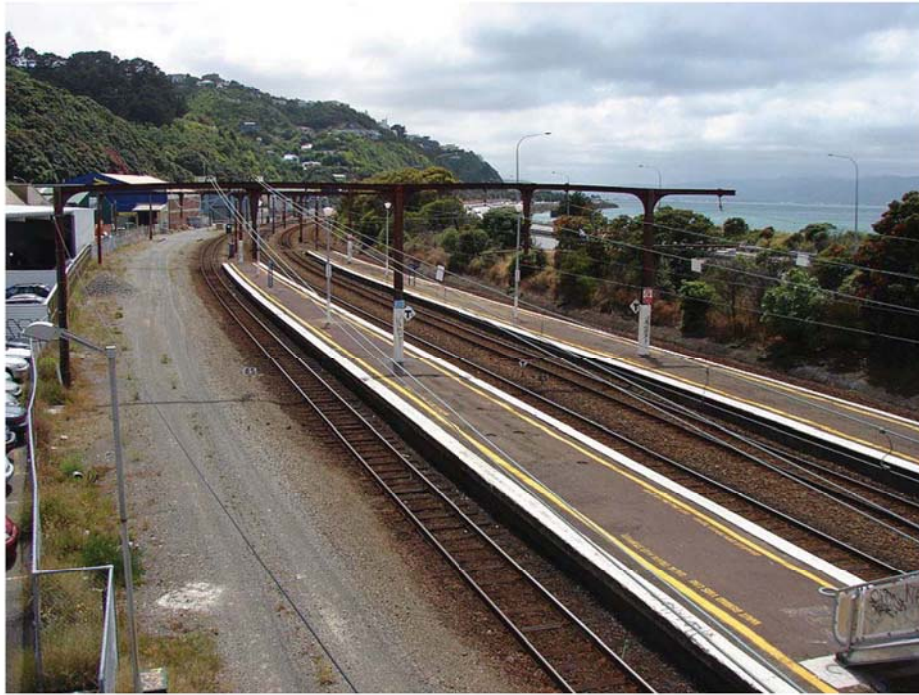
Figure 2: View of the dual Islands at Kaiwharawhara station

The location and layout of the access ramps and platforms, due to the narrow corridor and servicing of 4 tracks, already render the station relatively more hazardous than any other on the network. The extremely limited space between the ramps and the edge of the platform is clearly shown in the bottom right portion of Figure 2. This situation is present on both sides of each island platform.

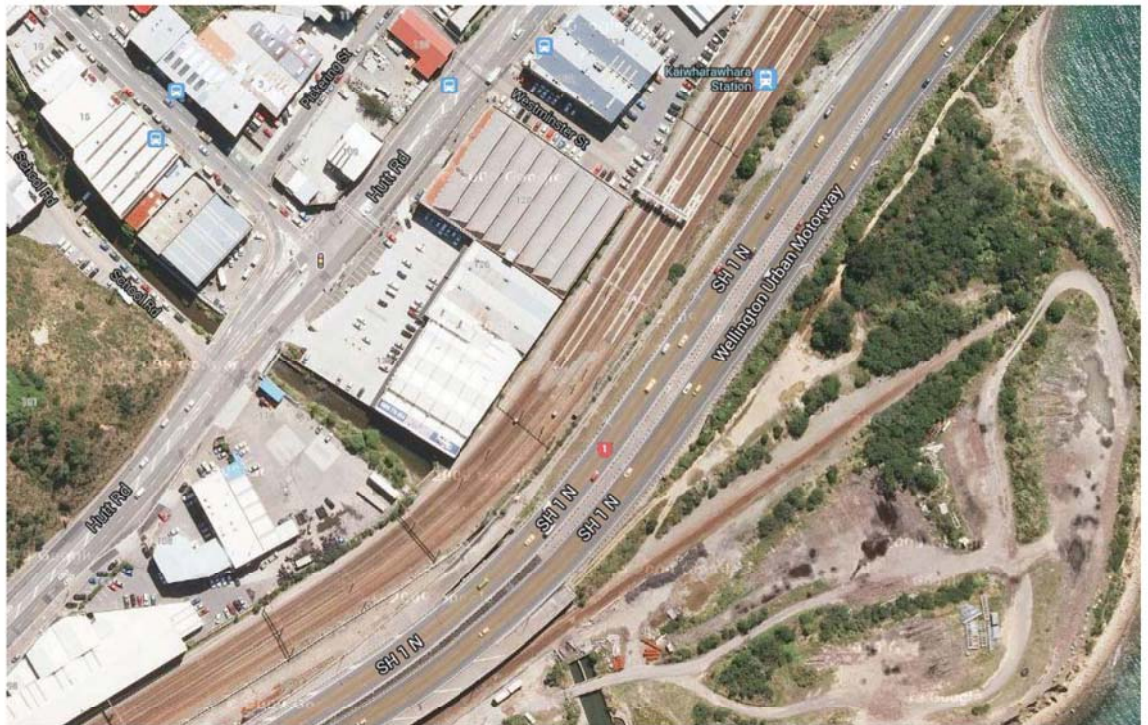
Figure 3: Aerial view of Kaiwharawhara Station, Stream mouth, Reclamation and bus stops

As can be seen from the aerial photograph (see Figure 3.) there is no legal access from the Kaiwharawhara station overbridge to anywhere but the station platform. Anyone using the overbridge to access the Reclamation or stream is trespassing on KiwiRail's corridor, which is both illegal (subject to a \$10,000 fine) and extremely dangerous, then walking between SH1 and the railway line for about 100metres before passing underneath the SH1 viaduct by or in the stream – all of which is unpleasant at best and at worst very hazardous especially at high tide.

There are several bus services operating to and from various destinations either stopping or passing close to Kaiwharawhara station. Through services operate along the Hutt Road stopping at both north and southbound bus stops which are located at the corner of Westminster Street and Hutt Road (see Figure 3.).

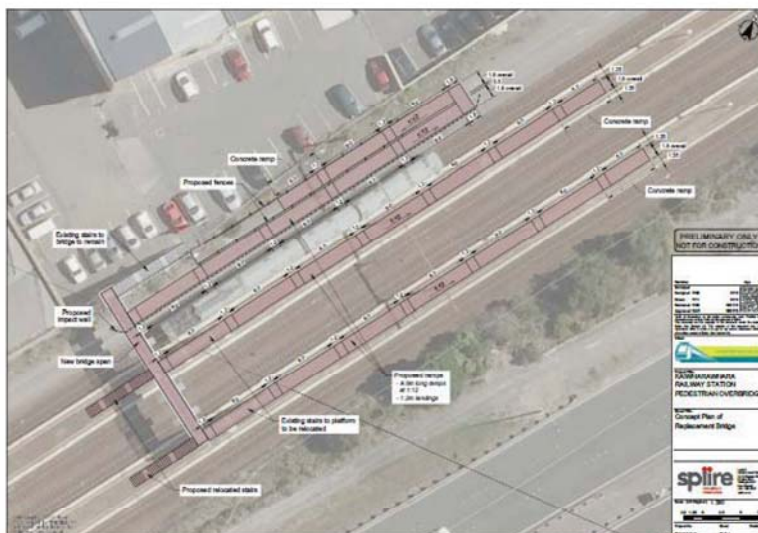
Figure 5 Concept drawing for new bridge and ramps

Replacement of the structure incorporating a fully complying ramp while re-using the existing stairs has been considered and includes:

- Reinforced concrete or galvanised structural steel piers with new reinforced concrete foundations for the span and ramp supports
- Precast reinforced concrete deck with either steel or concrete supporting beams for both the spans across the tracks and for the ramp spans. Galvanised steel balustrade.

Reinforced concrete impact wall as protection to the bridge supports along the west boundary in addition it is noted:

A budget cost estimate for a replacement bridge structure. This incorporates ramps complying with requirements for disabled while also re-using the existing stairs. The rough order budget cost estimate for the above is \$2,470,000.00.

It is considered that this is not to be a practical option for the following reasons:

- Significant cost
- Station platforms too narrow for the required width of ramps.

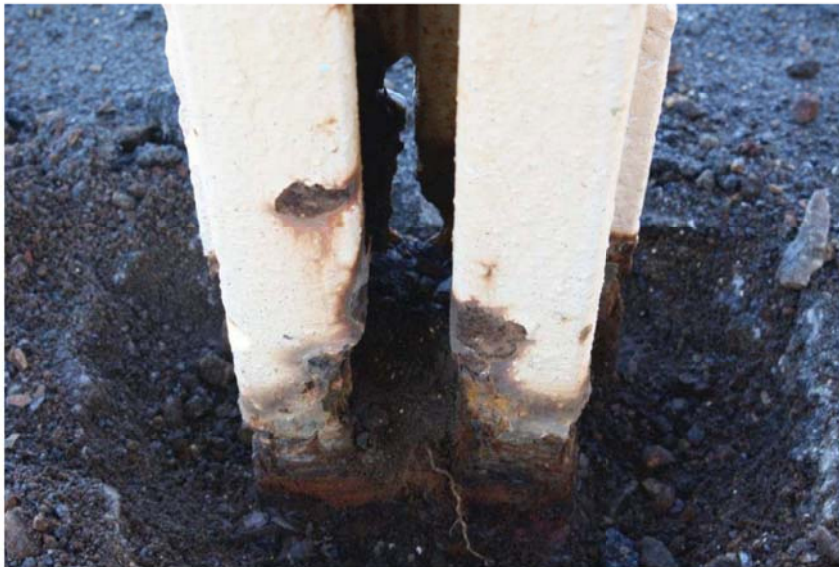
Figure 1: Corrosion of the footings

The main bridge I-beam spans are severely corroded and require replacement. The rail iron piers are also in very poor condition with significant loss of section evident and are in need of replacement. It is considered that the only parts of the bridge able to be incorporated into an upgraded structure are the three relatively new sets of stairs installed 2005. These are constructed of galvanised steel channel stringers with galvanised folded plate treads and risers. Because of the extremely poor condition of the rest of the existing structure, the extent of corrosion and loss of section of some of the bridge components it is not deemed practical or economic to repair the existing bridge piers or I-beam spans. Engineer's recommendation is to 'repair' the bridge by building new bridge spans and piers incorporating:

- Reinforced concrete or galvanised structural steel piers with new reinforced concrete foundations. Re-use or extending the existing foundations would be considered in the design process
- Concrete deck with either steel or concrete supporting beams
- Galvanised steel balustrade.

Rough order budget cost estimate for the above is \$550,000.00. This covers all but the stairs and does not include any charges for preparing an application for resource or building consents and necessary dispensations or additional works as a result of the submission.
