# On the beaches

Recreational water quality monitoring  
results for the 2013/14 summer

greater WELLINGTON  
REGIONAL COUNCIL  
Te Pane Matua Taiao

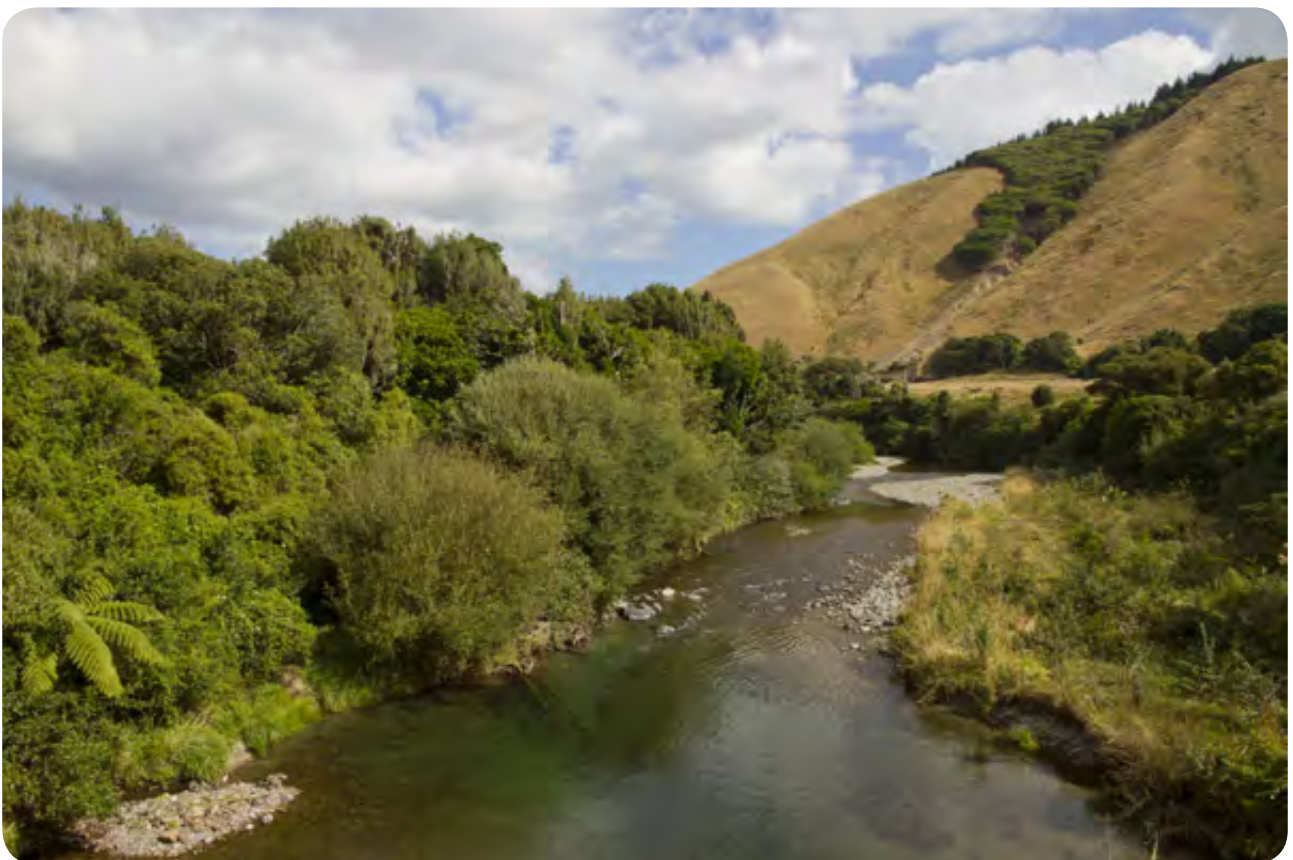
Waikanae River upstream of the monitoring site at State Highway One. This site has a 'dry weather' grade of 'good' and an 'all weather' grade of 'fair'

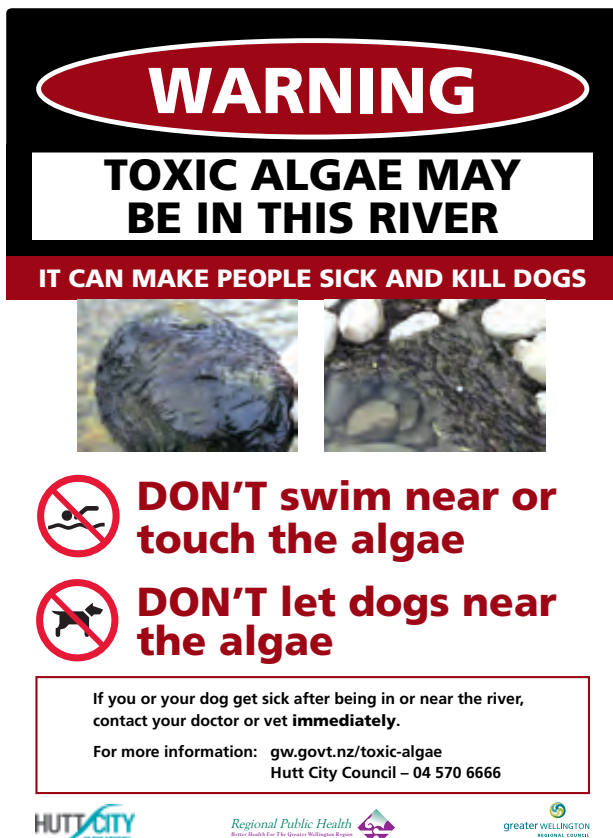
Figure 3.2: Warning sign used to inform the public of the health risk from cyanobacteria in rivers in the Wellington region

In 2009, interim New Zealand guidelines for cyanobacteria in recreational lakes and rivers were released (MfE/MoH 2009) for trial by monitoring and health agencies. The interim guidelines for rivers identify a three-tiered alert level framework for benthic cyanobacteria (Table 3.3). The warning sign used to advise the public of the risk from benthic cyanobacteria is shown in Figure 3.2.

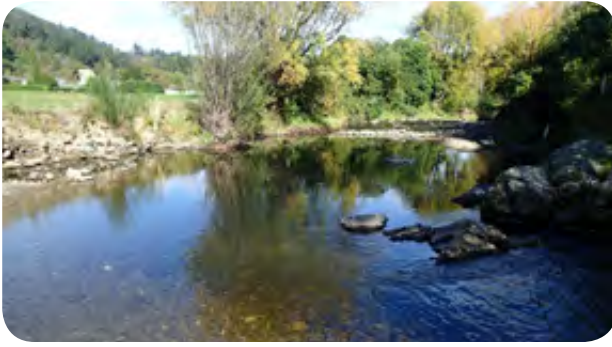
Wainuiomata River at Richard Prouse Park

On 1 April 2014 samples taken at four sites along the length of the Wainuiomata Stream indicated that *E. coli* counts decreased from high levels at the bottom of the catchment (1,460 cfu/100mL at Wainuiomata Stream at confluence) to moderate levels near the top of the catchment (580 cfu/100mL at Wainuiomata Stream at Brookfield Lane). In contrast, additional one-off sampling with HCC staff at 18 sites on 20 May 2014 found that *E. coli* counts were low in the lower catchment but high to moderate in the middle and upper catchment. Analysis of PCR markers at sites with high *E. coli* counts sites suggested human, ruminant and wildfowl contamination was present. Hutt City Council staff will inspect on-site wastewater treatment systems within the Wainuiomata Stream catchment in the second half of 2014 in order to identify those contributing to contamination of the stream (Gordon George<sup>9</sup>, pers. comm.).

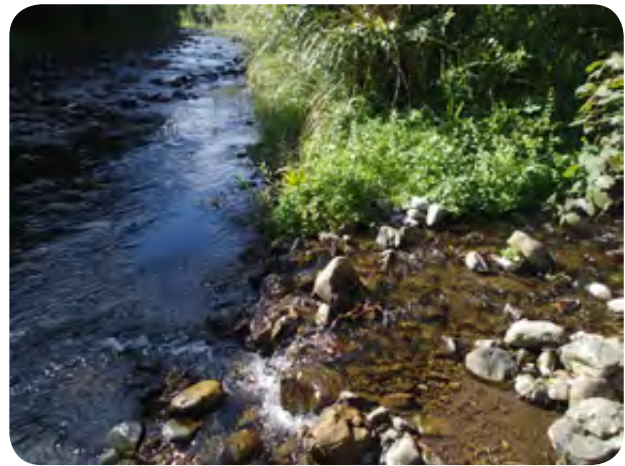
Skerrett's Creek at its confluence with the Wainuiomata River

A single water sample taken from Skerrett's Creek at its confluence with the Wainuiomata River on 1 April 2014 returned an *E. coli* count of 1,540 cfu/100mL. Both human and dog markers were detected in a PCR marker sample taken from the same site. Hutt City Council was notified of the results and undertook inspections of the sewer main and all sewer laterals along the street. No problems were identified with the main sewer but smoke testing identified a leaking sewer lateral at one property and a blocked sewer at another (Gordon George<sup>9</sup>, pers. comm.). These issues are currently being followed up with land owners.

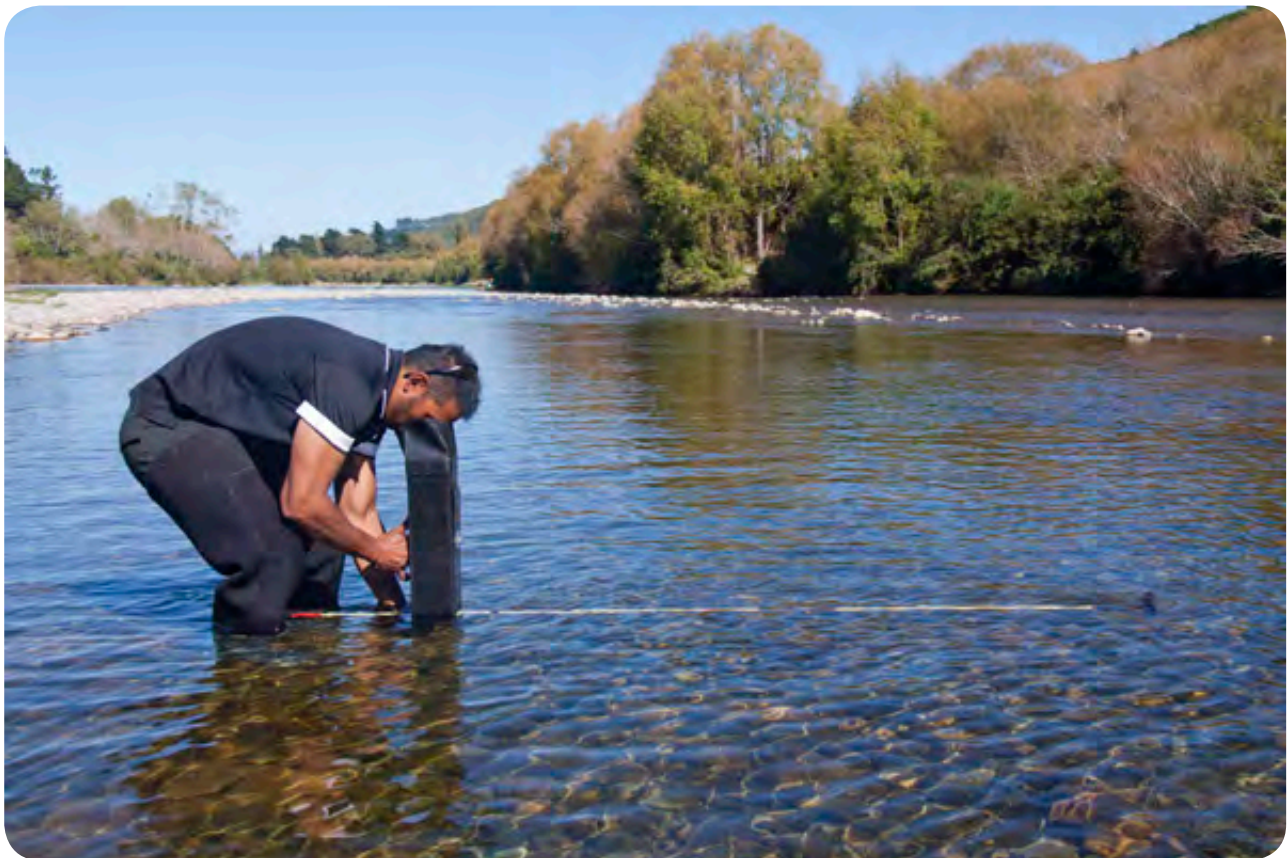
An assessment of water clarity on the Hutt River at Silverstream. A black disc fixed at 1.6 m from the viewer is used to assess whether the water clarity guideline is being met

The MfE (1994) guideline for water clarity was met most of the time (80% of sampling occasions). Poor water clarity following freshes accounted for the majority of occasions when the guideline was not met, with upstream river works affecting clarity on a few occasions at some sites such as Hutt River at Poets Park.

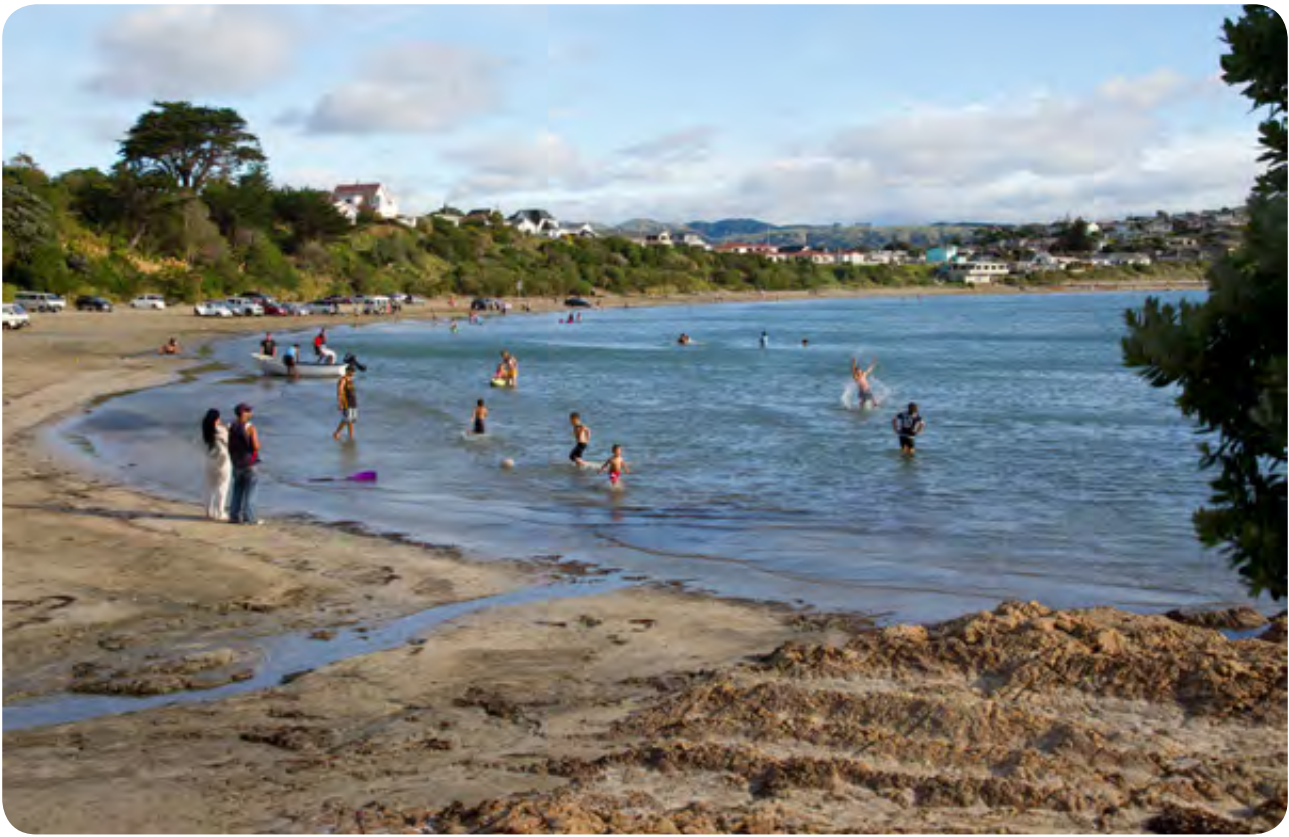
**Titahi Bay near the recreational water quality monitoring site at Bay Drive. This site is graded 'fair' for contact recreation**

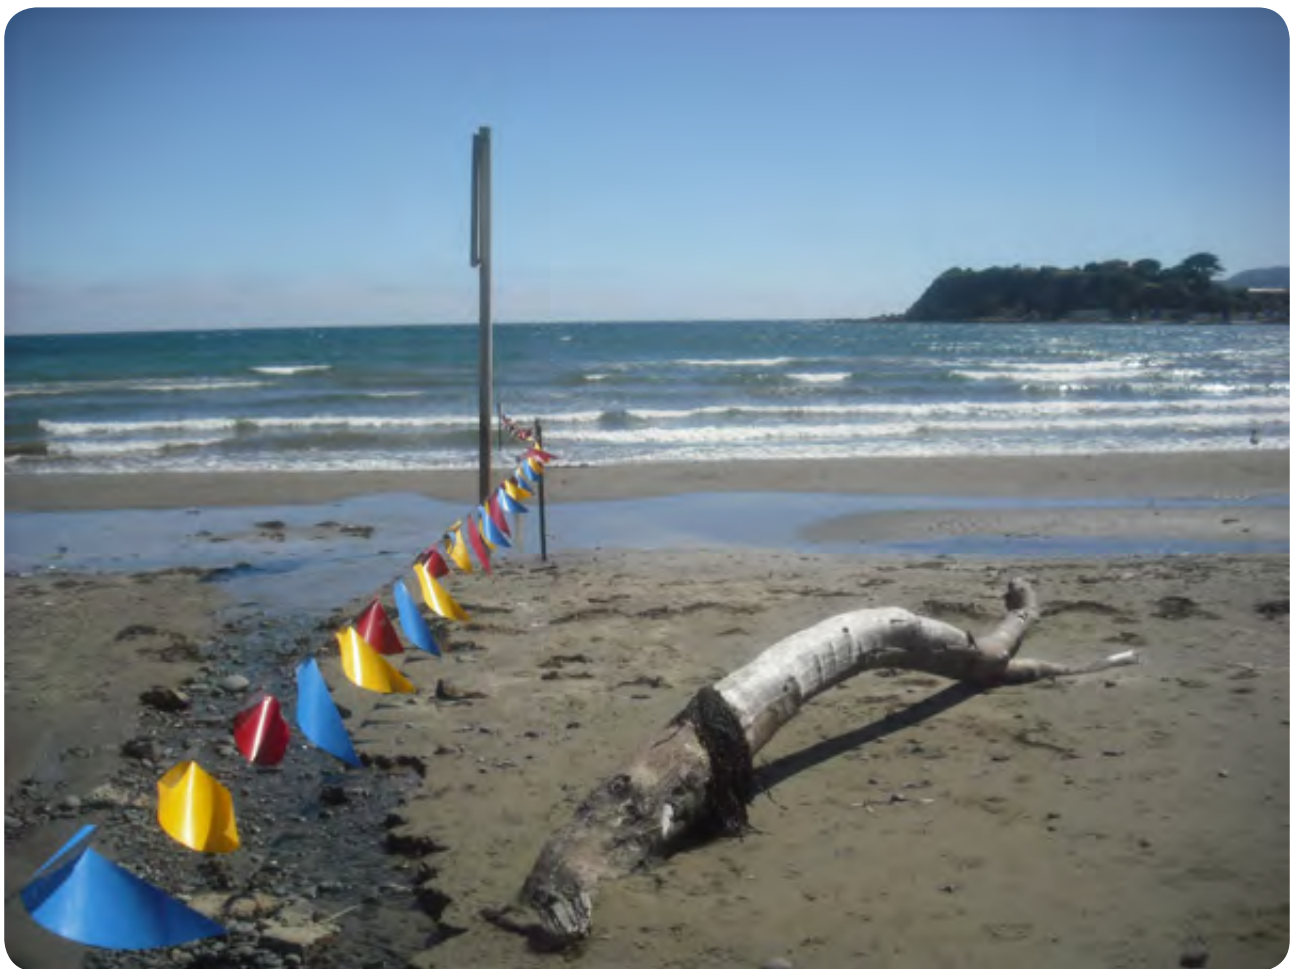
The only sample from Titahi Bay at South Beach Access Road with a high enterococci count during the investigation period was taken on 4 February. PCR marker analysis of this sample identified wildfowl as the source of contamination. High *E. coli* counts (1,620–18,000 cfu/100mL) were recorded in all but one of the eight samples collected from the piped stream in the vicinity of the South Beach Access Road site. However, as a very high level of human faecal contamination was identified at this site during investigations undertaken in 2013, no further analysis of these samples was undertaken. Since 2013, Porirua City Council have found a number of illegal sewage discharges to the stream and are continuing to investigate sewer and stormwater infrastructure in the area (Joanna Saywell<sup>14</sup> pers. comm.). A public health warning sign remains in place at the site.

**Titahi Bay at South Beach Access Road. Very high levels of human faecal contamination were identified in the small stream that discharges at this site. Investigations into sewer and stormwater infrastructure are ongoing**
