Chapter Three

THE FIRST SCHEME Flood Control for the "lower" Hutt Valley

1900-1924

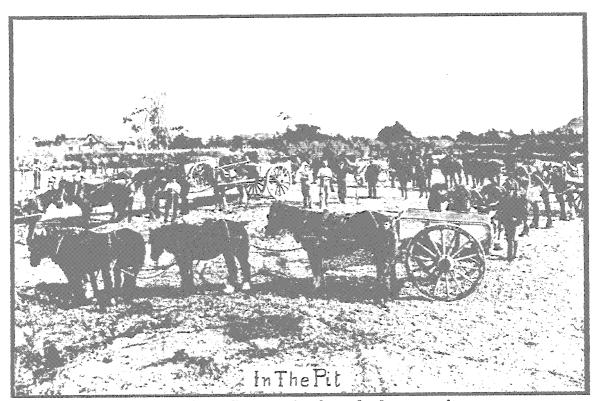
Plate 28: Construction of the first stopbanks - the borrow pit. Source: Alexander Turnbull Library, York studios, neg. F28348

Construction of the "Scheme for Conserving The Hutt River" 1901-1903. The stopbanks were constructed using shingle loaded by hand into half cubic yard trays (0.45 cu.m.) from selected river deposits. Compaction was achieved by directing the loaded drays along the embankments. The drays were unloaded using a steam powered crane and the shingle was spread by hand and horse drawn levelling bars. See also the Report rear cover for other photographs in this series.

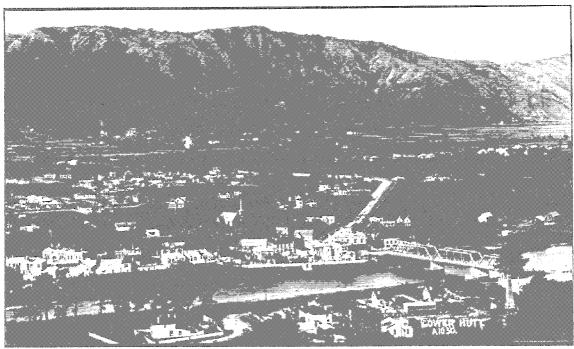
Plate 29: Lower Hutt c. 1907

Plates 29 and 30 show the stopbanks not long after their construction. In Plate 29 notice the undeveloped Strand Park, and the Waiwhetu farmlands in the background. This low-lying area or "Third River" is recorded as taking overflows from the Taita area during the large floods of the 1800s. In plate 30 the dark line across Strand Park and Gear Island shows the position of the river in the 1870s.

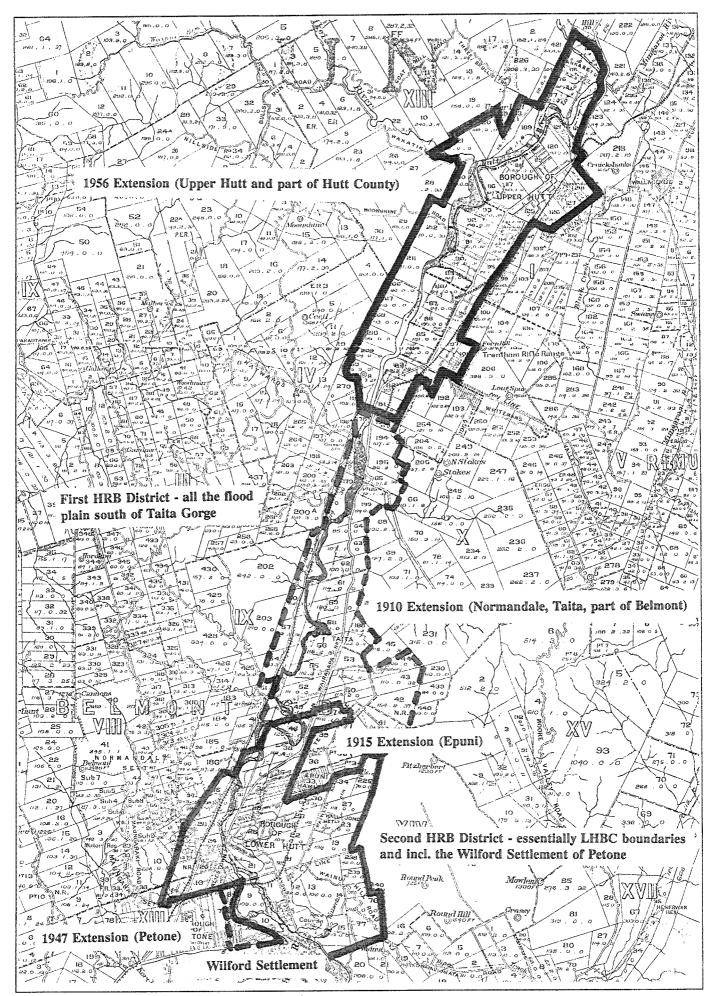
Figure 11: Hutt River District Boundaries. Source: 1954 Extension Proposals SSPHRB8

The First River District included all the area to Silverstream with the exception of the hill sections of Normandale and Belmont and the areas adjacent to Epuni.

The Second River District was constituted on the 14 February 1899 and included only the Lower Hutt Borough, with the exception of the Normandale area and the area around Epuni. At this stage the northern Lower Hutt boundary with Hutt County crossed the valley near Park Road but did not include the Belmont area on the western side of the river, from about the present position of the Firth plant northwards.

As a result of a petition in 1910, the district was extended to include the Normandale area, the Taita area (including the gorge) and part of Belmont. In 1915 the River Board sought the inclusion of Epuni and Petone, however only Epuni was included at that time. Petone remained outside the area until a further, successful petition by the Board in 1947.

The Hutt River Board requested the Local Government Commission to order the extension of the district to include the upper valley in 1955 and an Order In Council to that effect was subsequently issued in March 1956. The extension was at the request of the Upper Hutt Borough Council and Hutt County Council, and allowed for a Board consisting of nine members; five representing the Lower Hutt subdivision, two representing the Petone subdivision and two, the Upper Hutt subdivision. Prior to this date the Board had consisted of six members; two from the Petone subdivision and four from the remainder of the River District.

Archive Table 6, p. 53, backgrounds the rating systems used by the Hutt River Board. Figure 11, p. 52, shows the changes to the rating district between 1900 and 1972, when rating was changed to a regional basis.

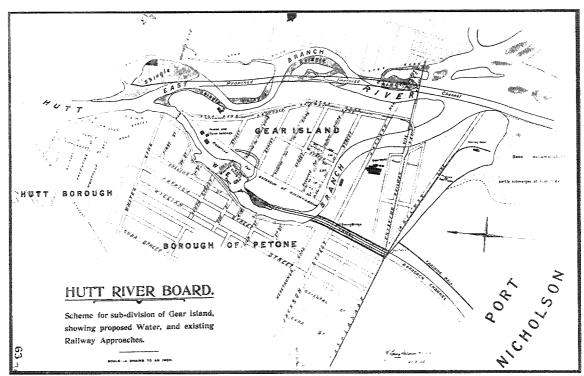
Plate 31: Gear Island Proposals 1913

For an account of the debate which followed the development of Gear Island the reader is referred to *Petone: A History* by Susan Butterworth. Plate 31 shows one Hutt River Board scheme for the area. The Board investigated the development of a Hutt Valley port on a number of occasions in an attempt to stimulate growth in the Hutt Valley and to earn revenue. The proposals were abandoned at each attempt as the anticipated trade volumes could not support the capital outlay.

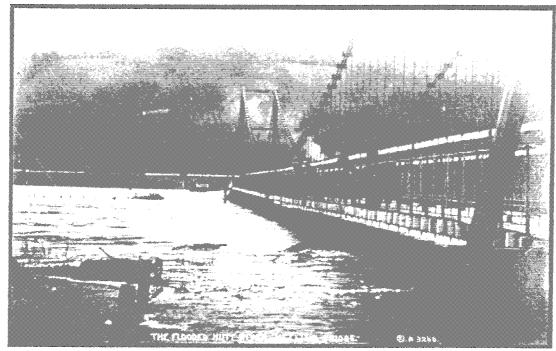
Plate 32: 1913 Flood viewed from Melling Suspension Bridge. Note the freeboard to the train in the background. Source: Hutt City Memorial Library.

The photograph in plate 32 was taken from beside the Melling Suspension Bridge eastern support looking across to the Western Hutt Road. The bridge spanned this stable bend from 1909 but was eventually replaced in 1956, at that stage when the bridge was in an advanced state of disrepair. Backing-up of flood water associated with the bend would have been part of the mechanism which resulted in the operation of the Boulcott Overflow. The bend served to prevent the movement of river gravels into the Kingdon's Beach extraction area opposite the present upper car park and was of concern to the Hutt River Board for many years.

In December 1912 the overseer was required to proceed with protection works following a November 1912 flood and in May 1913 the chairman took personal responsibility for reporting the flood. Again the best record is the photograph of the flood, plate 32, below.

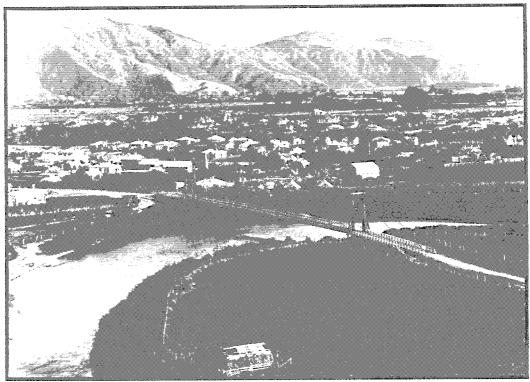
Plate 34: 1910 photo of Lower Hutt illustrates the HRB concern for stopbank failure at Melling. Source: Alexander Turnbull Library, S C Smith col. neg. G22763.
