Hutt River Flood Control Scheme Review - Volume 12

**A Modern History
1840-1990**

The Wellington Regional Council - 1991

**Hutt River Flood Control Scheme Review
Volume 12
A History of River Management**

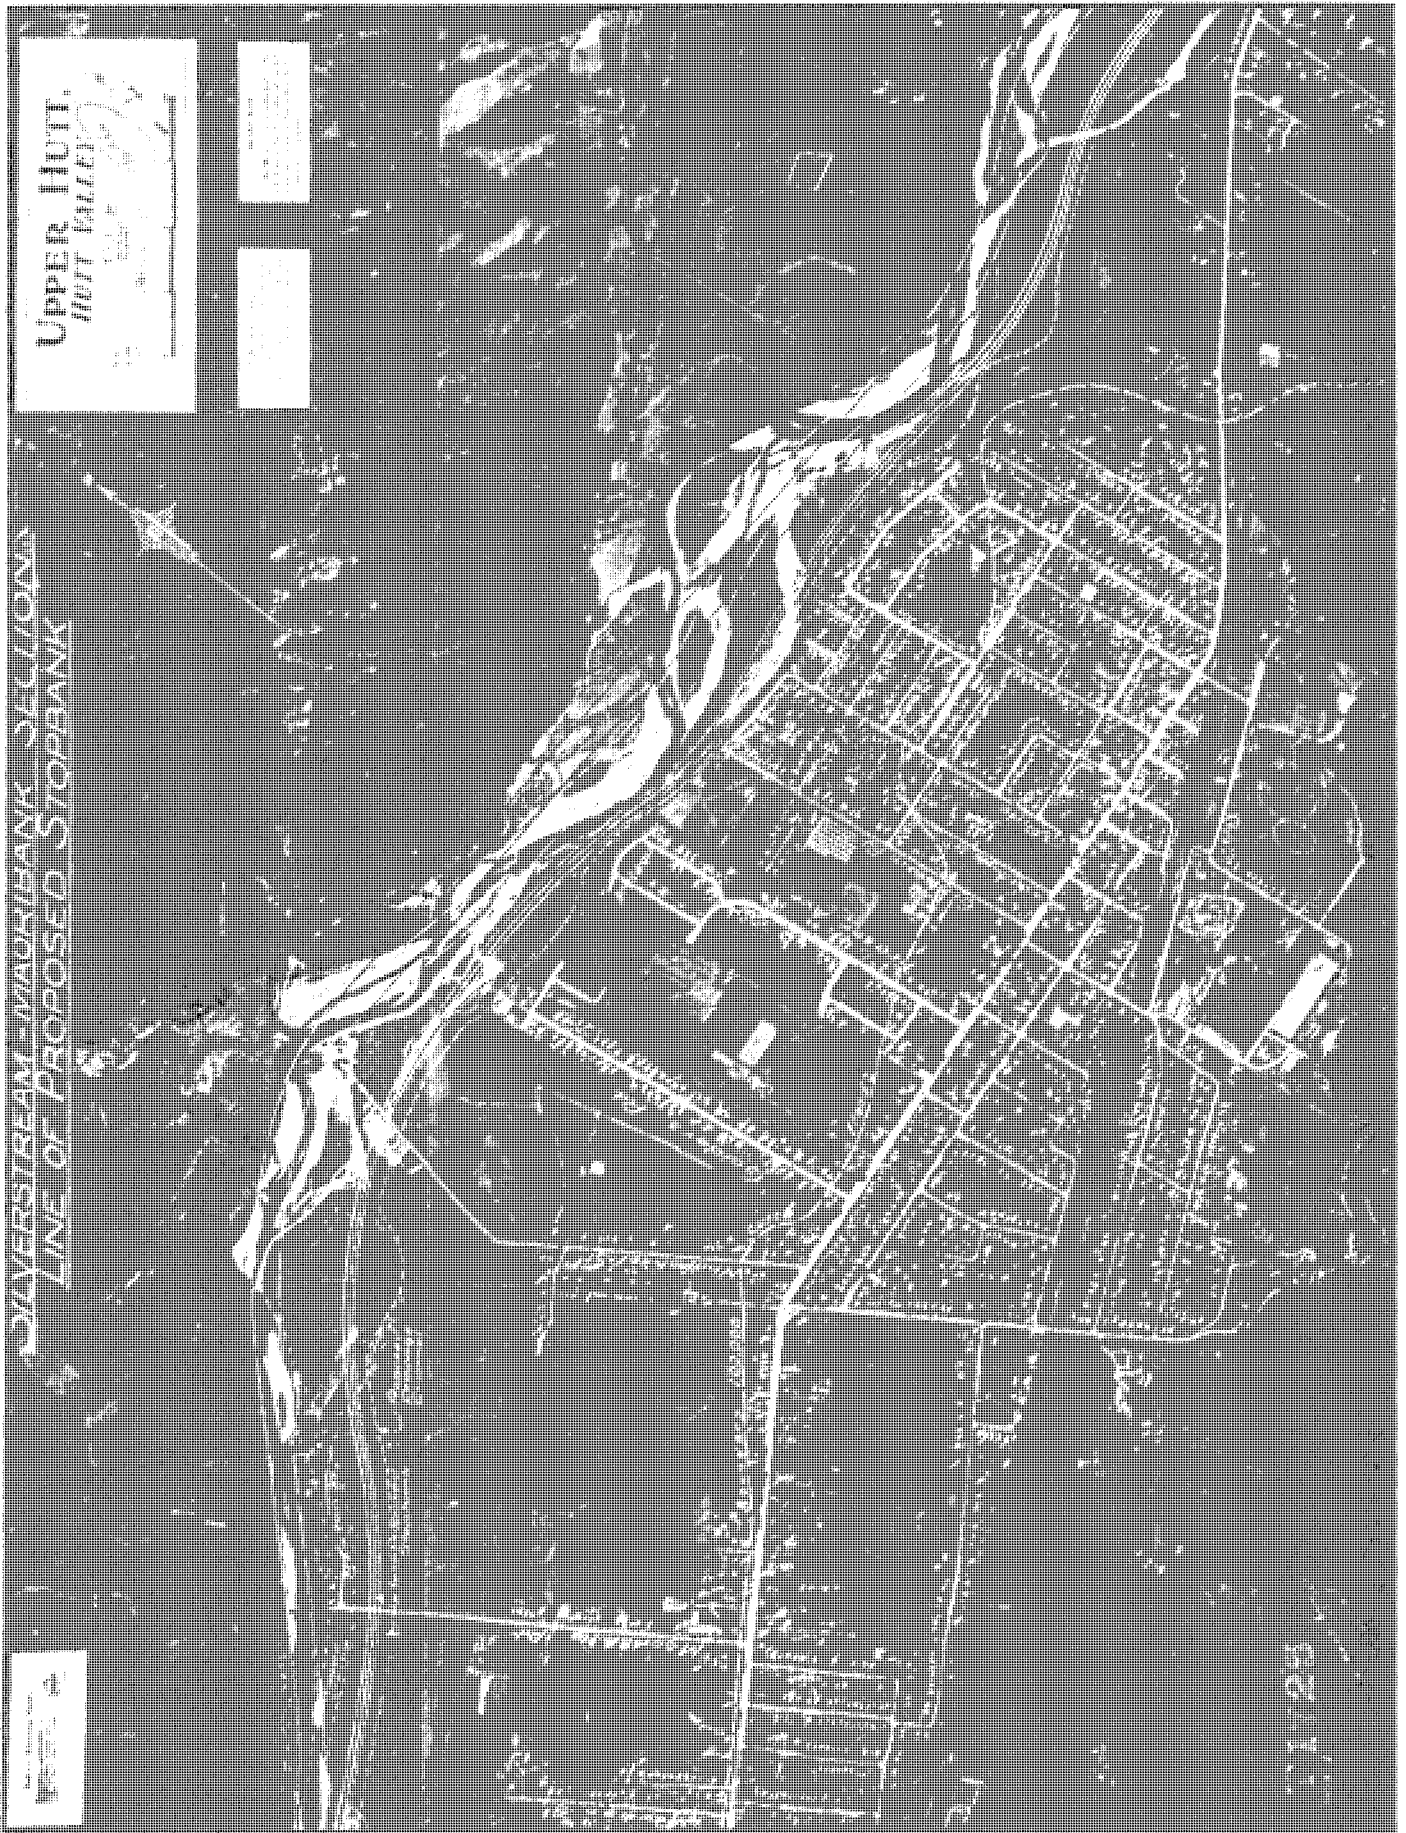
Plate 72: 1953 Upper Valley Scheme proposed by Trentham Residency, PWD (plan T1725).

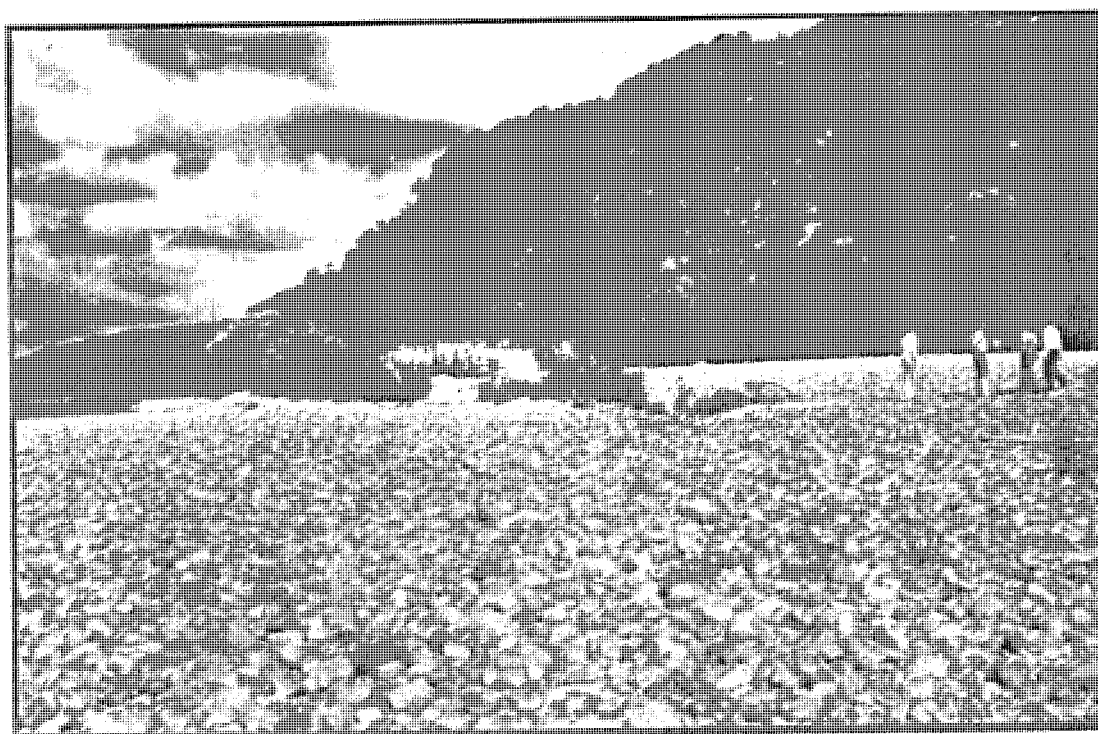
Plate 75: Failure of Silverstream Cut, c. 1984, showing the breach in the western bank protection works and the reactivation of the old western channel.
Source: WRC photo.

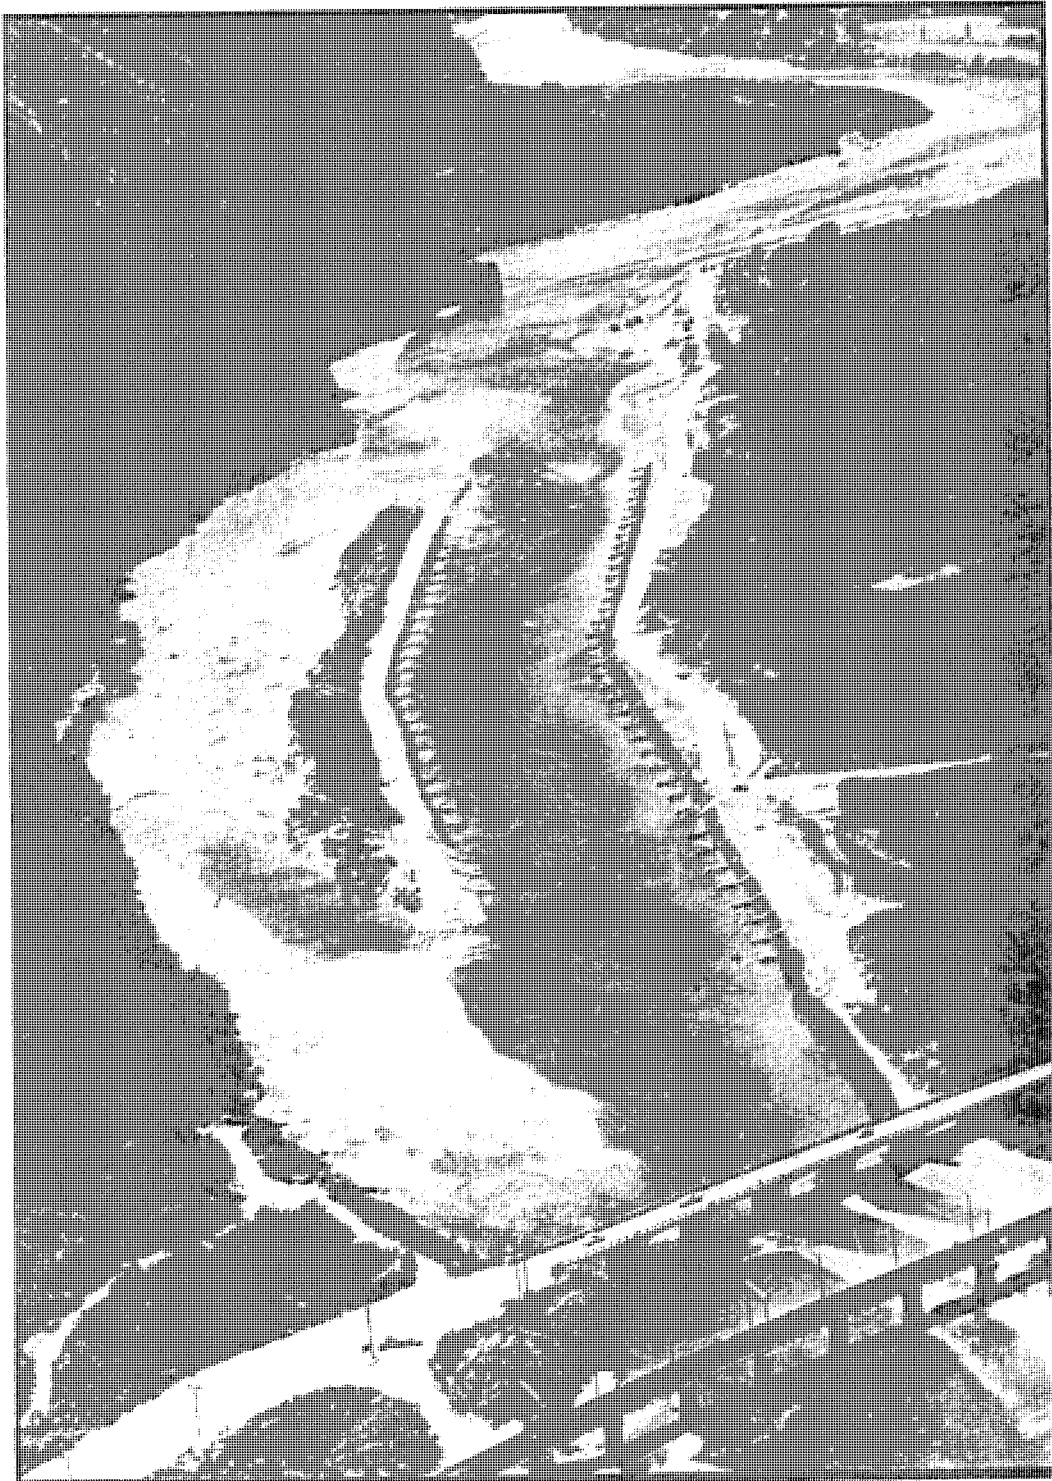
Plate 81: Silverstream Cut 1st Stage, 1960. View looking northwards to Barton's Bush. Source: HRB photo

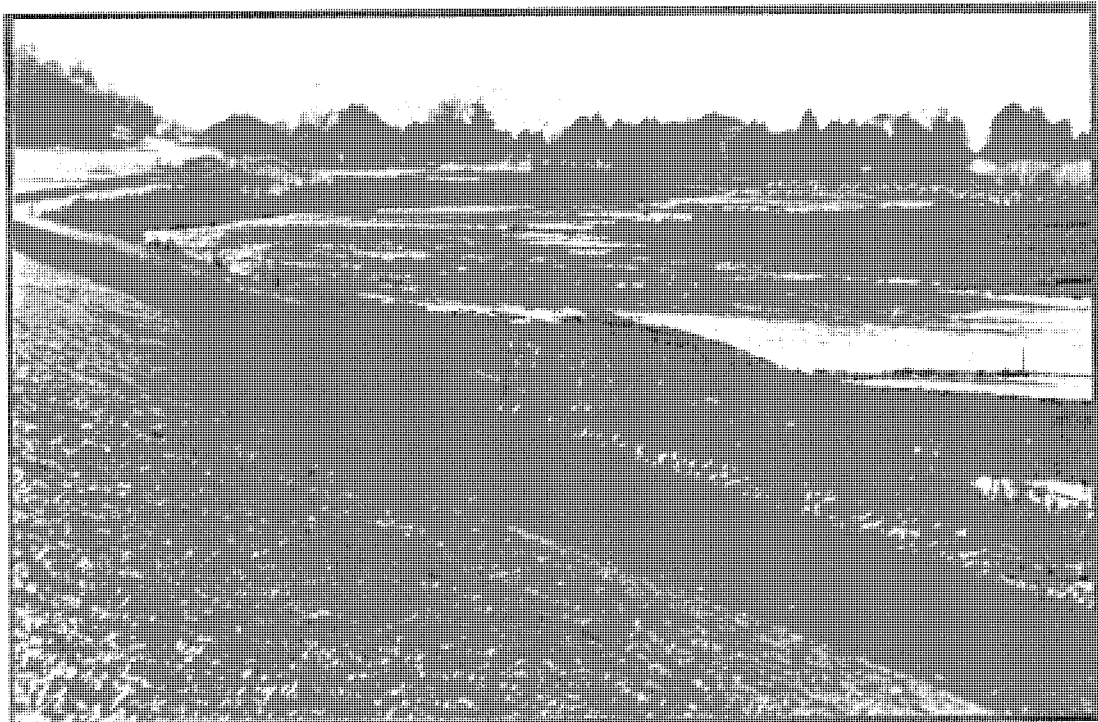
Plate 88: Newly Established Alignment, downstream Moonshine Bridge, 1986.

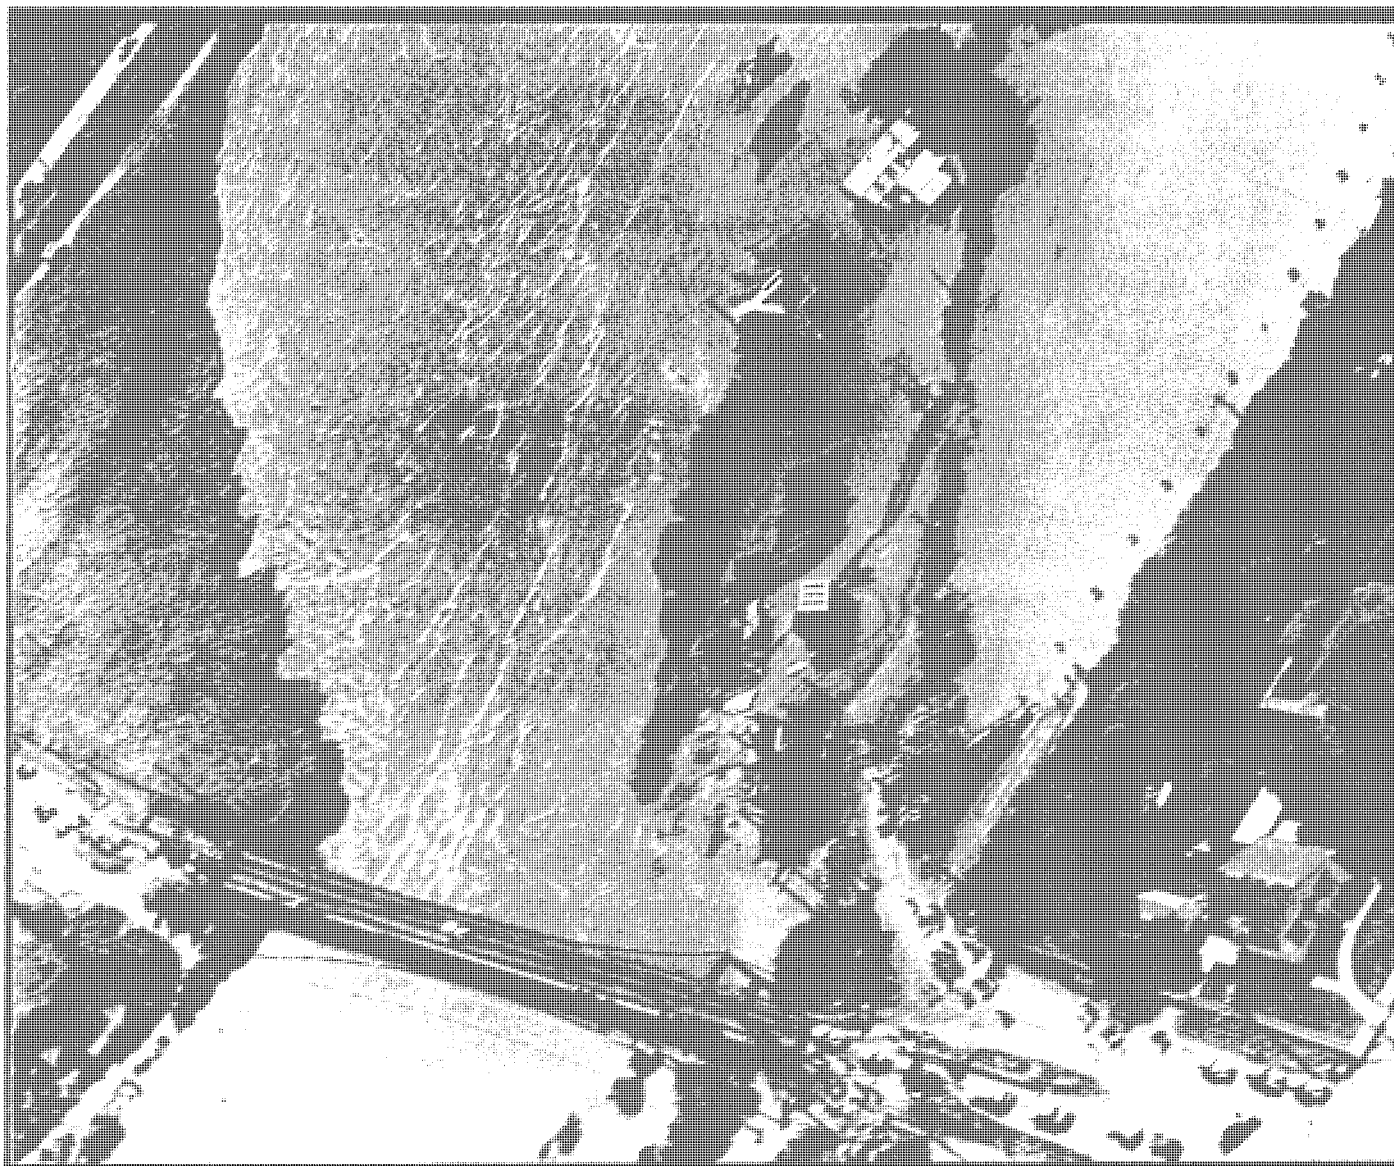
Plate 92: 1955 Flood showing the restriction formed by the Melling bend.

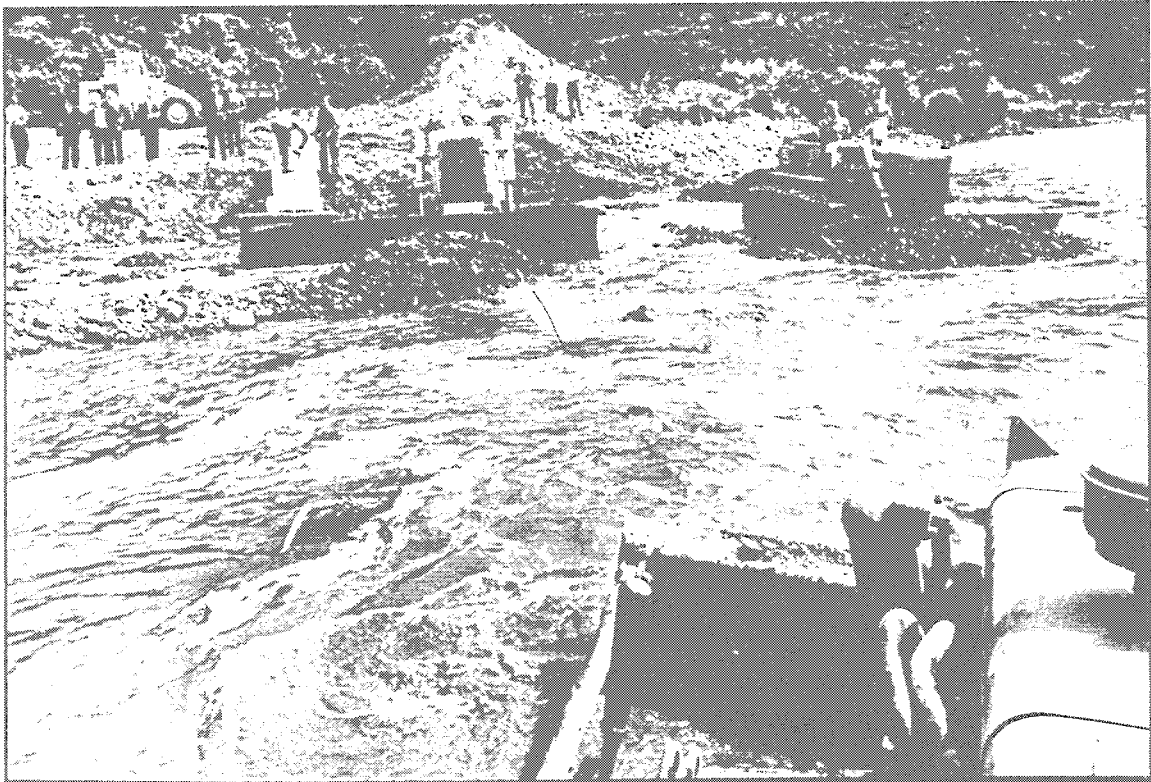
Plate 93: Closing the channel to direct water through the first stage, Nov 1969.
