# Pilot study: indoor air quality monitoring on Metlink buses

2022/23

GW/ESCI-T-23-6

AIR MATTERS REPORT 22214

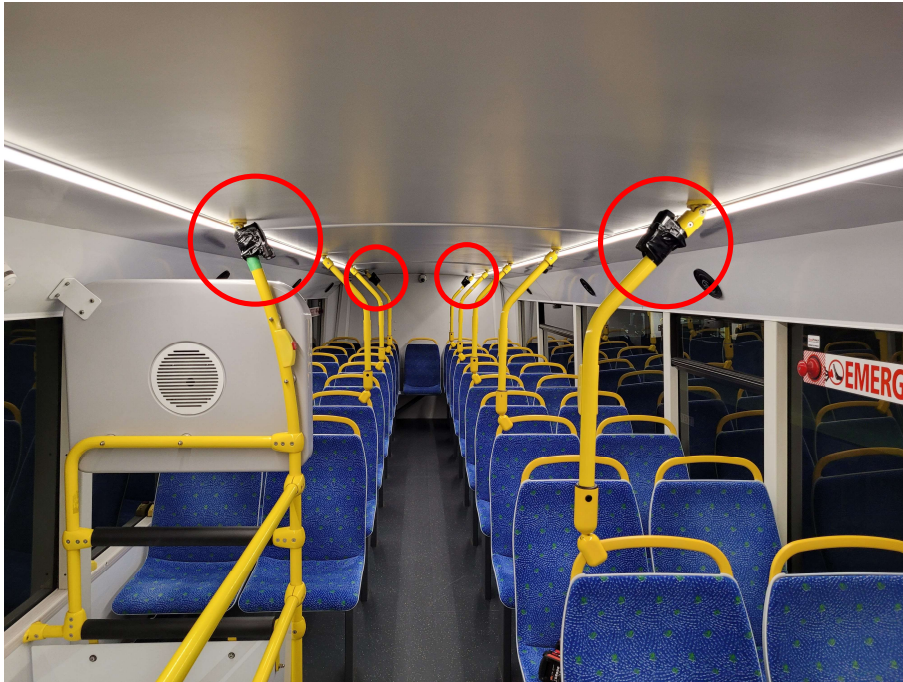
Figure 1. Example of the monitoring installation (red circles) in upper level of Bus 3701.

Air Matters Ltd installed two CO<sub>2</sub> sensors in each bus level (mid and back of the cabin). There were two monitors per single deck bus and four per double deck bus. Between 18-20 October 2022, eight in-service buses were monitored each day representing a total of 64 trips (Table 3.1). The monitors used were personal CO<sub>2</sub> meters (SAN-10), which use non-dispersive infrared (NDIR) technology.

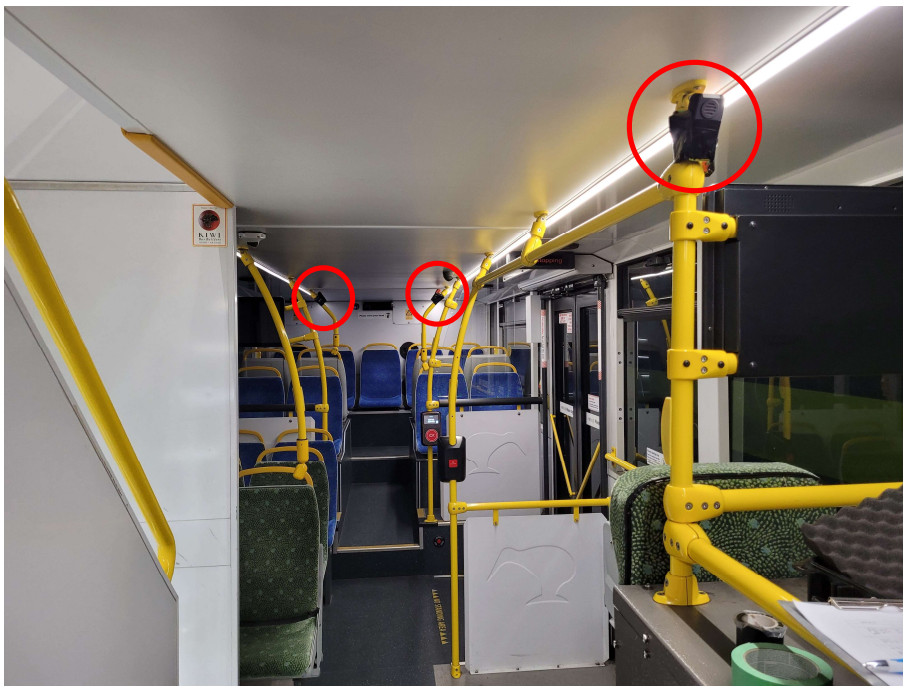
Figure 2. Example of the monitoring installation (red circles) in lower level of Bus 3701. Note on double decker buses the mid monitors were located back-to-back due to the location of the stairwell.

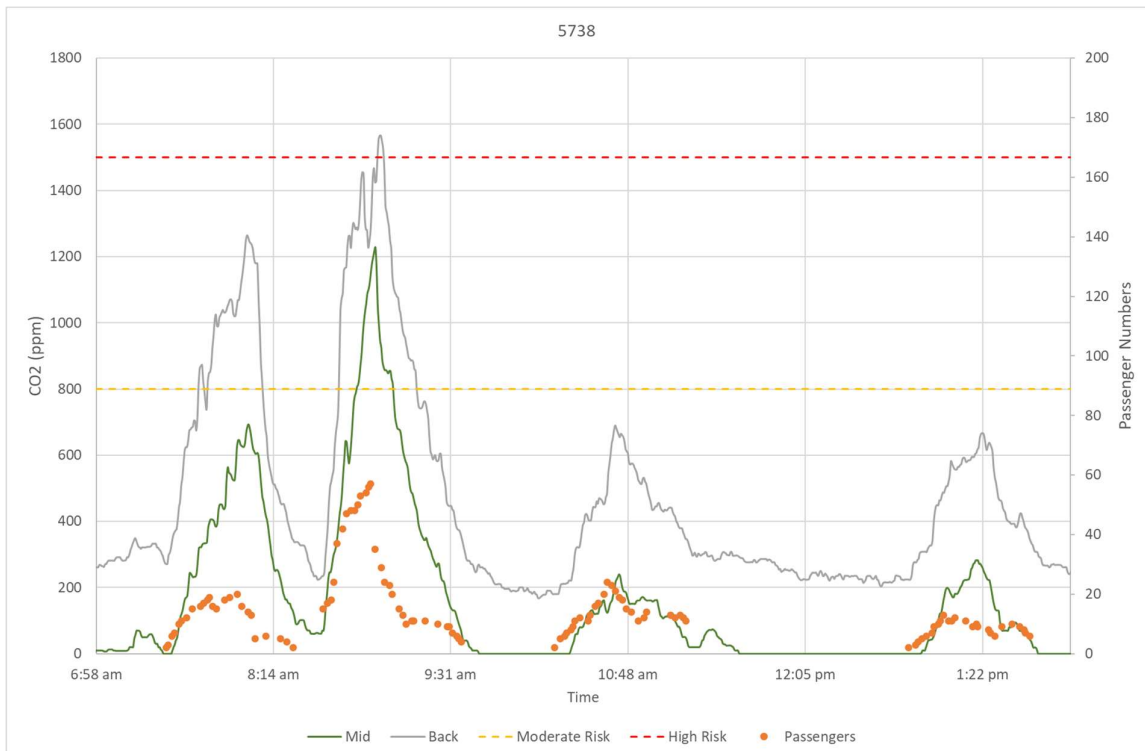
**Figure 3. Bus 5738. Electric monitored on 18 October 2022. Note the Mid monitor’s potential drift recording CO<sub>2</sub> concentrations of zero at times.**

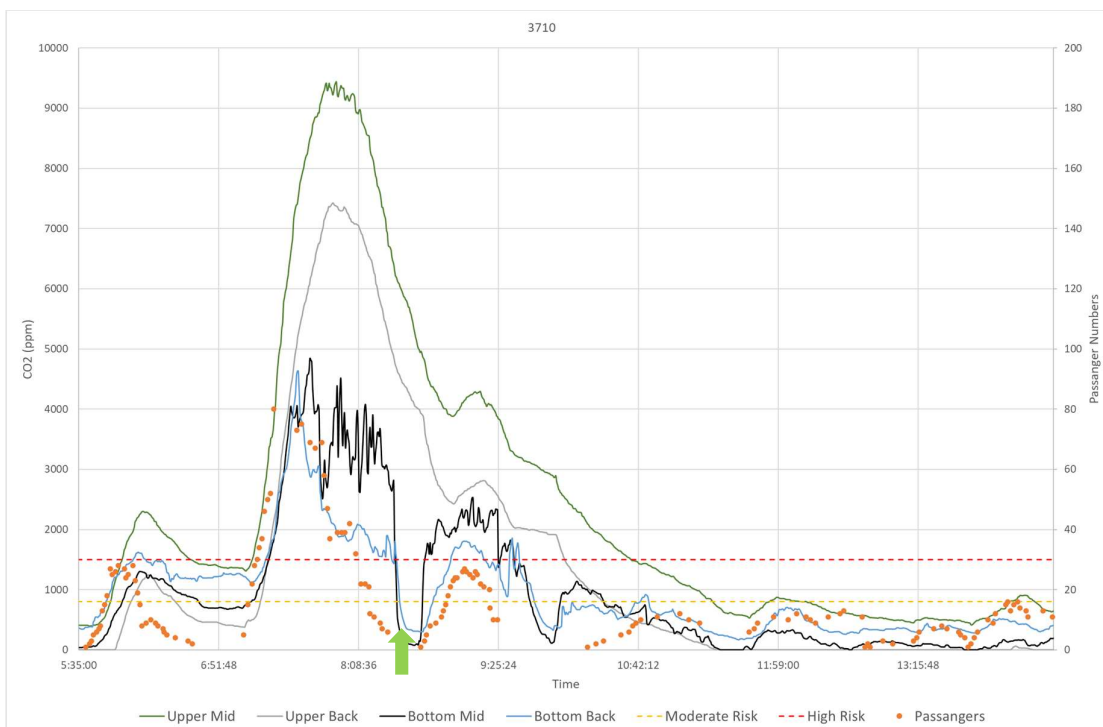
**Figure 6. Bus 3710. Electric double decker monitored on 20 October 2022. Note Bottom Mid and Upper Back monitor’s potential drift recording CO<sub>2</sub> concentrations of zero at times.**

Bus 3701 and 3710 showed the most significant difference between the upper and lower levels with the lower level having notably lower concentrations of CO<sub>2</sub> (refer Appendix A: Figure 5 and 6). This contrasts with the two other double decker buses (3523 and 5083) which showed a much closer correlation between upper and lower levels (refer Appendix A: Figure 7 and 8). This may have been caused by variation in passenger numbers between the levels however this information was not recorded.

The author was on board 3710 throughout the morning peak and observed that the bus was at capacity (fully seated in the upper level and seated / standing in the lower level). Concentrations on the lower level may have been reduced due to improved ventilation and/or fresh air ingress from door openings. Bus 3701 was also fitted with manually opening windows, so it is possible that passengers on the lower level had opened one or more windows allowing better circulation of fresh air.

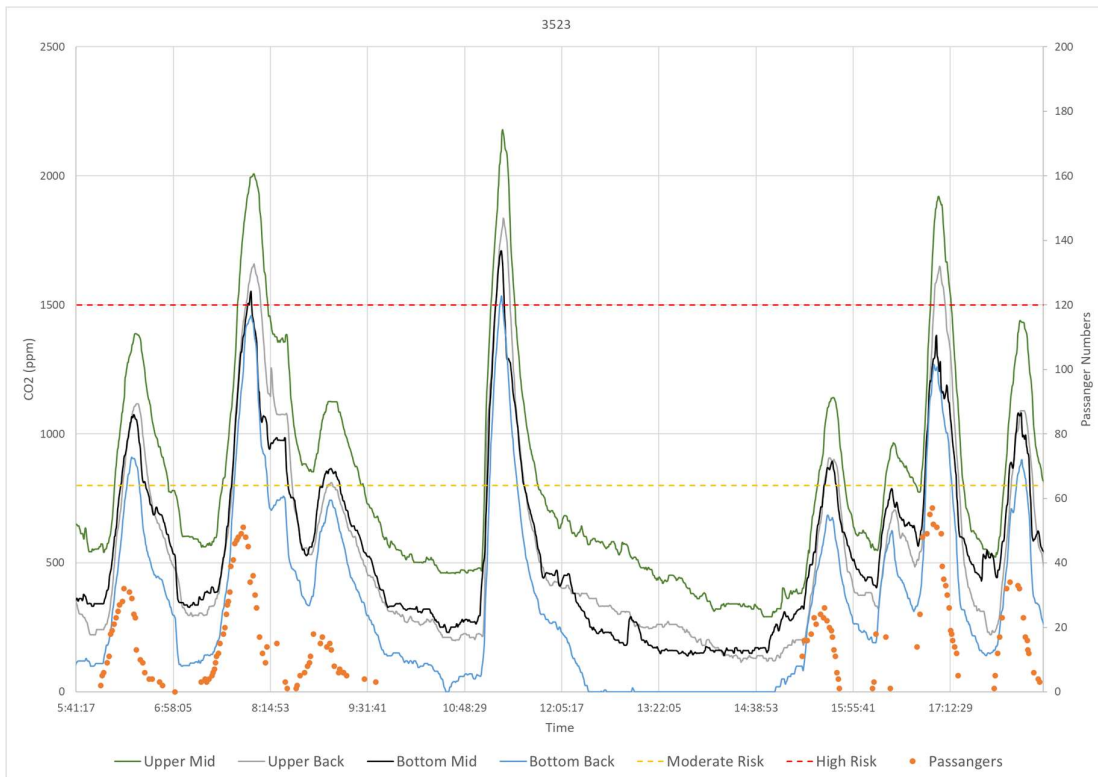
**Figure 7. Bus 3523. Diesel double decker monitored on 19 October 2022. Note the Bottom Back monitor’s potential drift recording CO<sub>2</sub> concentrations of zero at times. An increase in CO<sub>2</sub> between approximately 11am-midday is likely due to passengers however no passenger information was available over this period.**

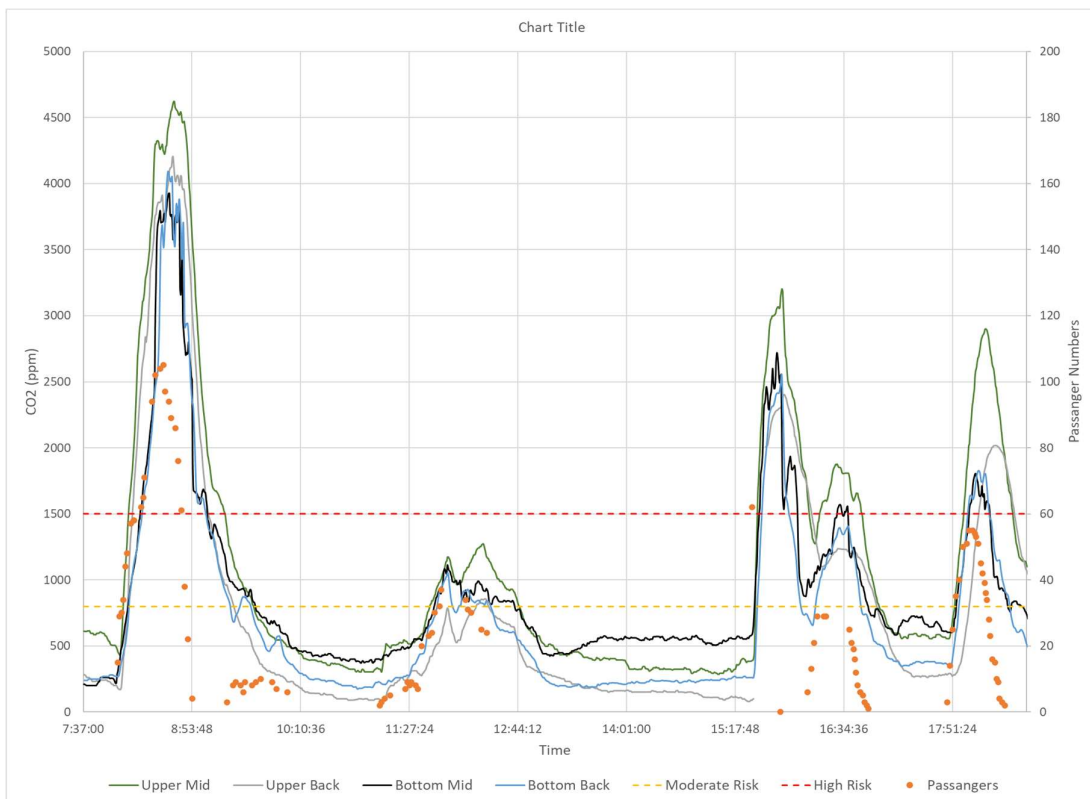
**Figure 8. Bus 5083. Diesel double decker monitored on 18 October 2022. Note the gap in Upper Back CO<sub>2</sub> record from 15:31 – 15:39 when it is expected that the monitor was tampered with.**
