Request for information 2023-168 and 2023-169

An investigation commenced in relation to the Paremata waste water pipe incident that took place on 17 July 2021. On 23 September 2021 Wellington Water submitted an Emergency Works Report along with confirmation that it was their belief that the works were undertaken in accordance with the emergency provisions of section 330 of the Resource Management Act 1991 (RMA). These provisions allow a network utility operator to undertake works for the purpose of preventative or remedial action under certain circumstances. The investigation was subsequently de-prioritised. Following the receipt of the Emergency Works Report, the overseeing officer raised some concerns with the use of section 330 RMA emergency provisions in this instance, however it appears that the officer responsible at the time opted to not pursue any further enforcement action in relation to this incident. Subsequently, we engaged with Wellington Water on the use of section 330 RMA emergency provisions.

- This report provides information related to a ruptured pressure wastewater pipeline in Porirua.
- The report describes the work completed in the context of s330 and s330A o

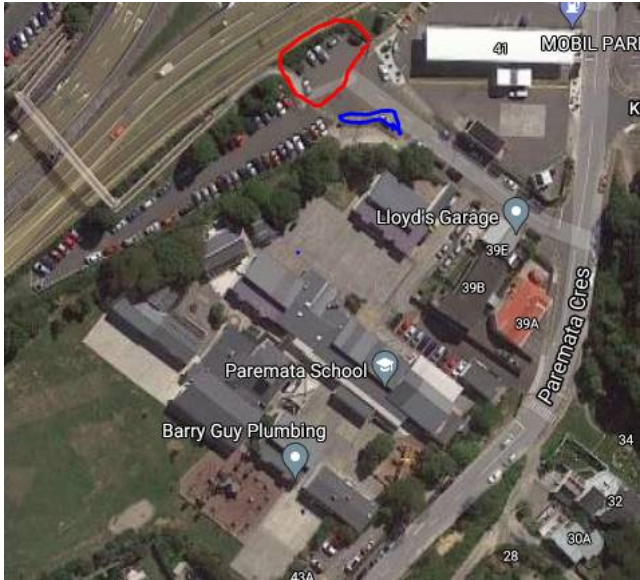
The team were successful in completing the repair this evening and the rising main is now operational. Our team will be monitoring the repair overnight. Note that we will still have some carparks coned off in the turning circle of the carpark due to machinery being onsite for monitoring purposes. Please see the picture below for approximate location of pumps (in blue) and carparks in red.

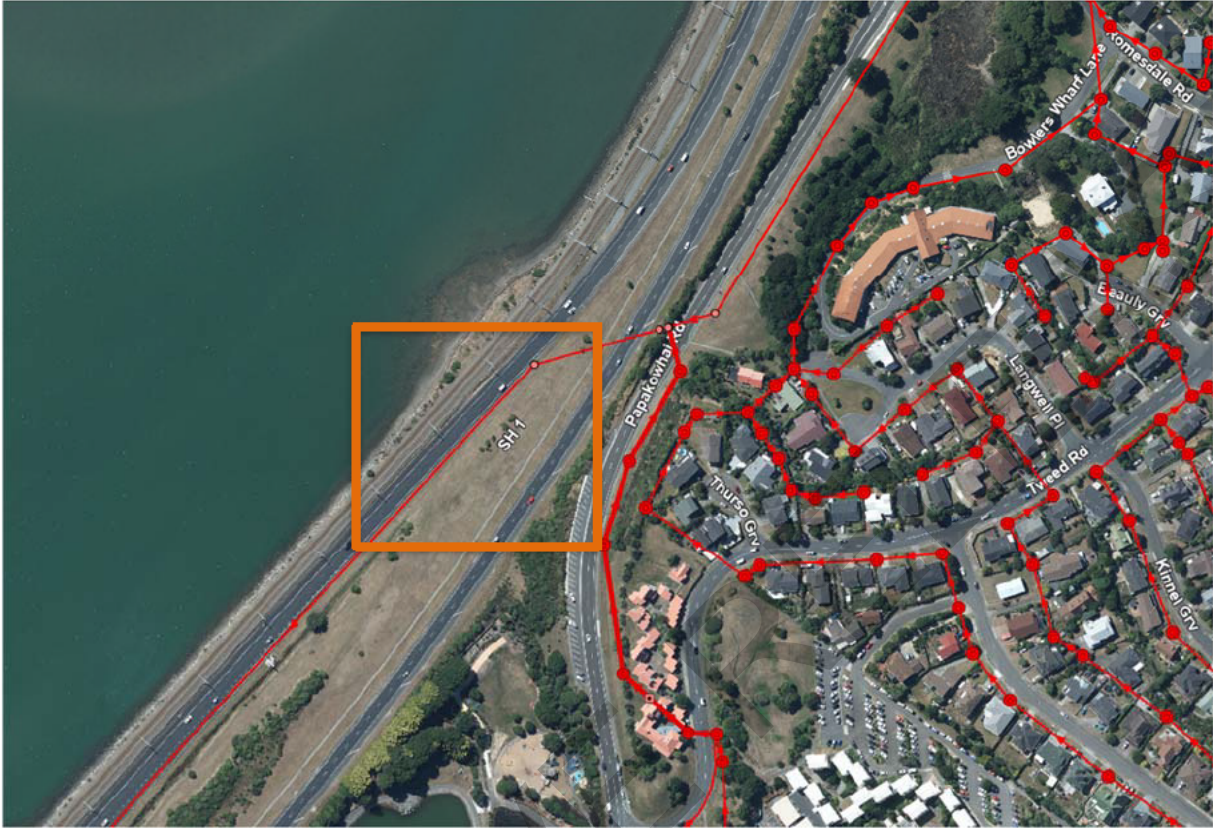
Figure 1: Pipeline Failure (shown in orange)

- The pipeline failed (ruptured) between the carriageways on State Highway 1, approximately 600m north of Whitford Brown interchange. (See Figures 1 and 2 in Attachment A)

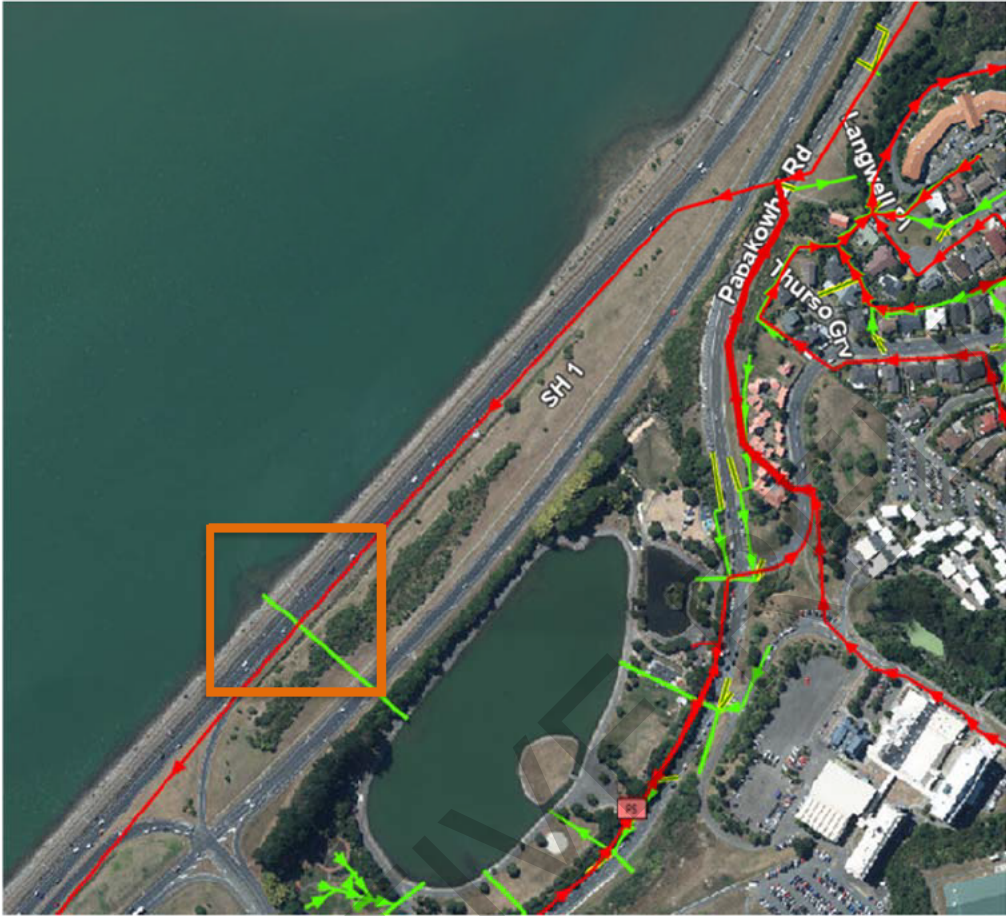
Figure 3: Aotea Discharge Location (shown in orange)

- Wastewater from the break (rupture point) travelled southwest along the State Highway 1 median and entered a stormwater culvert approximately 400m from the pipe failure. The wastewater then discharged to Te Awarua-o-Porirua Harbour (See Attachment B, Figure 3).

July 2021 and approximately 4.00 pm to 5.00 pm on 22 July 2021 at Aotea (See Attachment B, Figure 3). These discharges are a result of the initial and subsequent pipeline ruptures. These ruptures and associated discharges are a result of an unanticipated failure of the pipeline that could not have reasonably been provided against. Wellington Water acted immediately to mitigate the effects of the discharge by deploying vacuum (sucker) trucks and making requests to the public to minimise water use in order to reduce the volume of wastewater being discharged. Wellington Water also sought to minimise the effect of the discharge by shutting pump stations to move the discharge point closer to open water to increase dispersion of potential contaminants. Repairs were completed and normal operation resumed as soon as was reasonably practical.

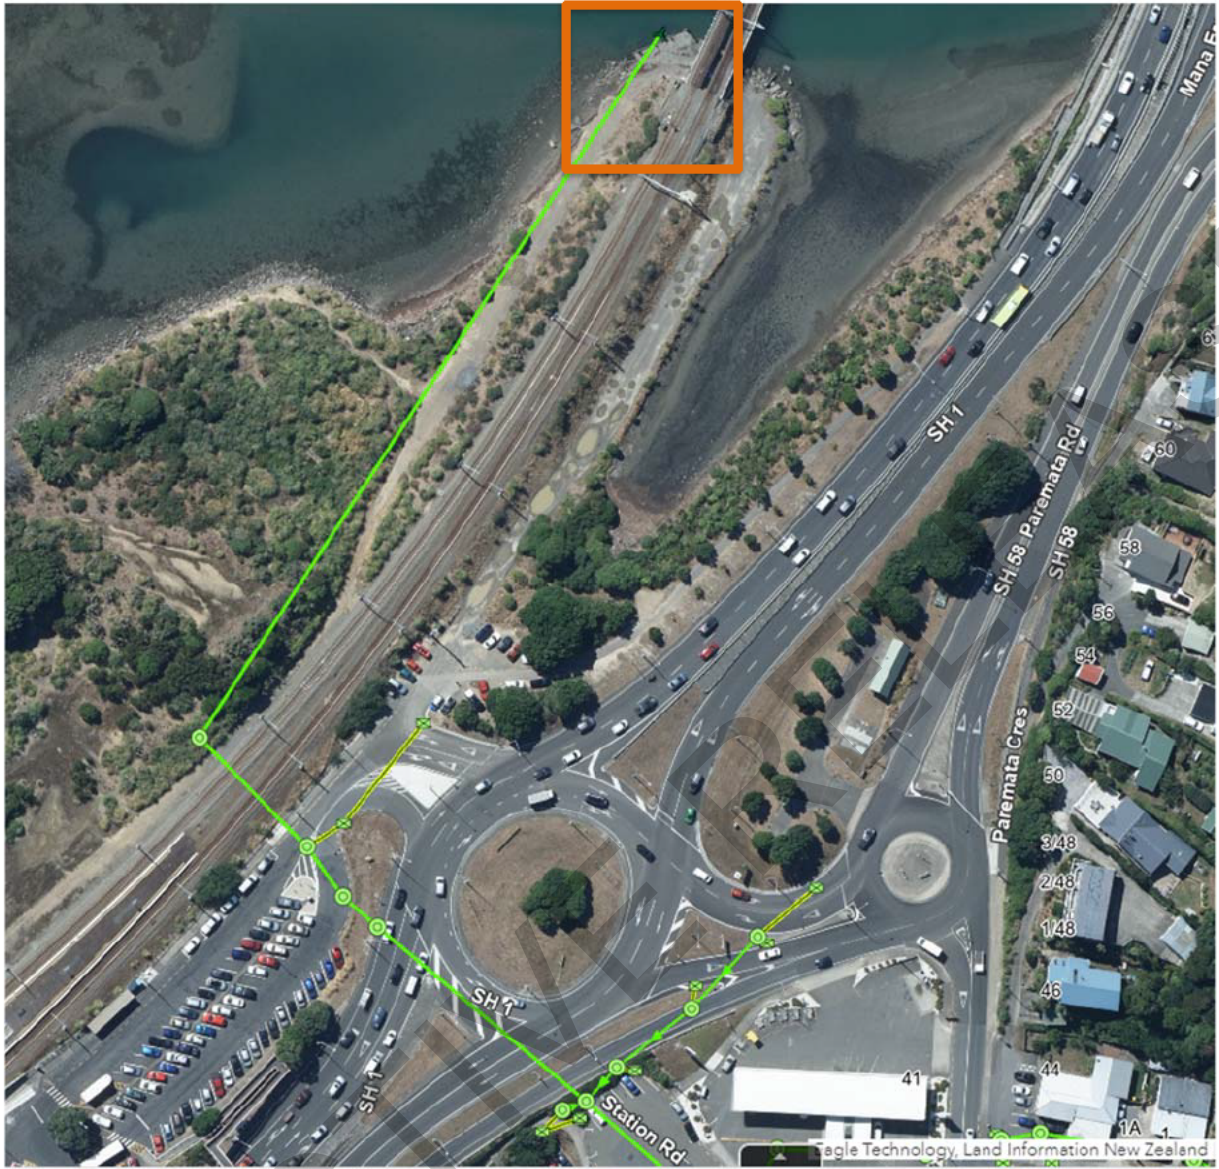
Figure 4: Paremata Discharge Location (shown in orange)

- The wastewater also flowed onto the two north bound State Highway 1 lanes.
- In order to avoid damage to property, avoid creating a traffic and health hazard, and to facilitate the repair work of the ruptured pipeline in a safe manner, the Pumping Stations in Paremata were turned off. These pump stations are directly 'upstream' of the rupture, and intercepts all the wastewater from the surrounding communities that flows through the main trunk pipeline towards the city centre. The wastewater then backed up within the wastewater system and overflowed at Station Road and Paremata Crescent into the stormwater system which then flowed into Te Awarua-o-Porirua Harbour at Paremata (See Attachment B, Figure 4).

Awarua-o-Porirua Harbour at Paremata. The decision to stop the pumps at Station Road and Paremata Pumping Stations backed up the wastewater network until it flowed into the stormwater network. In addition, mobile pumps were deployed to pump the overflowing wastewater into the stormwater network. This decision ensured that wastewater did not pond on State Highway 1, Station Road and Paremata School which would cause a traffic and health hazard, property damage and ensured the safety of our response crews working to repair the pipeline at Aotea. Vacuum sucker trucks were also onsite to transport wastewater around the site to Porirua City Centre Pump Stations.

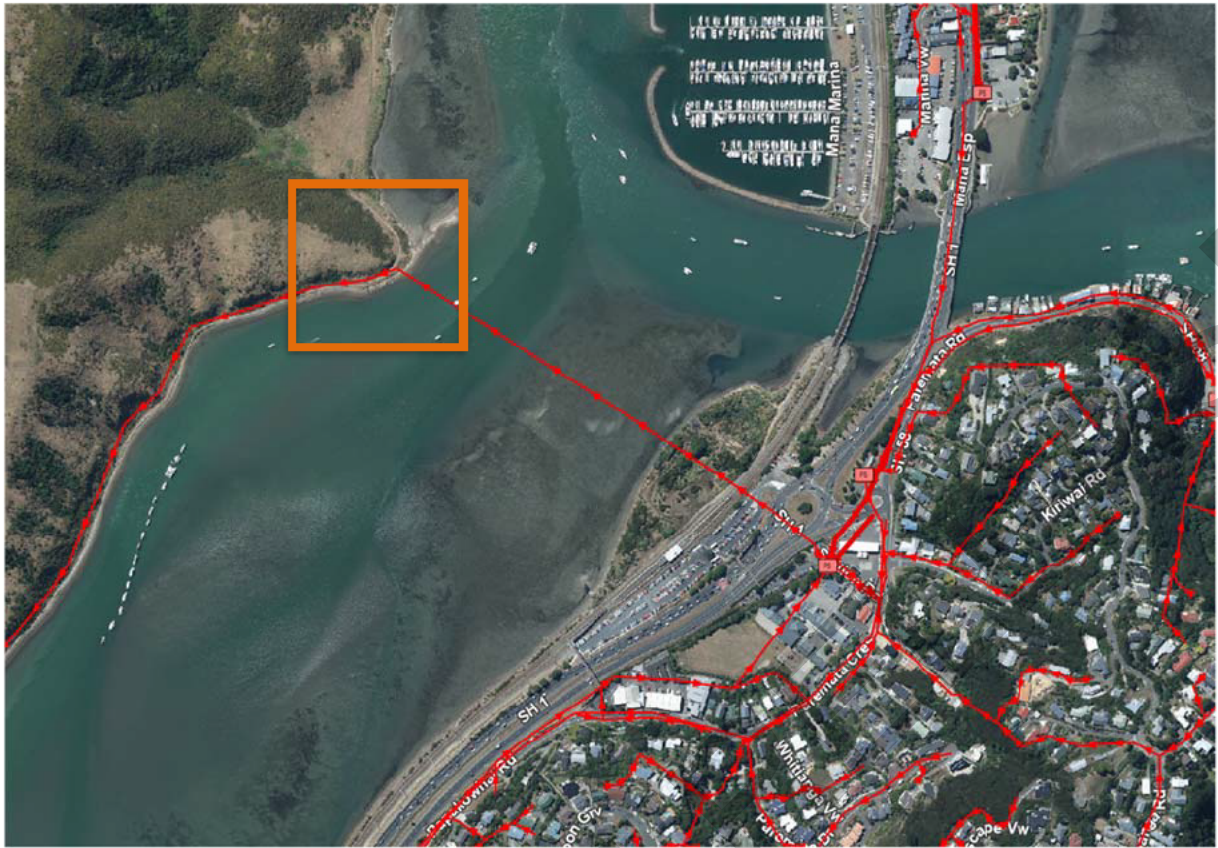
Figure 5: Whitireia Park Reserve Discharge Location (shown in orange- approximate)

- In addition, due to the capacity of the stormwater system, some wastewater ponded onto Paremata School until additional mobile pumps could be deployed. These pumps transferred the overflowing wastewater to the stormwater network, which then flowed into Te Awarua-o-Porirua Harbour at Paremata (See Attachment C, Figure 7).
- To protect property and avoid creating a health hazard, the cross harbour pipeline between Paremata and Whitireia Park Reserve was utilised to convey wastewater (See Attachment C, Figure 8). This pressure pipeline had previously been inspected through creating small openings at Onepoto and Whitireia Park Reserve, and unbeknown to Wellington Water, these inspection points remained open when the pipeline began to convey wastewater under pressure. These openings resulted in discharges of wastewater to Te Awarua-o-Porirua Harbour at Onepoto and Whitireia Park Reserve.

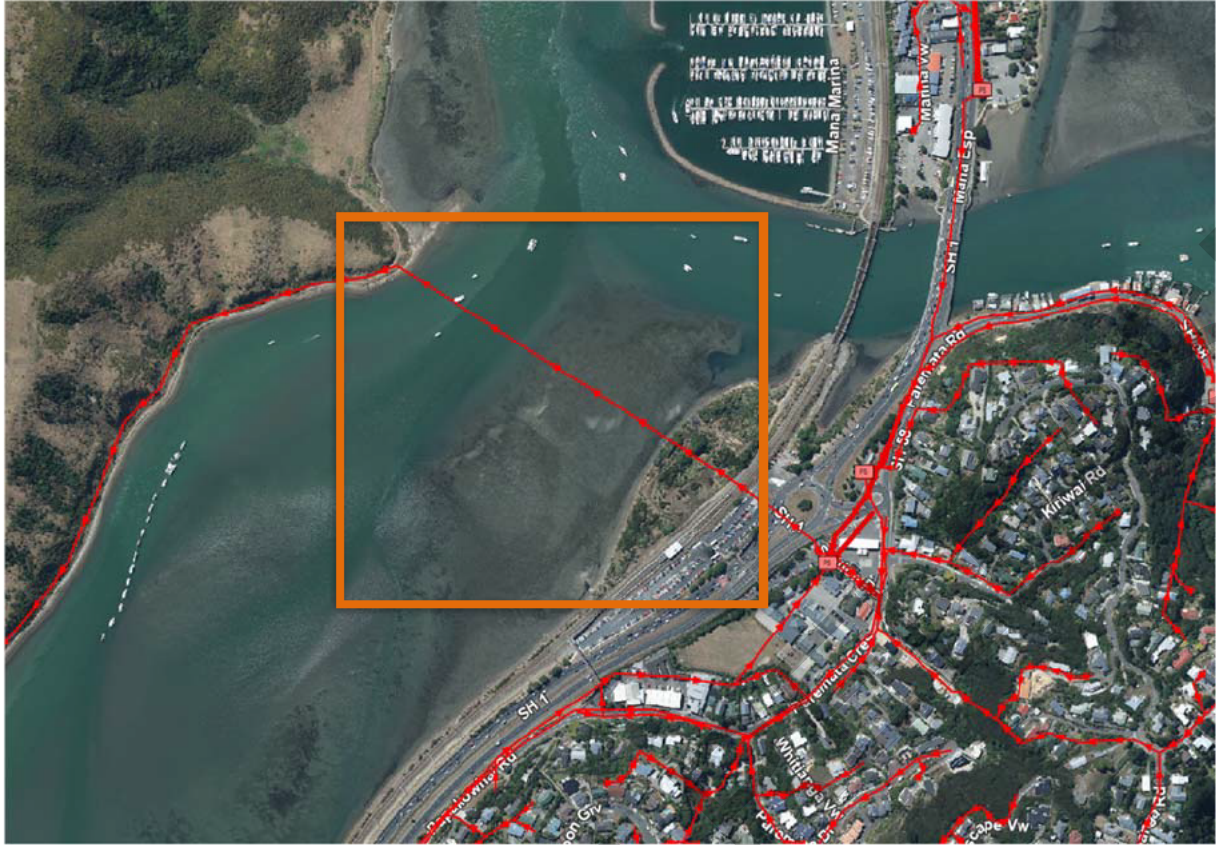
Figure 8 Cross Harbour Pipeline (shown in orange)– Paremata to Whitireia Park Reserve

- On Tuesday (20 July 2021), wastewater diverted through cross harbour pipeline. On site observation notes a leak in the pipe and wastewater entering Porirua Harbour. Commenced dye testing to confirm location. Wastewater leak detected in Onepoto Road. Cross harbour pipeline repaired and pressure tested with drinking water.
