Queen Elizabeth Park

DRAFT Coastal Erosion Plan

Prepared by **PAOS**[®]

for Greater Wellington Regional Council

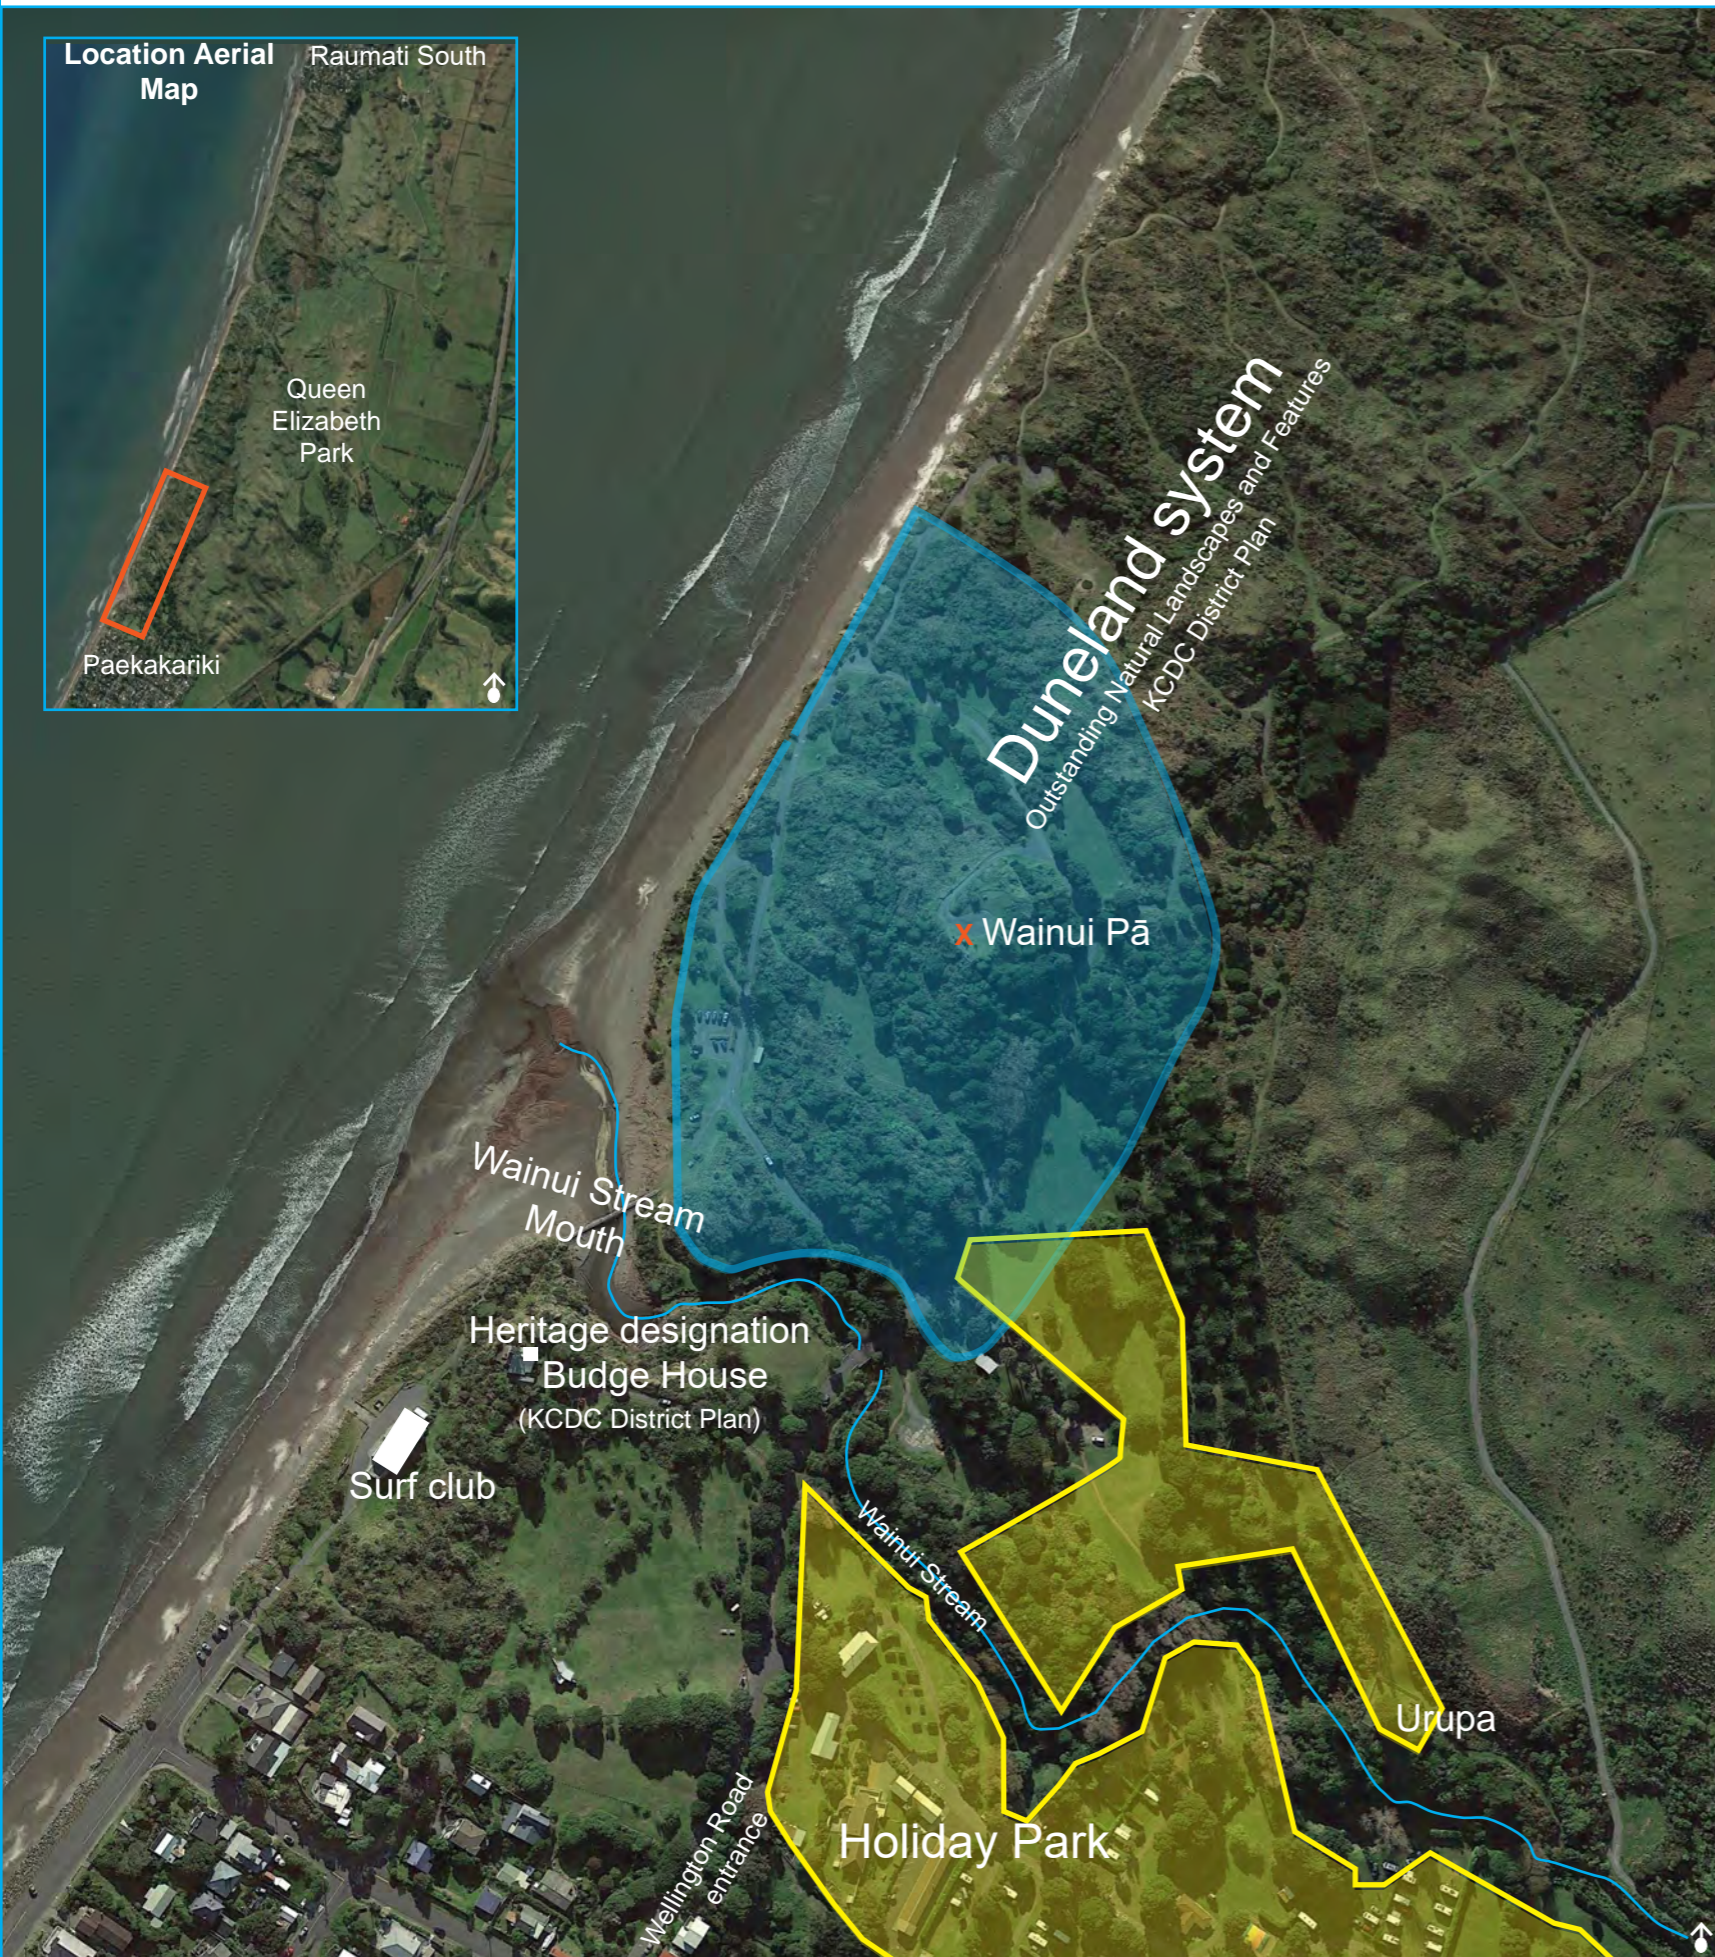
Figure 1 - Aerial view of the erosion zone covered by this plan showing designations

This plan focuses on the coastal edge from the park's southern entrance at Wellington Road in Paekakariki to approximately 900 metres to the north (see the location aerial map on this page). It includes dunelands, Paekakariki surf club, Budge House, Wainui Pā, Wainui Stream, and a network of green open spaces, picnic areas, roads, carparks, trails and beach access, but not the holiday park or urupa.

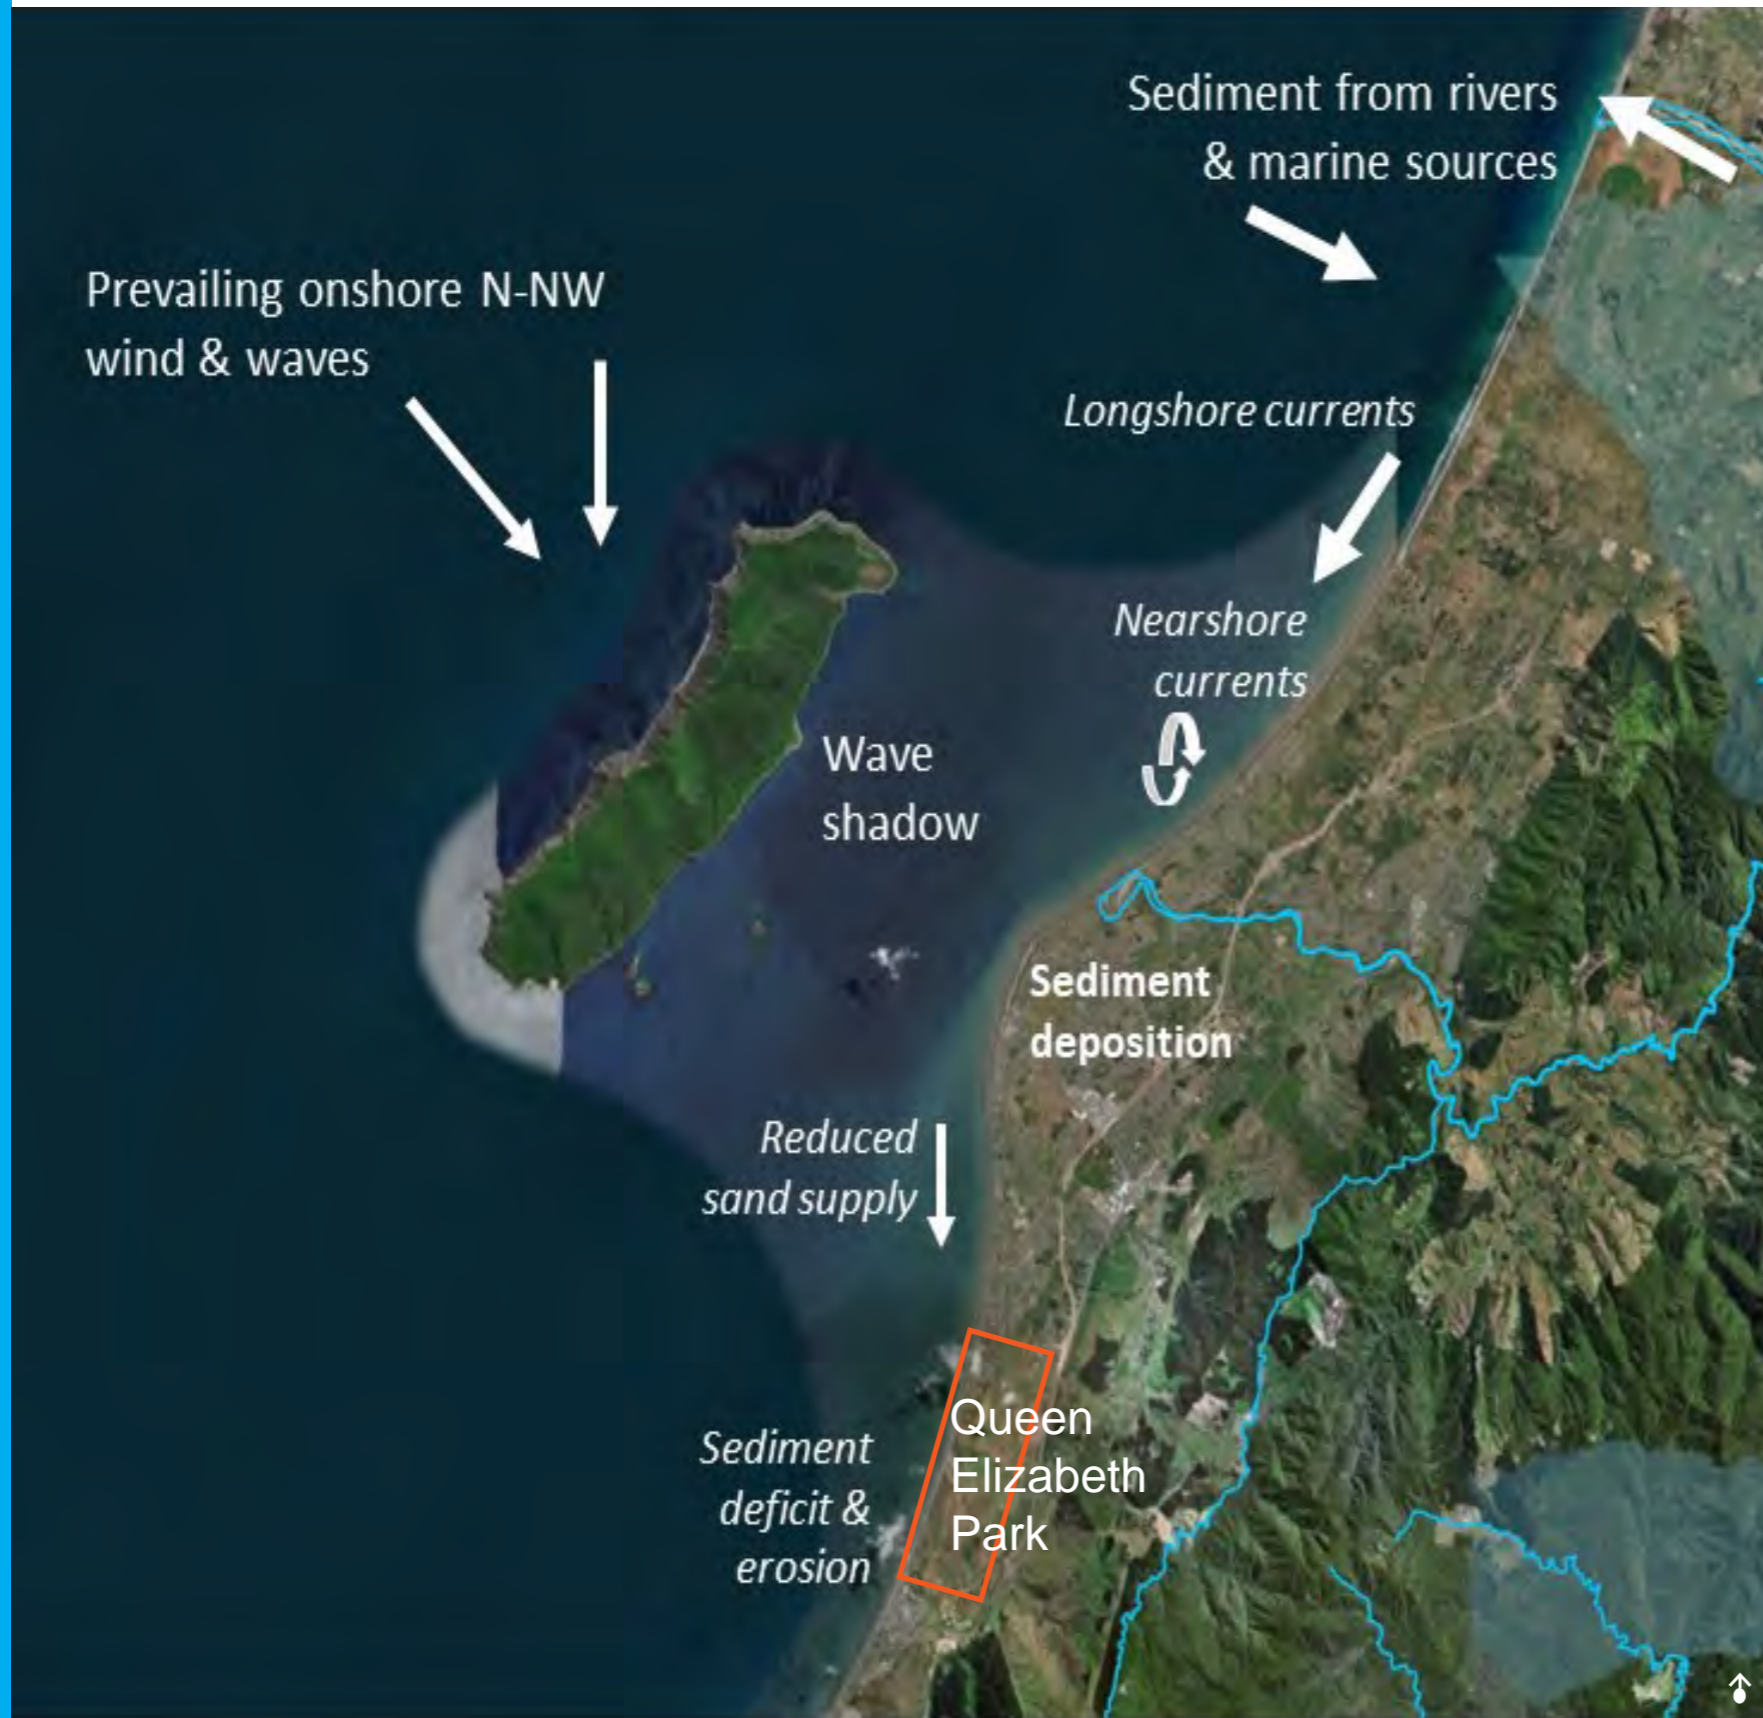
Figure 2 - Diagram showing sediment movement

Effects within this 40 metre erosion zone are exacerbated by a lack of sediment to replenish sand eroded after storm events. Figure 2 shows the processes along this part of the Kapiti Coast that lead to a sediment deficit and reduced sand supply.

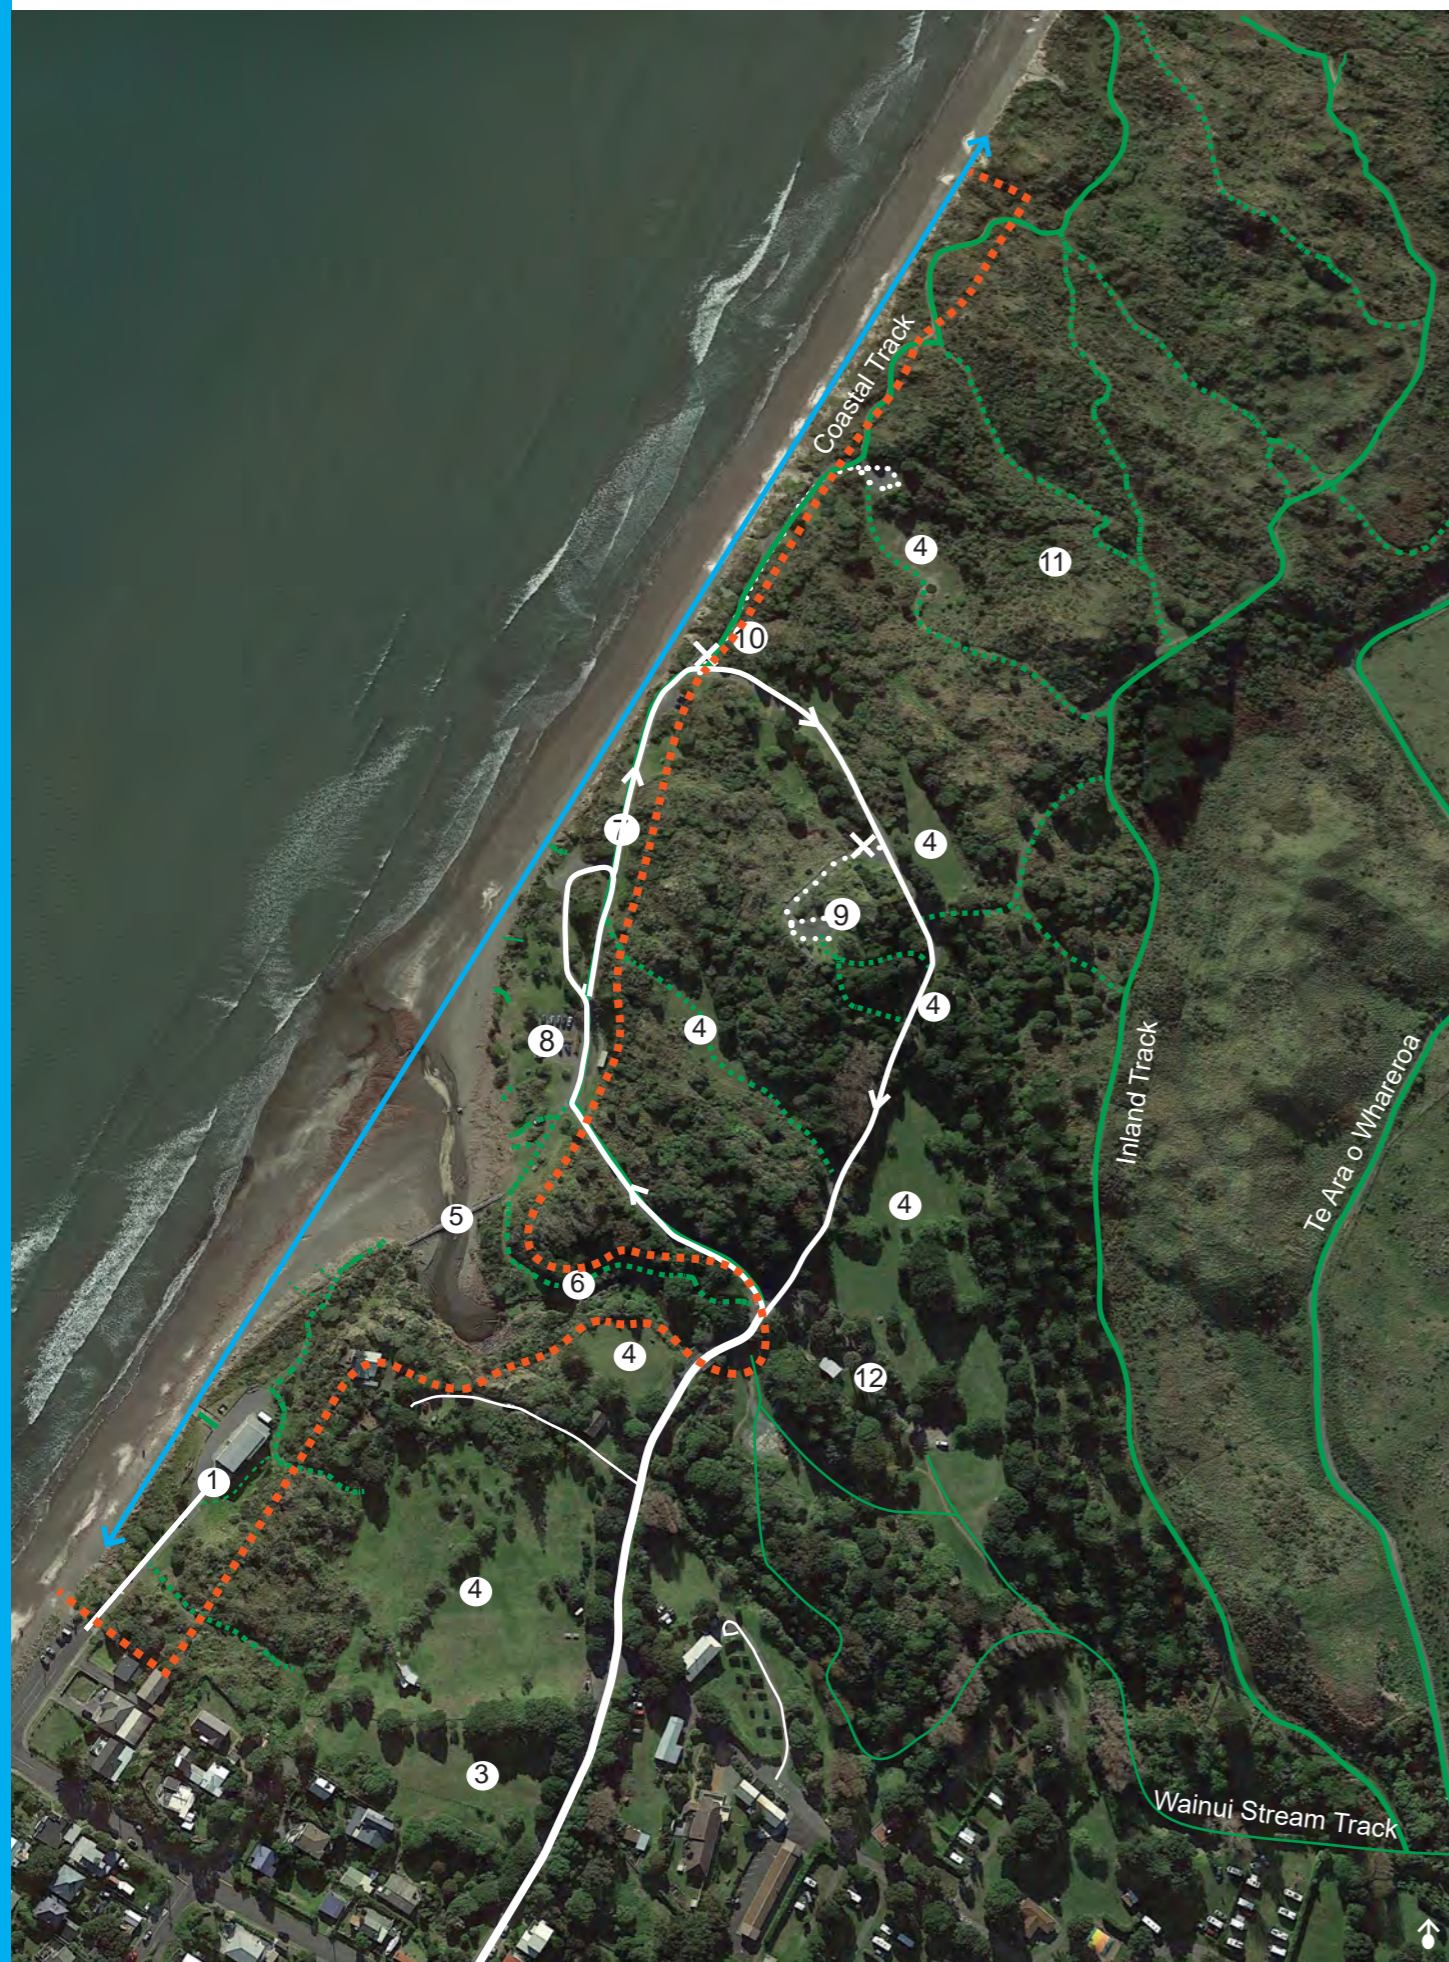
Figure 3 - Aerial view showing the site

- Erosion along the beach edge (see pages 8-10)
 ➤➤➤ Beach access is difficult and in some places the beach is inaccessible from the park.
- - - 40 metre Erosion zone
 ➤➤➤ Road, carparks, toilets and park furniture within the erosion zone are vulnerable to storm events and are proposed to be relocated.

- Three trails run North/South parallel to the coast - Te Ara o Whareroa, the Inland Track, and the Coastal Track/Te Araroa
 ➤➤➤ The Coastal Track is within the erosion zone and proposed to be closed

- - - Trails through dunes link coastal and inland trails
 ➤➤➤ Once the coastal track is closed the linking tracks are no longer necessary.
- 1 Surf club access from The Parade
 ➤➤➤ The surf club lies within the erosion zone. A 2018 Erosion Hazard Assessment recommended retreat to a site east of the foredune.

- 2 Budge House (park ranger's house) on foredune with private driveway and storage shed
 ➤➤➤ Budge House is partly within the erosion zone and may have to be relocated in future.

- 3 Slightly elevated area at Wellington Road entrance with information
 ➤➤➤ This area has good surveillance of the park entrance and is a suitable location for a new park ranger's house.

- 4 Grassed open spaces of different sizes with picnic tables, toilets, shade, and open space for flexibility and choice for large and small groups.
 ➤➤➤ Flexible open spaces are important as they cater for a wide variety of visitor and community needs and can be developed for specific purposes as required.

- 5 Pedestrian bridge over Wainui Stream mouth destroyed during 2018 cyclones
 ➤➤➤ Pedestrian bridge was within the erosion zone and replacement is not recommended.

- 6 Track above the stream bank (see page 9)
 ➤➤➤ This track is within the erosion zone and ongoing maintenance is not recommended.
- 7 One way ring road through the foredune and along the coastal edge
 ➤➤➤ The coastal section of this ring road lies within the erosion zone and is proposed to be replaced by a low impact track.

- 8 Parking with beach access, picnic tables and toilets
 ➤➤➤ Facilities and infrastructure lie within the erosion zone and are proposed to be relocated behind the restored and naturalised foredune.

- 9 Pa site with views and lookout structure reached by the one-way ring road
 ➤➤➤ This plan proposes removing vehicle access and improving accessibility in partnership with iwi.

- 10 Locked gate controls vehicle access to a parking/turning area
 ➤➤➤ The asphalt turning/parking area lies within the foredune and is proposed to be removed and the area planted using indigenous sand binding species.

- 11 The dune landscape
 ➤➤➤ The duneland and sheltered picnic areas lack interpretation or information.
- 12 The sharp spines of Phoenix palms are a hazard and known to injure people and animals
 ➤➤➤ The proposal is to replace Phoenix palms with Nikau palms

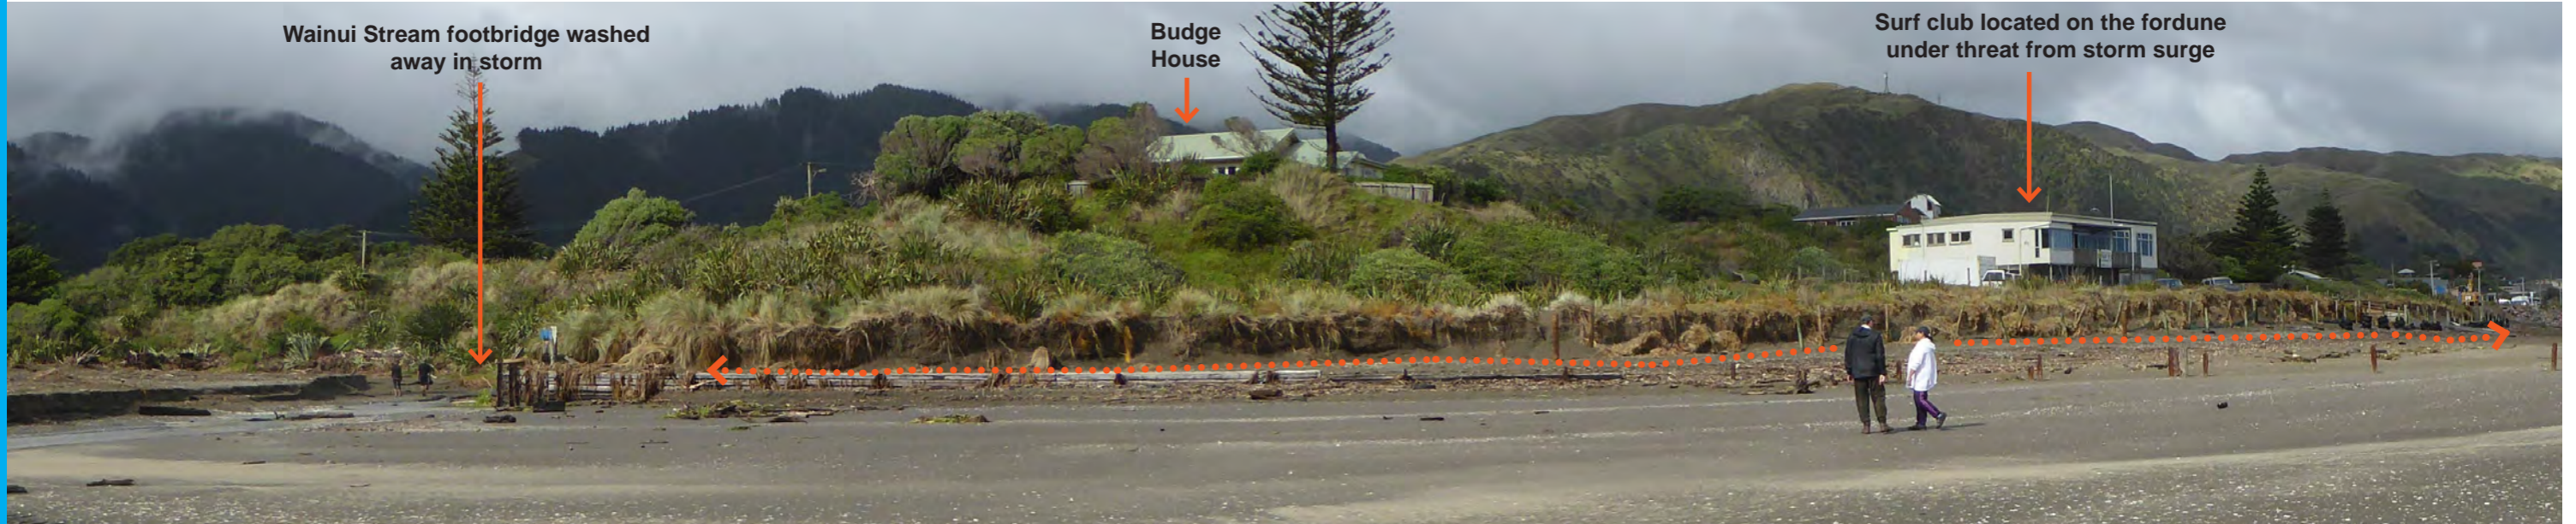
Erosion at toe of foredune below Budge House and surf club

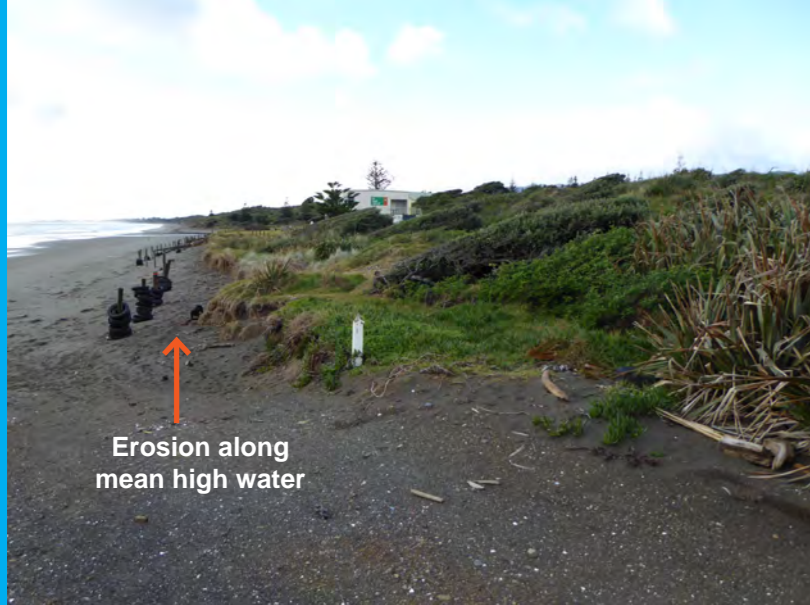
Erosion at beach edge in front of surf club

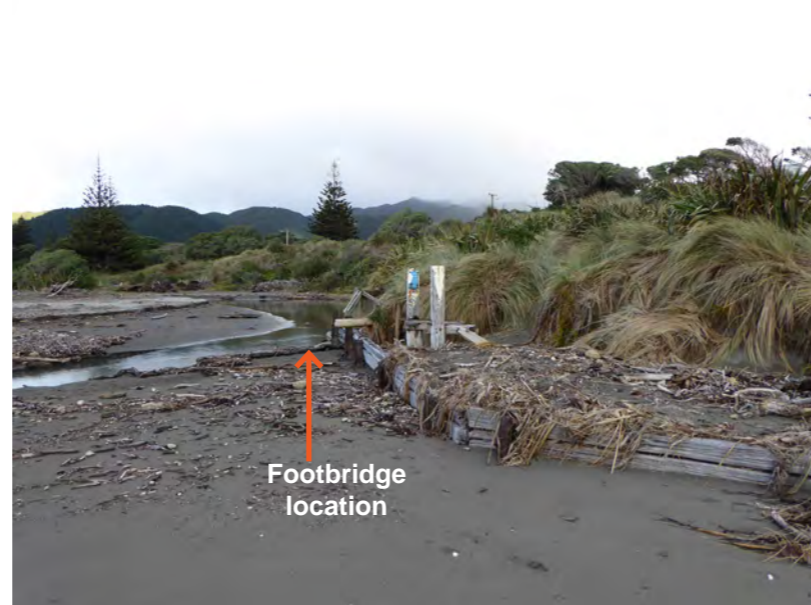
Footbridge across Wainui Stream washed away

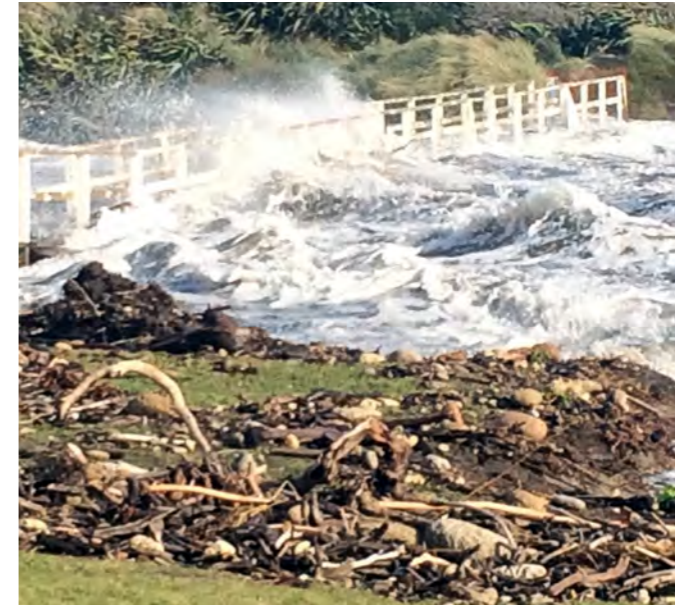
Footbridge during storm early 2018

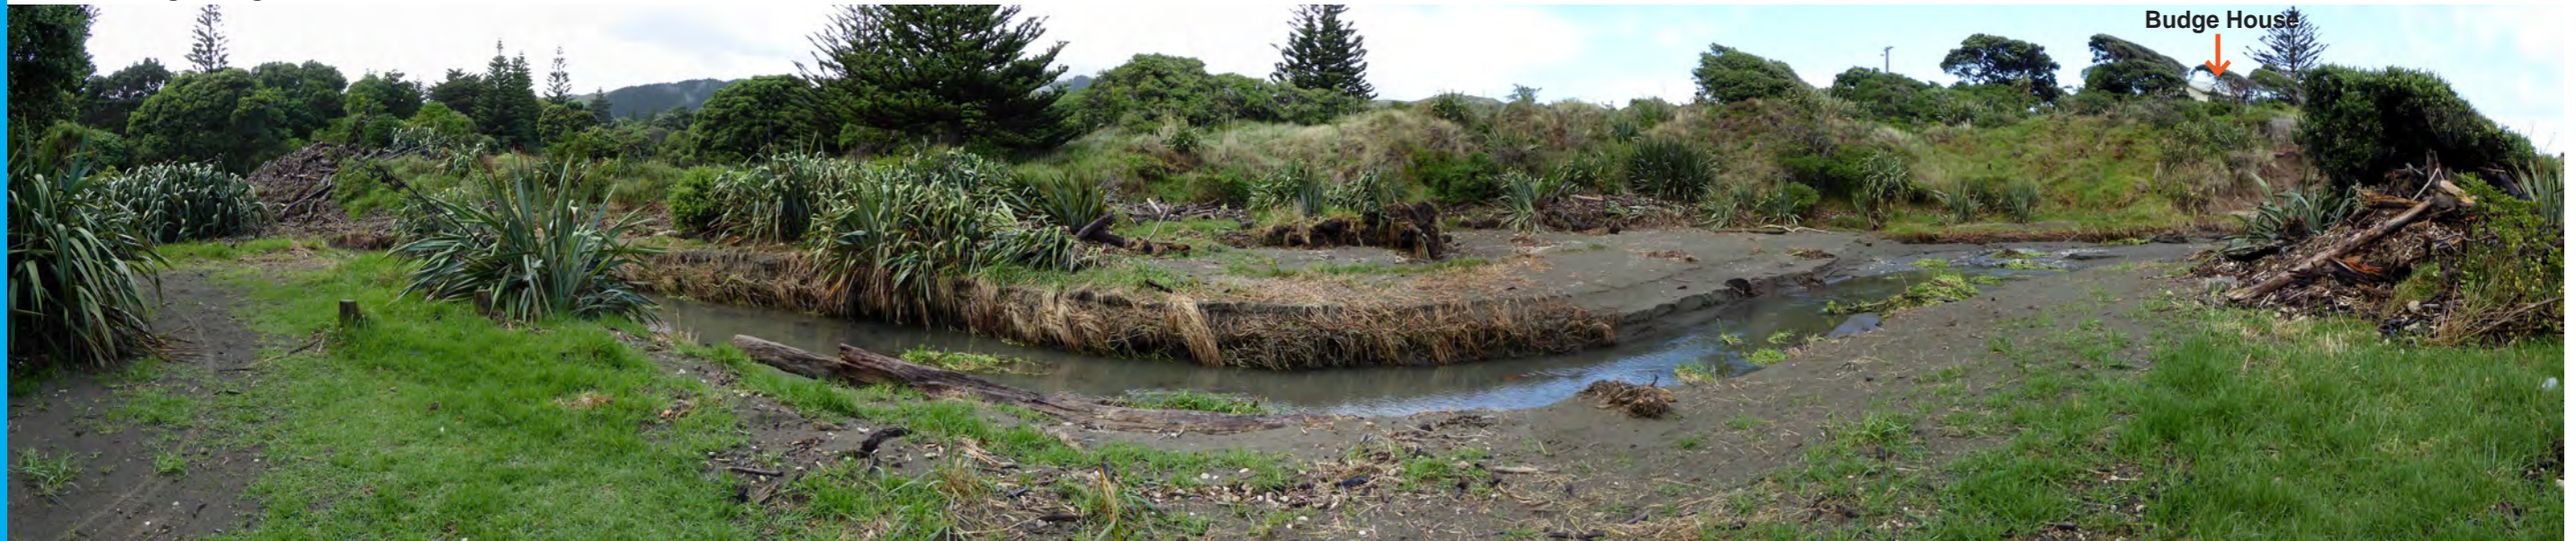
Storm damage along Wainui Stream

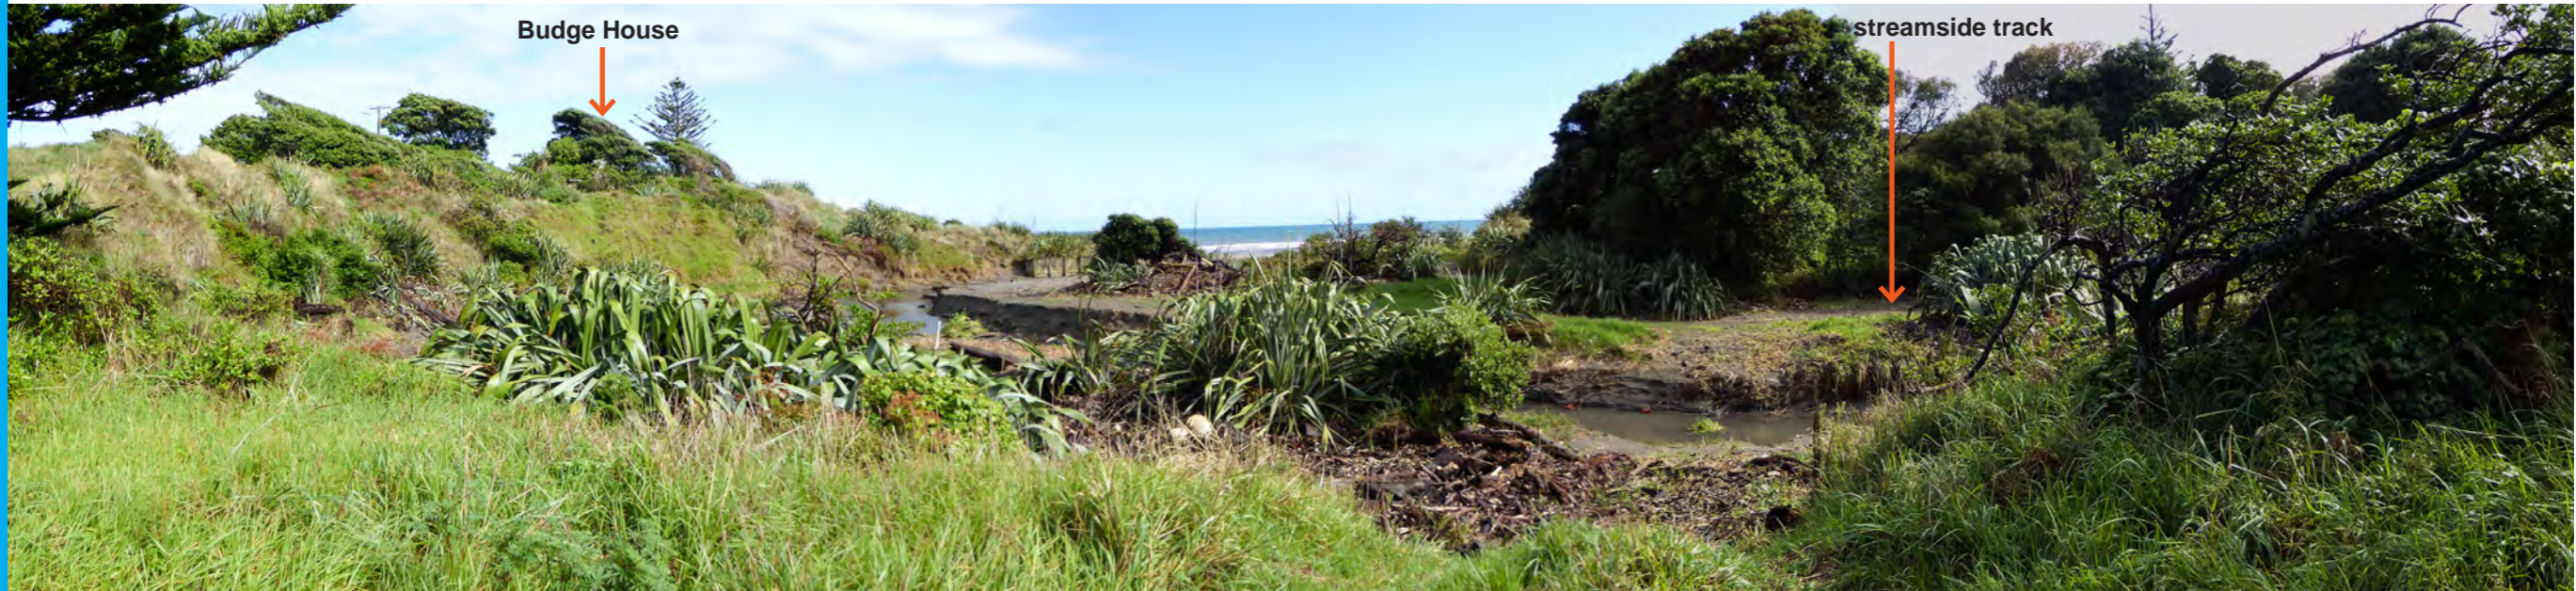
Stream bank erosion and debris at mouth of Wainui Stream after a storm

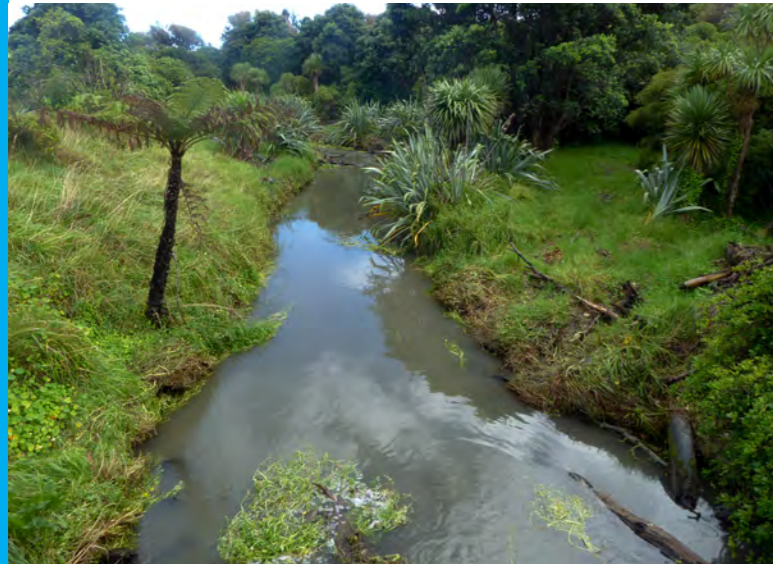
Debris in stream after storm surge - viewed from bridge

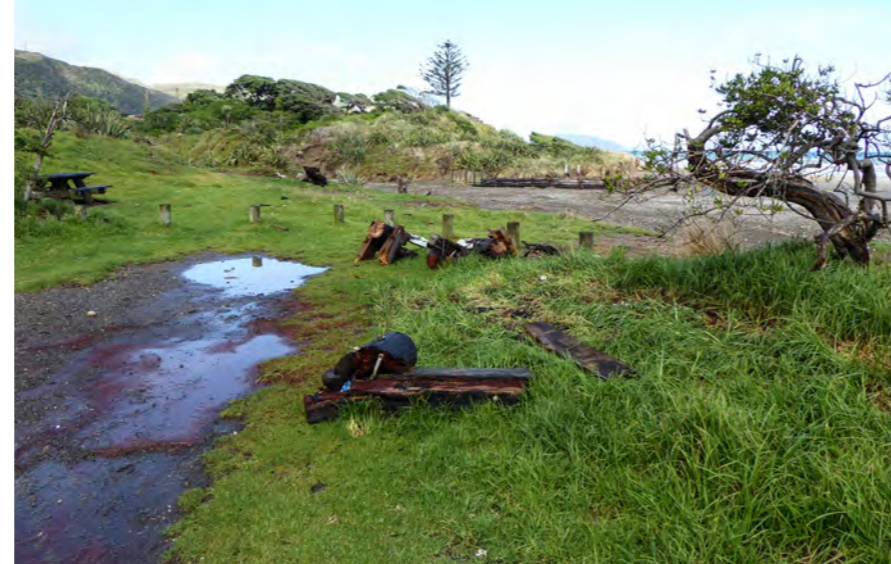
Debris from footbridge scattered around Wainui Stream mouth

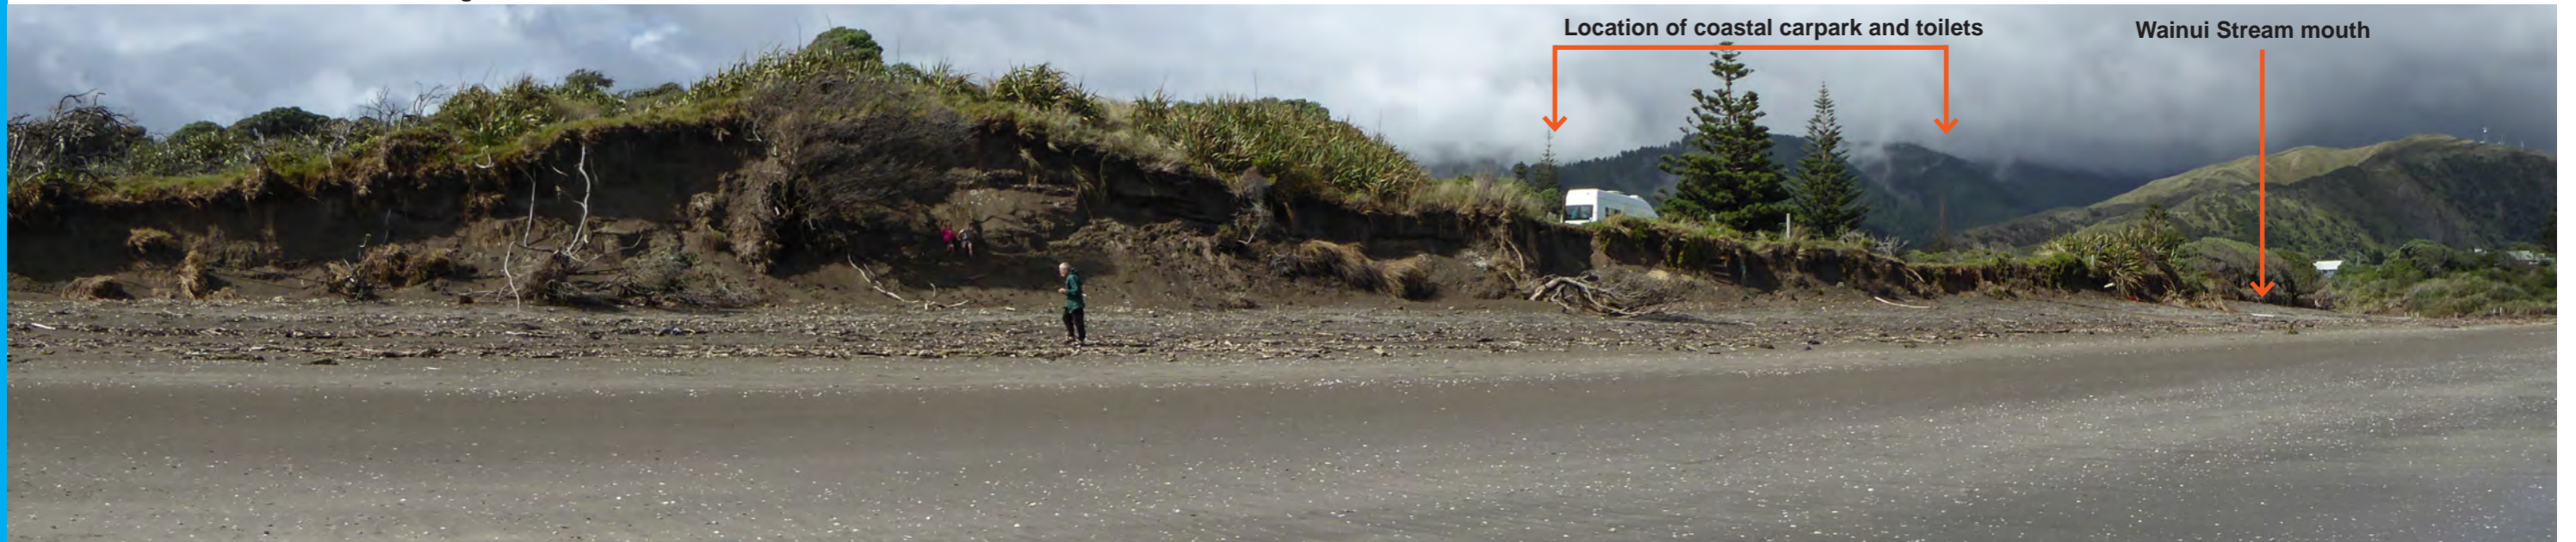
Erosion north of Wainui Stream reducing beach access

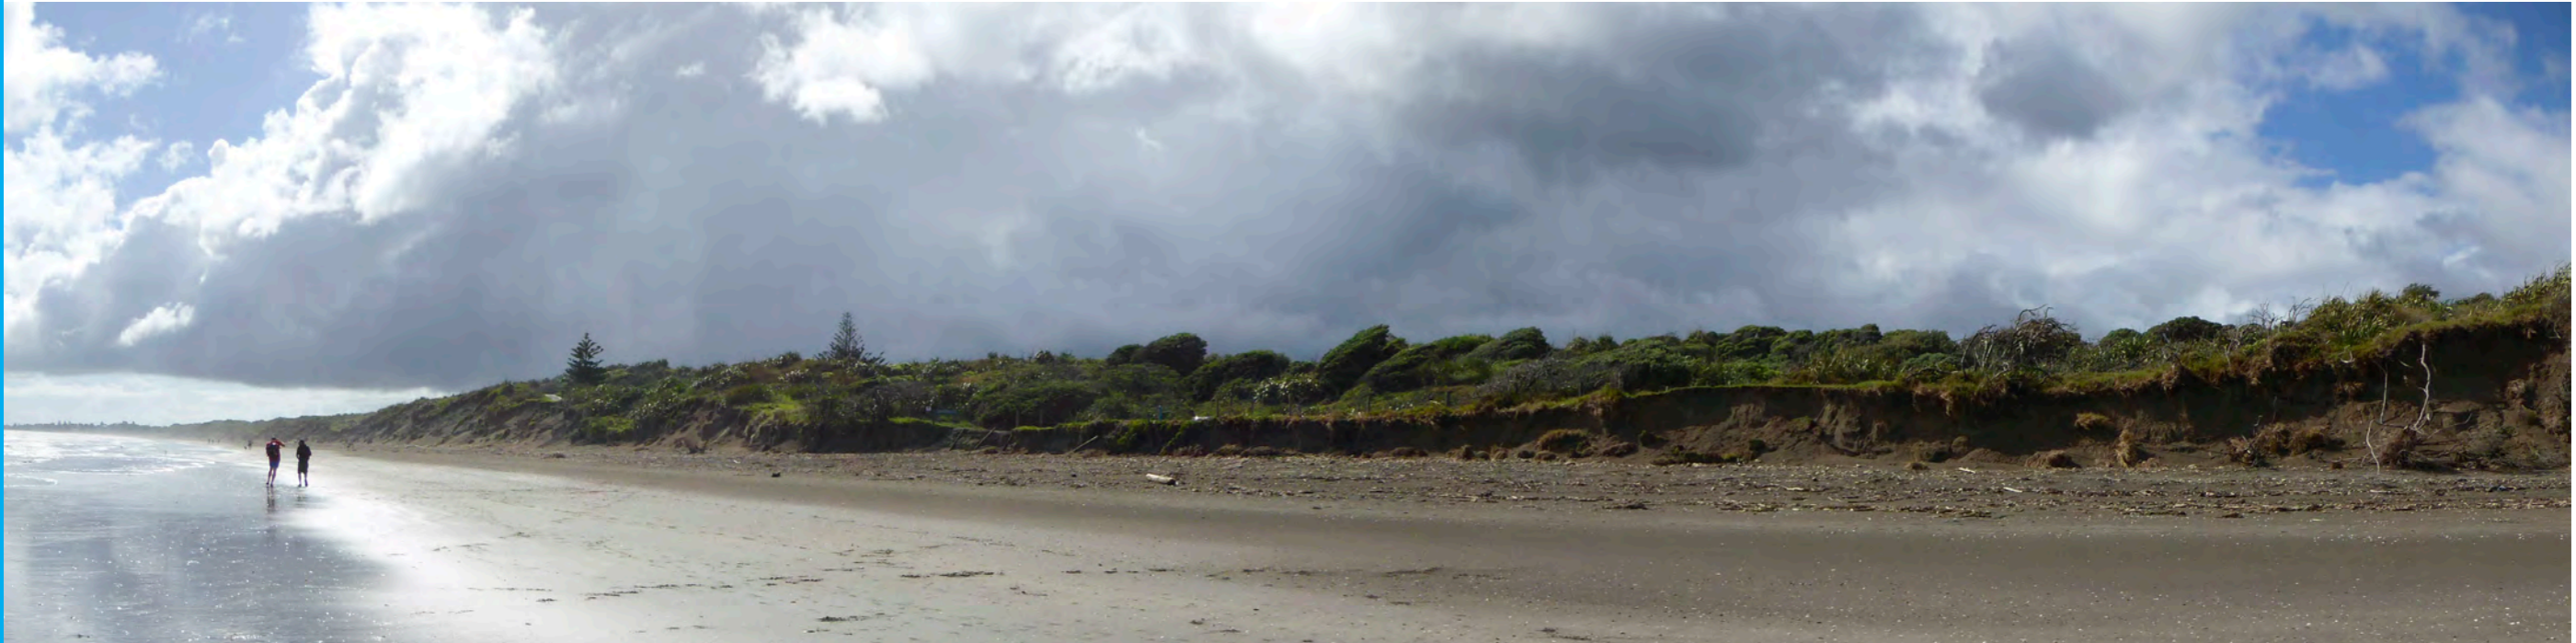
Erosion along the Coastal Track and difficult beach access

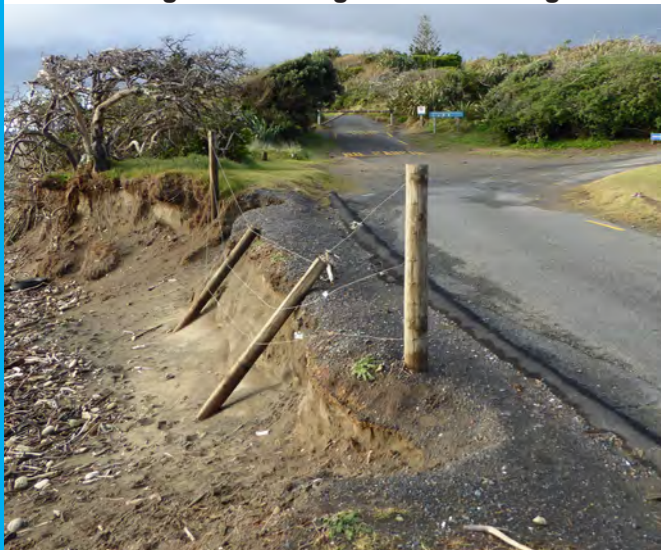
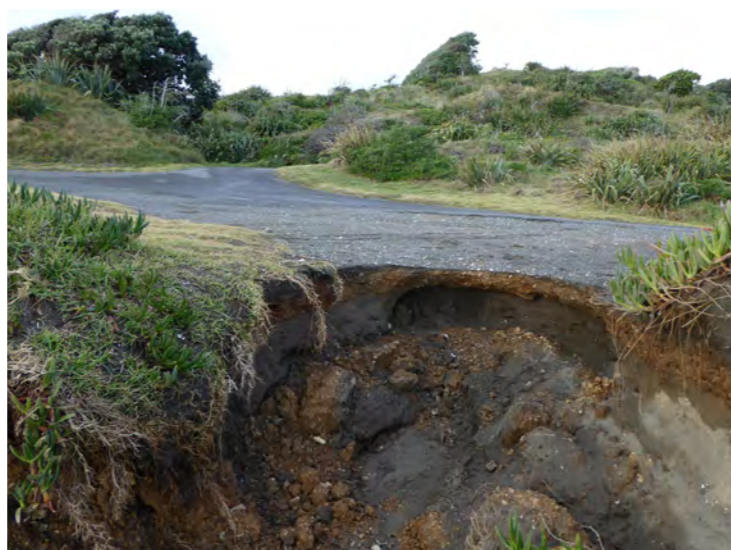
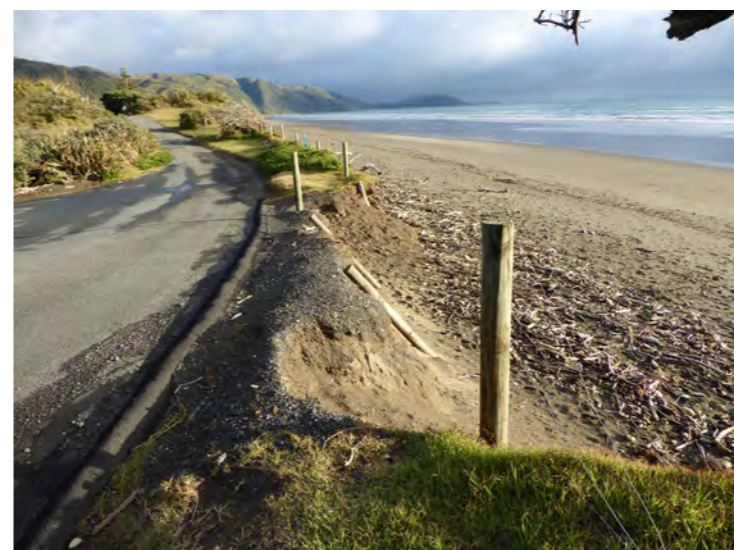
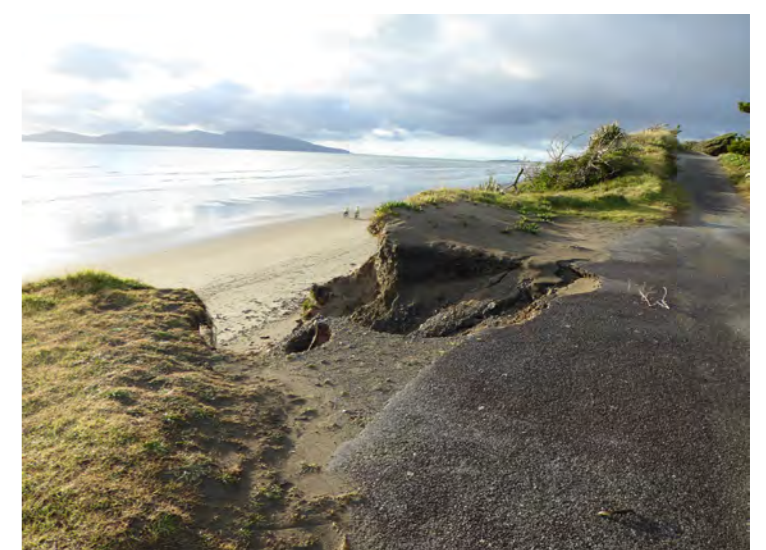
Coastal ring road eroding after storm surges

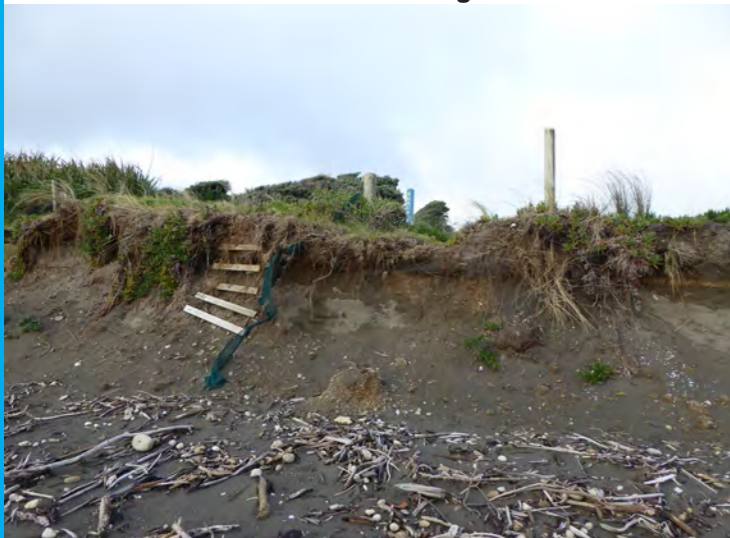
Beach access from the coastal ring road eroded

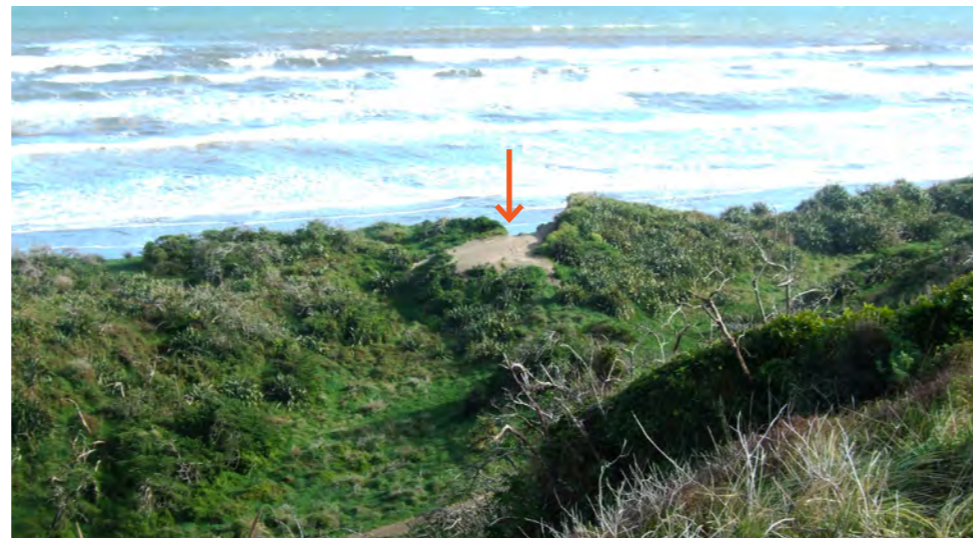
Dune blow out near the Coastal Track
