Queen Elizabeth Park

DRAFT Coastal Erosion Plan

Prepared by **PAOS**[®]

for Greater Wellington Regional Council

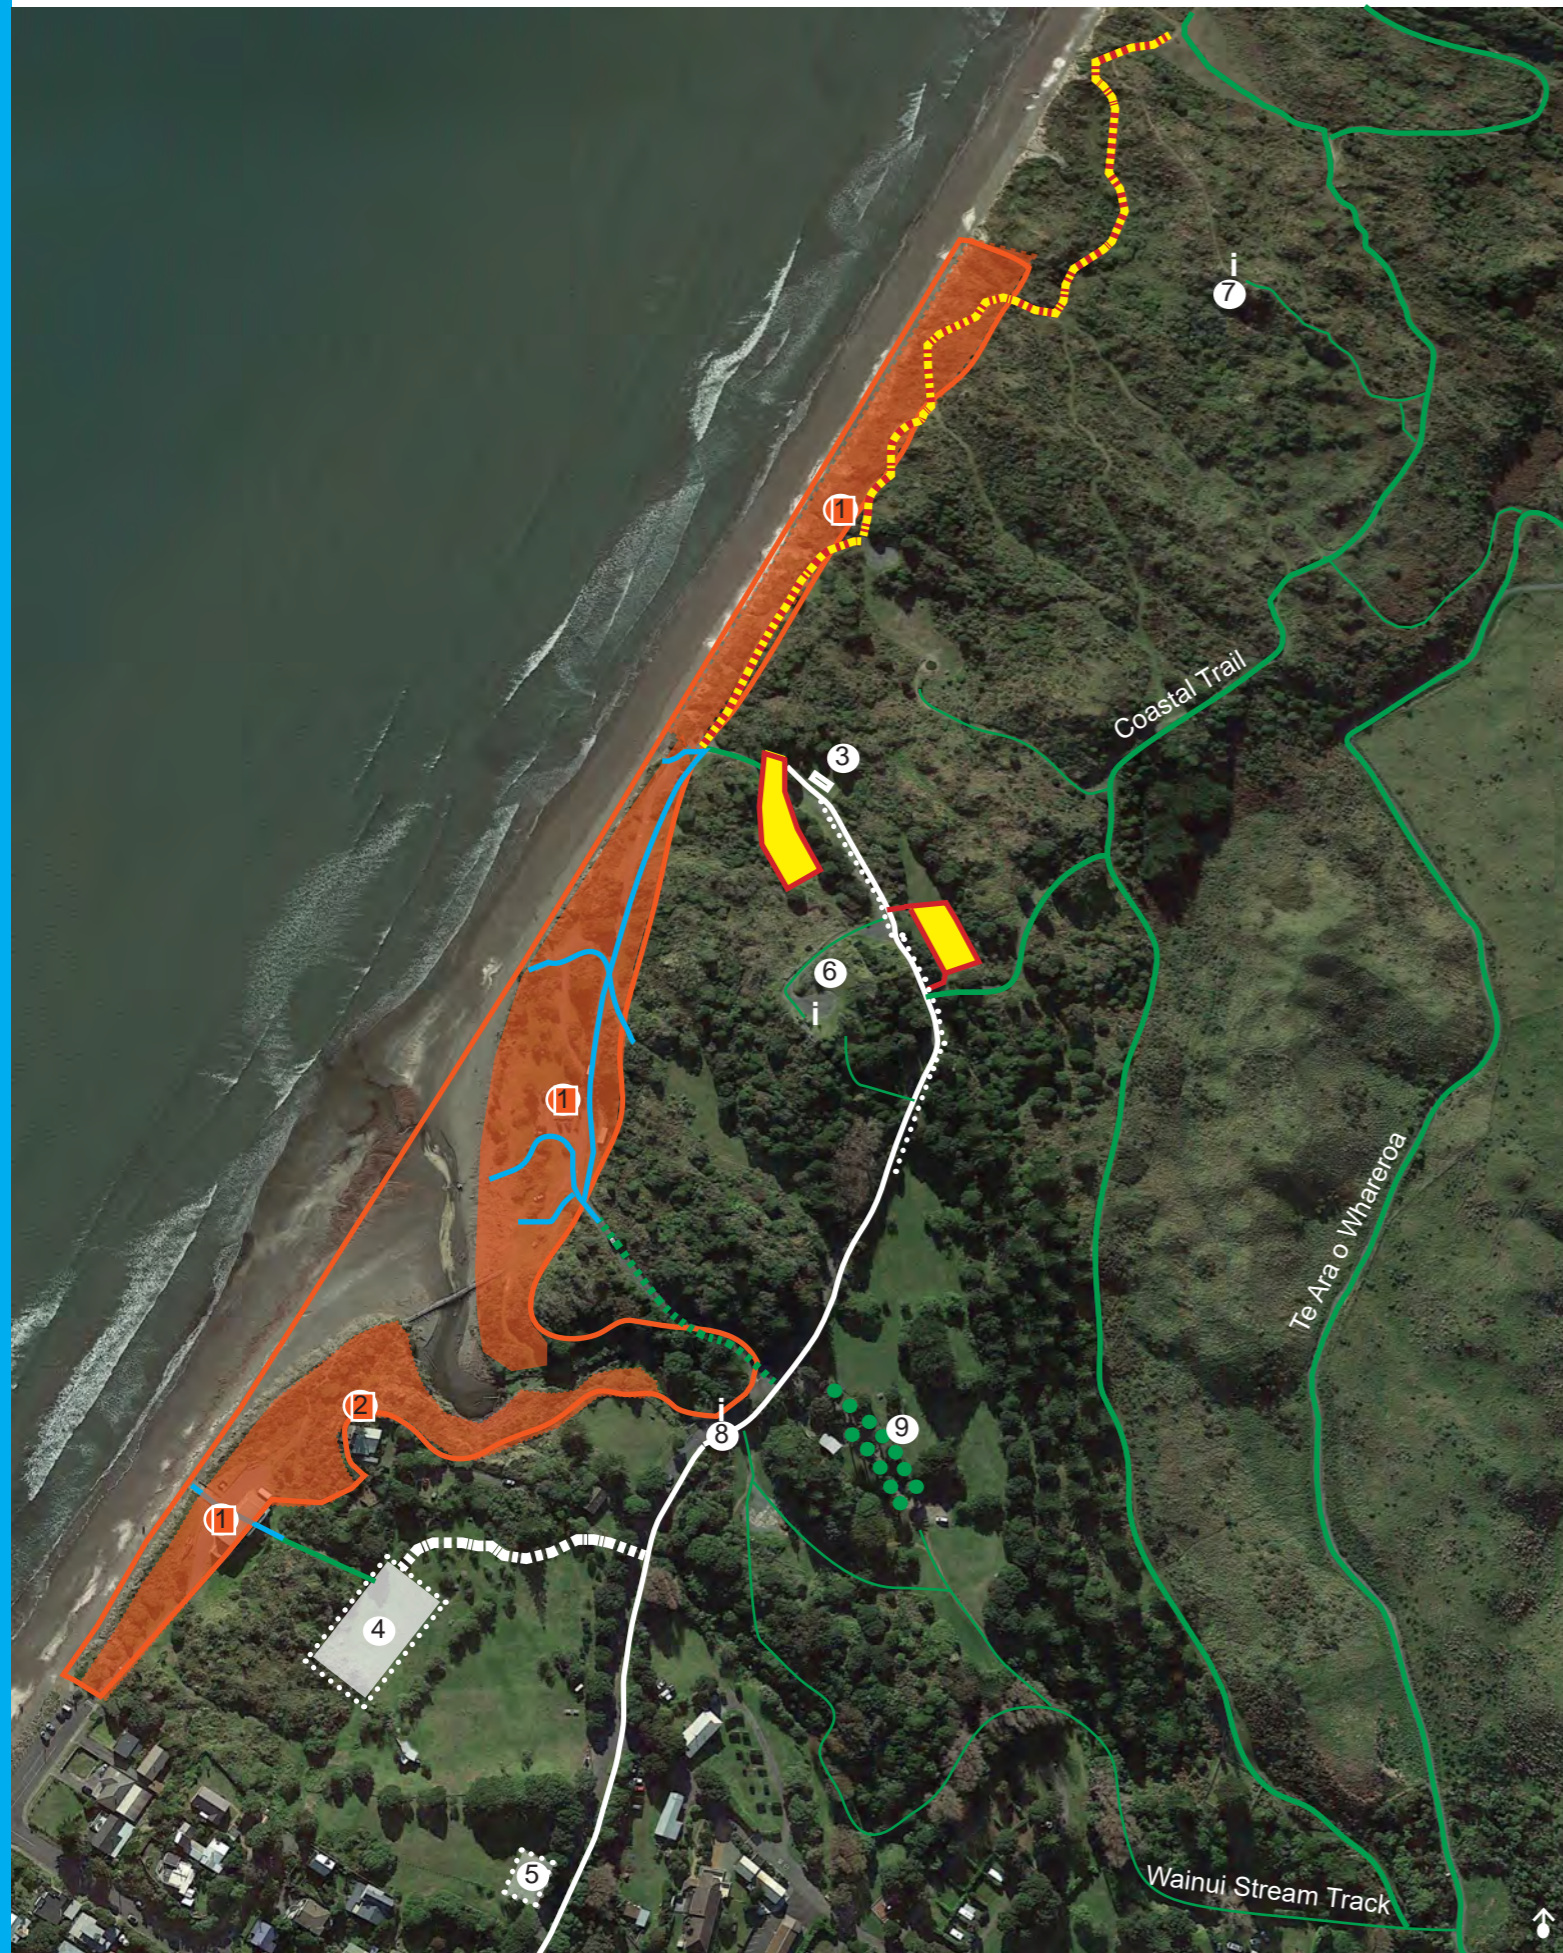
Figure 4 - Aerial view showing proposed relocation and development

- ① Removal of structures on the seaward side of the foredune - toilet block, carparks, asphalt ring road, picnic tables, coastal trail and surf club,. The storage shed next to Budge House driveway is also proposed to be removed.

- ② Dune restoration to enable natural coastal processes and dune renewal - removal of hard and fill material, reinstatement of toe of foredunes, planting using native sand binding species such as spinifex, pingao, sand coprosma, sand tussock etc (see page 14 for examples of foredune restoration).

- ⑤ Coastal Track decommissioned. Existing inland track becomes Coastal Trail/ Te Araroa with views to the sea. With decommissioning of the current coastal track there is no longer need for most connecting tracks across the dune system. Their removal will help protect the dune system.

- ③ Replacement toilet block location.
- ④ Replacement surf club building with parking, accessed at the driveway entrance to Budge House.
- ⑤ Future site for park ranger accommodation with good surveillance at the park entrance.

- Beach access via low impact tracks through restored toe of foredunes(see page 14).
- Existing tracks.
- Ring road becomes walking/cycle path.

- ⑥ Removal of vehicle access to Wainui Pā site with access for pedestrians only, removal of asphalt at the summit. Redevelopment of the lookout with interpretation of iwi settlement and use in partnership with iwi.
- ⑦ Existing highpoint and seat developed as lookout with interpretation of natural dune processes and ecology (see page 13).
- ⑧ Wainui Stream interpretation panel at existing bridge.

- Existing vehicle access (widened in places to become 2-way).
- New vehicle access off Budge House driveway to new surf clubroom and parking.
- ④ New carparking for picnicking and access to Wainui Pā and Coastal Trail (current Inland Track).

- ⑨ Phoenix palms replaced by Nikau palms.

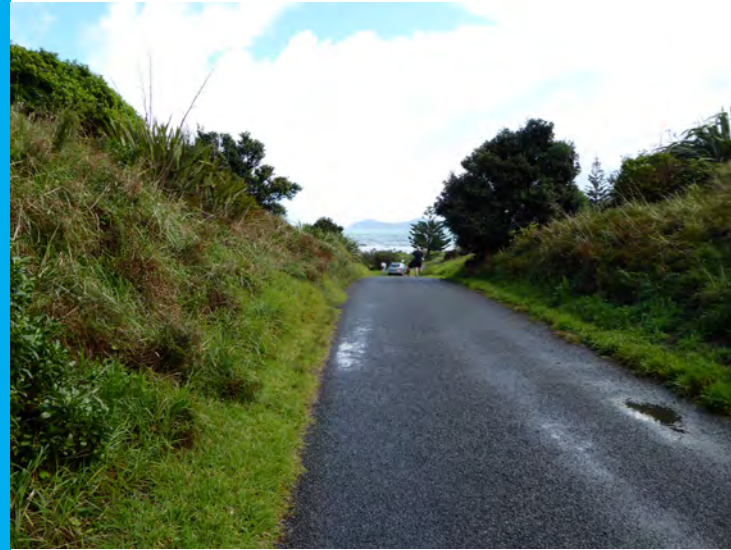
One-way ring road through foredune to beach proposed to become a pedestrian and cycle path

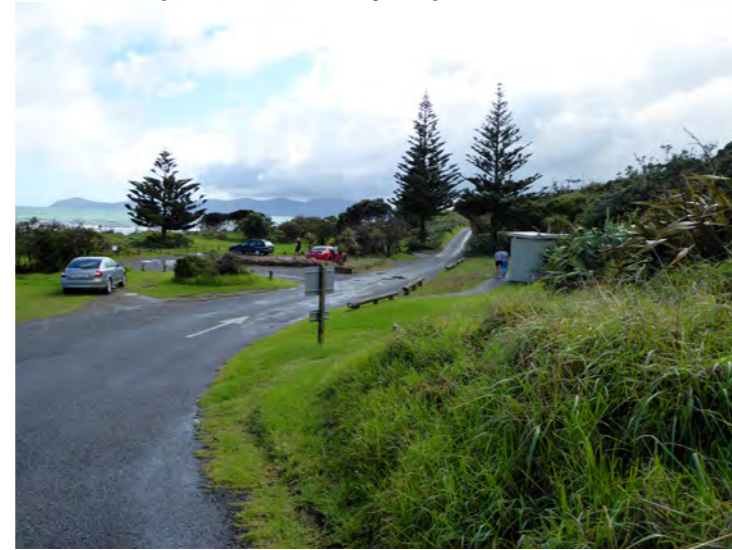
Coastal carpark and toilets within the erosion zone removed and the coastal edge restored. The ring road becomes a pedestrian and cycle path

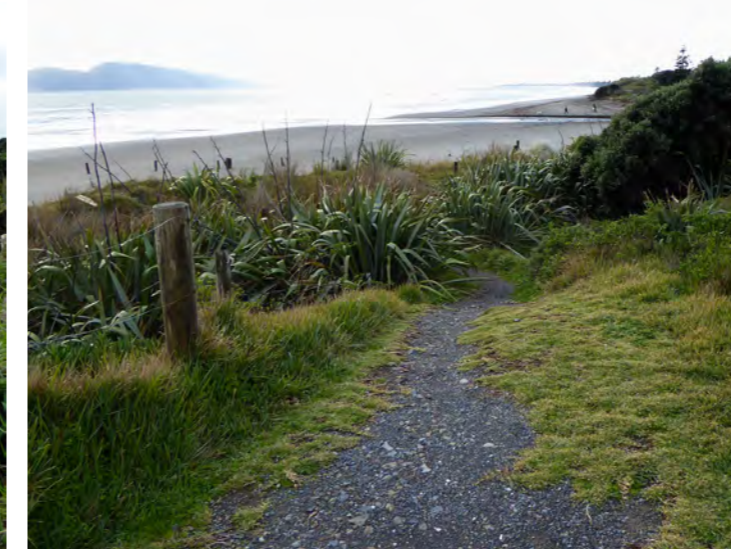
An example of foredune restoration near the surf club with low impact path access

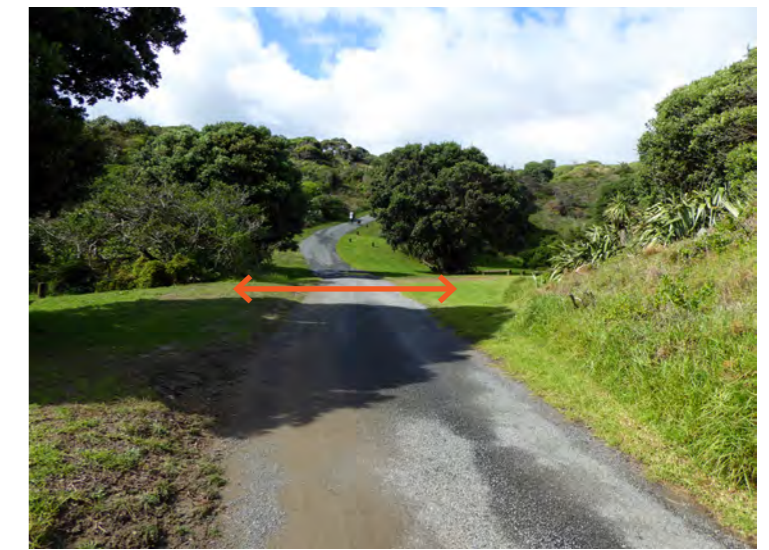
Proposed location for replacement parking and toilets in a more protected site behind foredunes below Wainui Pā

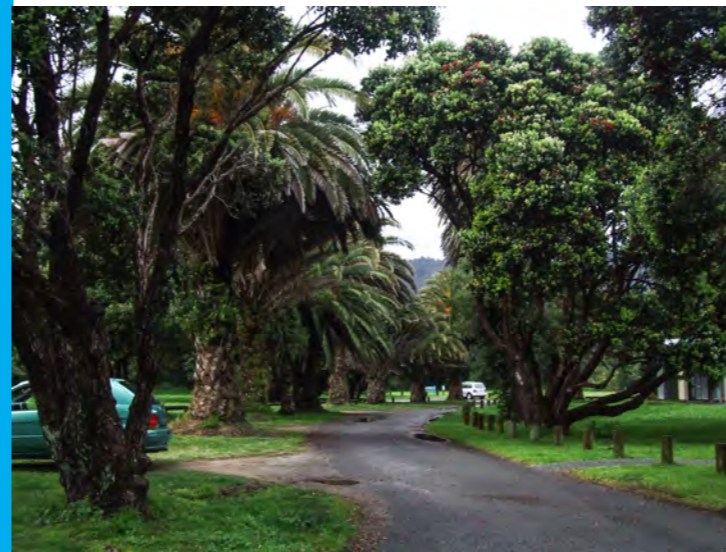
Spines from Phoenix palms along the driveway can injure people and animals and are proposed to be replaced with Nikau palms
