# GREATER WELLINGTON REGIONAL COUNCIL

## WELLINGTON HARBOUR NAVIGATIONAL RISK ASSESSMENT

Report Number: 15N2328  
Issue: 04  
Date: 31 August 2018

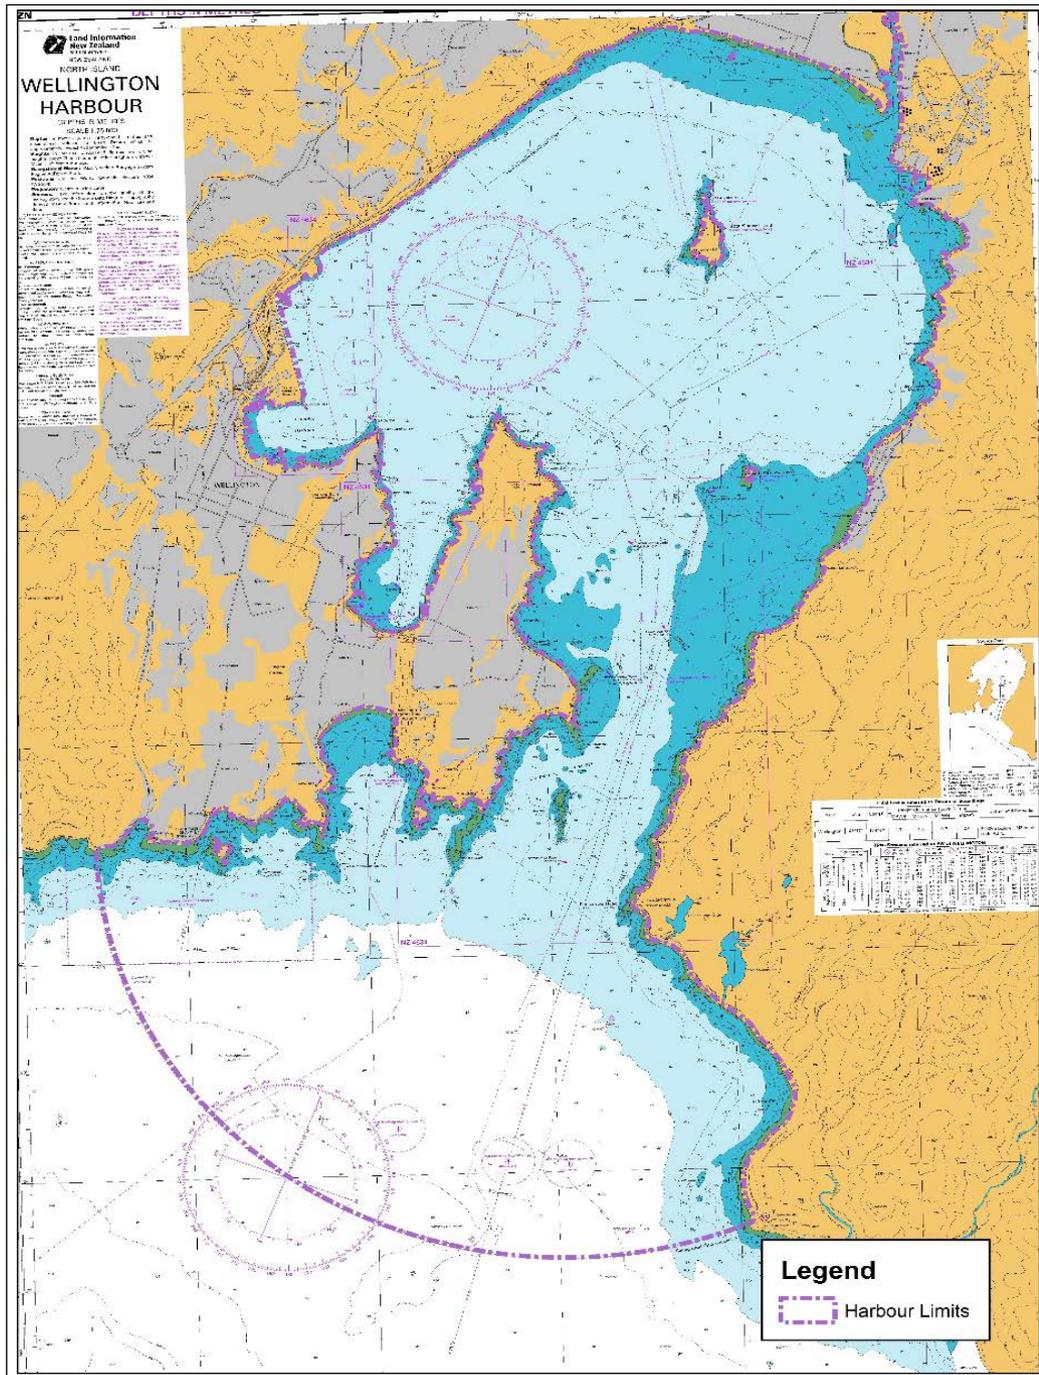
Figure 1: Harbour Limits of Wellington - Bylaws and Maritime Rule Part 90

The extents included harbour waters out to the Harbour/Pilotage limits, as defined in Maritime Rule Part 90 and the Wellington Bylaws<sup>2</sup>. A diagram of harbour extents is shown in **Figure 1**, below.

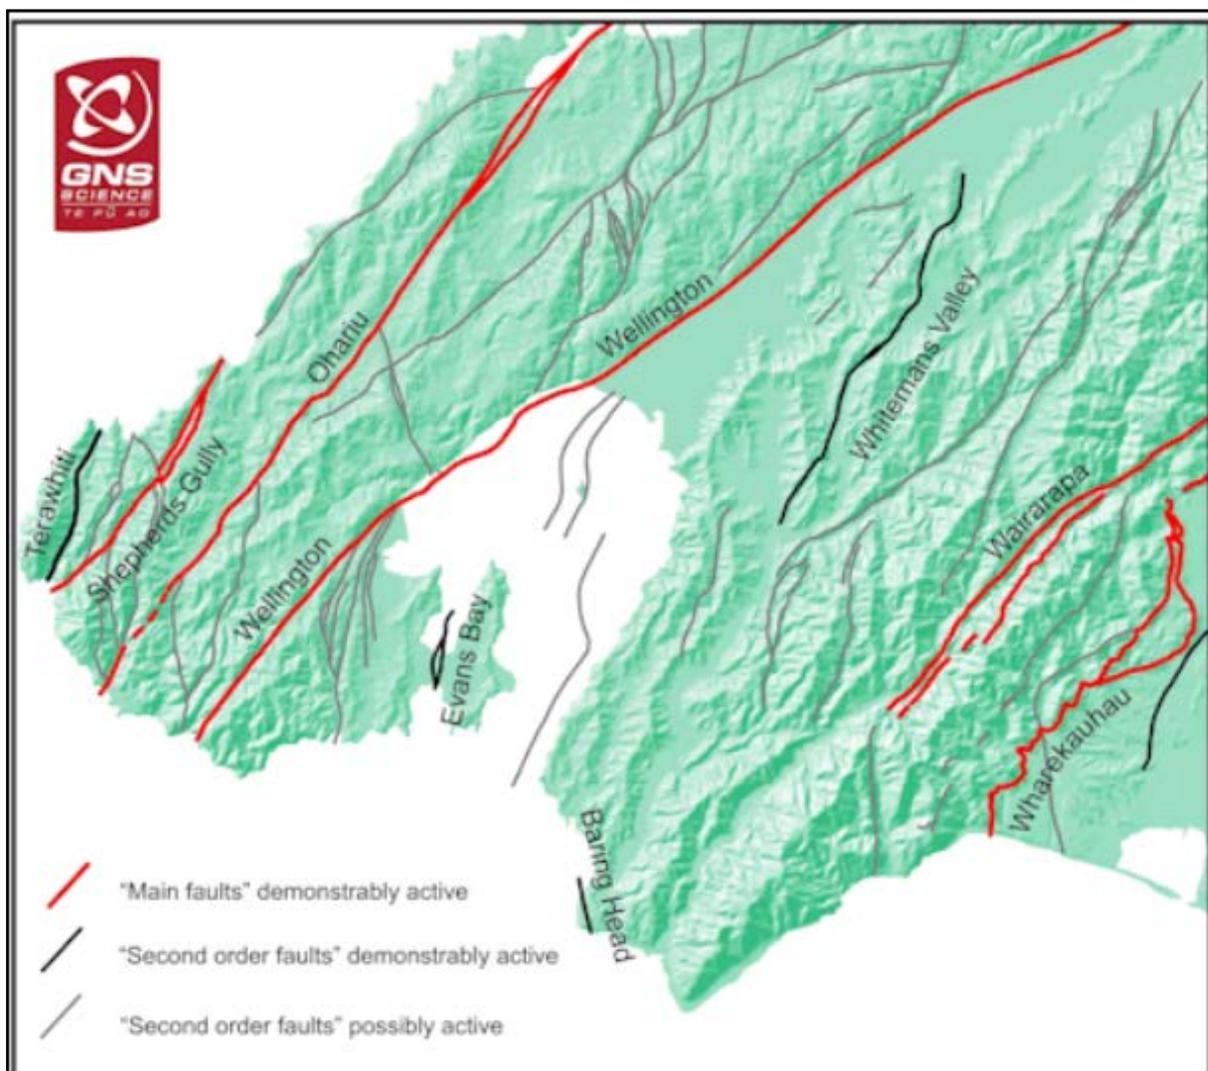
**Figure 2 : Recorded Seismic Faults - Wellington Region (Source GNS Science)**

**Figure 2**, (GNS Science), shows the fault lines affecting the harbour on a regional basis. The main Wellington fault passes through the Interislander RoRo terminal (**Figure 3**). There is an inherent uncertainty of the true extents of fault lines, but recent investigation (2010) of the main Wellington fault suggested its risk of slippage was lower than historically considered. It is reported to have last ruptured about 300 years ago and the return period was extended out to an estimated 900 years. However, the uncertainty of this provides a range of 500 to 1000 years between ruptures and GNS provide opinion that the “Wellington” fault is more likely than other Wellington area faults to rupture (**Figure 2**).

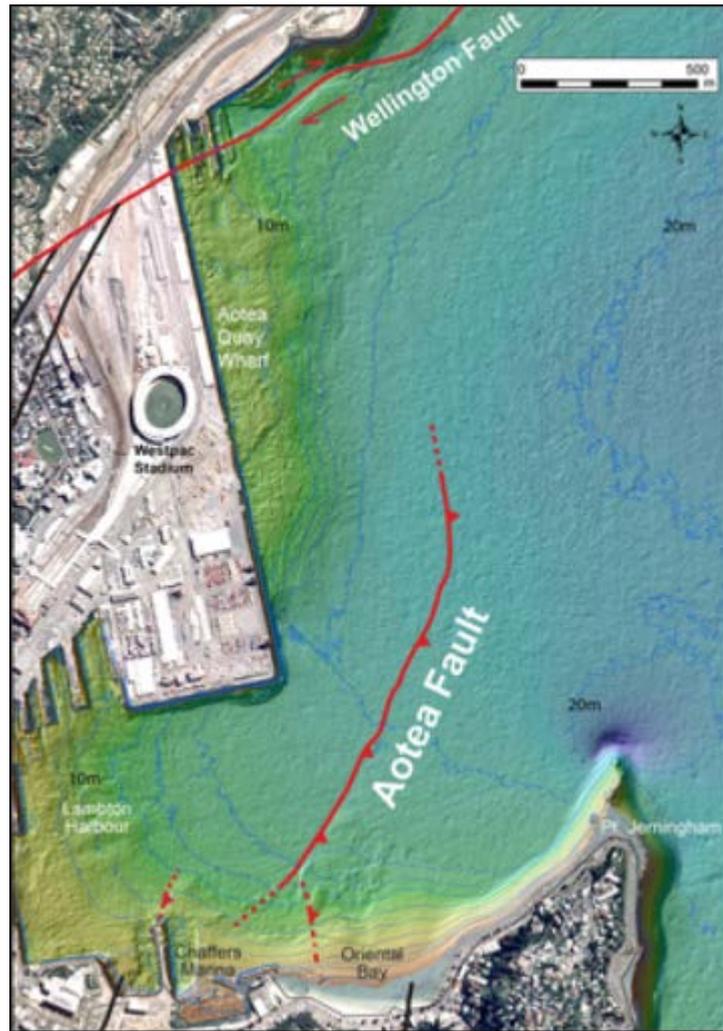
**Figure 3 : Aotea Fault**

However, a more recently discovered fault line called the Aotea Fault appears to run parallel to Aotea Quay (**Figure 3**), with its periphery endings unclear. This suggests that the main harbour area remains susceptible to a future seismic event. It is outside the Authors' expertise to interpret this information, although the need for a long-term port terminal recovery plan is a critical mitigating action. The recent Kaikoura earthquake's effect on the Wellington harbour infrastructure was unexpected, but significant. However, the event has reawakened an understanding of the importance the port and its facilities have to any post-quake recovery effort in the general area.

**Figure 3** shows how the Wellington Fault and the Aotea faults lie in relation to the harbour waters. Aotea Quay is close and there is no evidence that Authors could research to suggest that the Aotea Fault moved during the Kaikoura earthquake. However, the Aotea development is a combination of land recovery by infill and piling to support the Aotea Quay apron, cranes and cargoes being worked. This has been adversely affected by the seismic events, causing both quay movement and liquefaction.

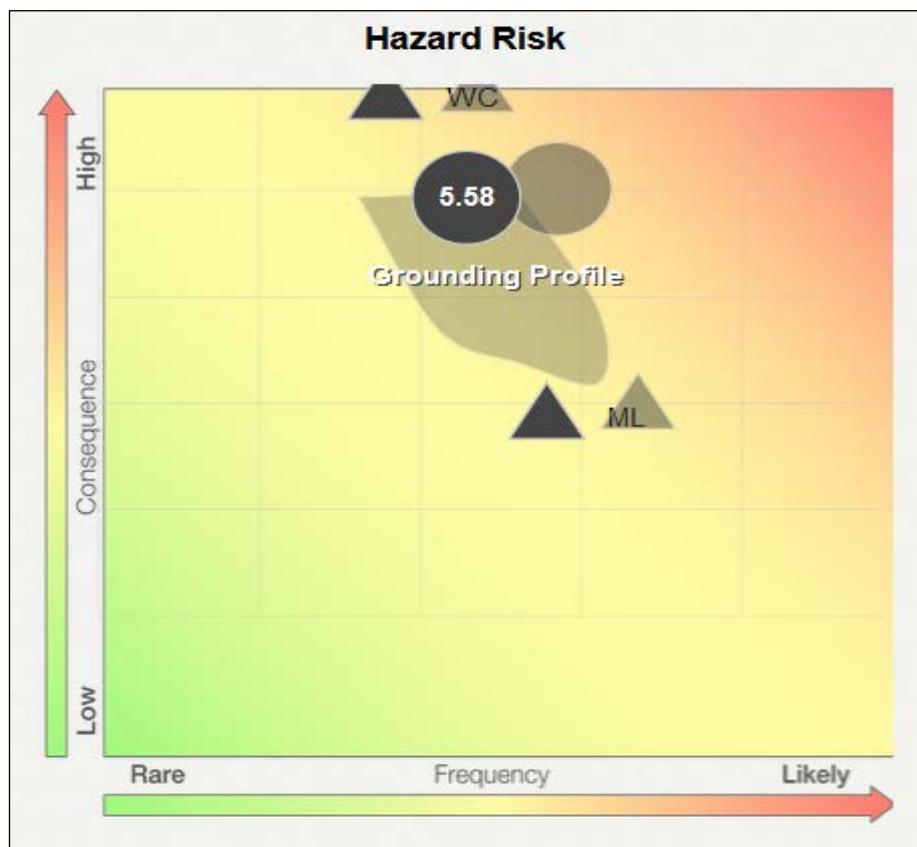
Figure 4 : Risk Plot Showing Risk Reduction

In Hazman II, this is presented online by a Hazard-Risk plot which shows where a particular risk is against a shaded background, representing all of the risks in that category (the large shadow is the *profile*) and further shadows showing the calculated position assuming mitigation was not in place. The risk mitigation effect of an existing risk control can be appreciated pictorially in **Figure 4**.

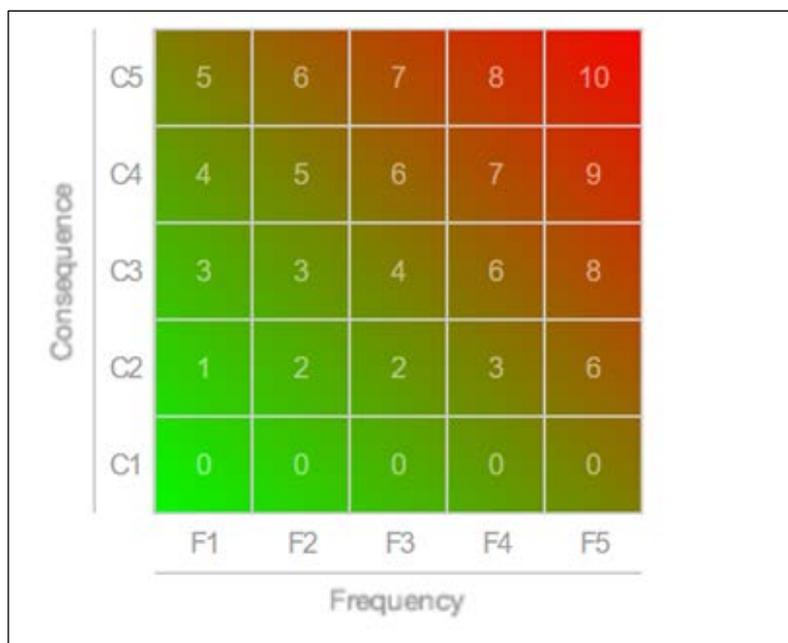
**Figure 5: Risk Matrix Used for Wellington Harbour**

The Wellington Safety Management System uses the risk matrix design as shown in **Figure 5**. Using this risk matrix, which is set up within the Hazman II software, each hazard was scored on a scale of 1 to 10 for each of the four consequence categories within the NZ Risk Assessment Guidelines (i.e. impacts on: People; Property; Environment; Stakeholders).

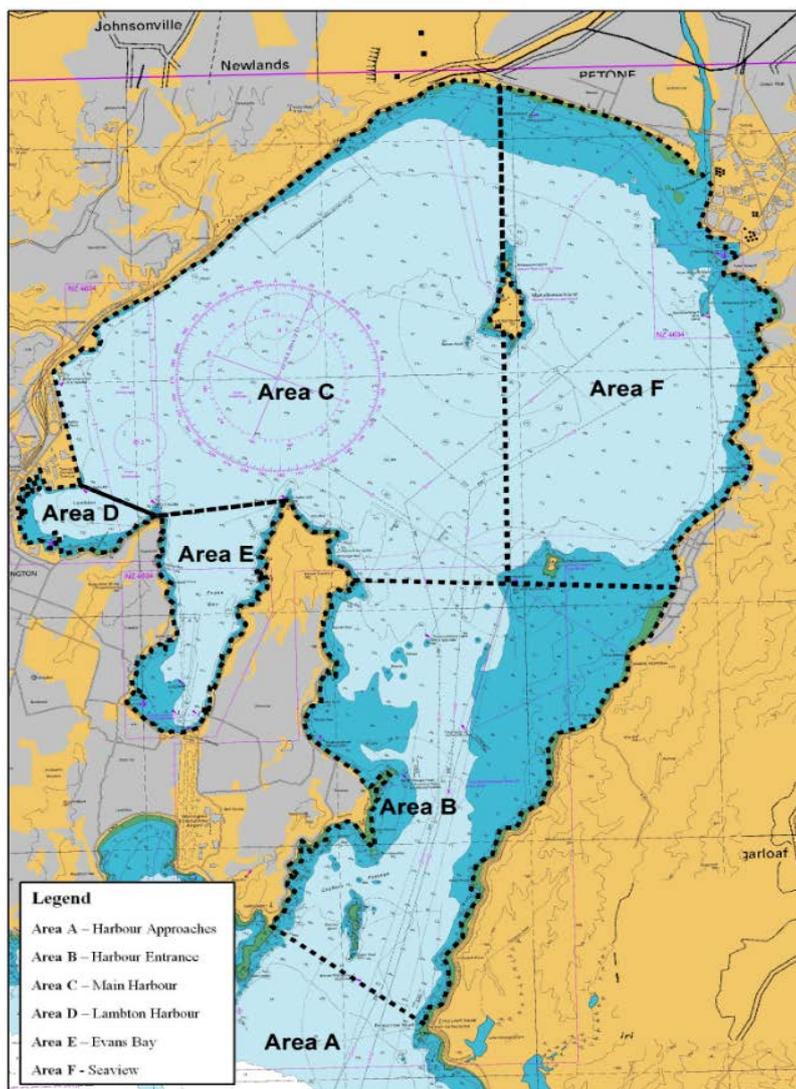
**Figure 6: Risk Assessment Areas - Wellington Harbour**

For this risk assessment, the harbour was divided into areas associated with the type of vessel activity in that location. The areas were based initially on the 2006 Risk Assessment, with a new area being added based on feedback by the Harbours Office. Each area is described with respect to the topography of the harbour and its effect on incident potential. Incidents of note that have occurred in each area are also referenced. Some feedback from interviews with users and observations whilst on board ferries has been incorporated into this section. Six Risk Assessment Areas were derived and are shown in **Figure 6**.

- Area A: Harbour approaches and outer boarding areas.
- Area B: Entrance channel.
- Area C: Waters of the main harbour basin.
- Area D: Lambton Harbour.
- Area E: Evans Bay.
- Area F: Seaview and its surroundings (separate from Area C).

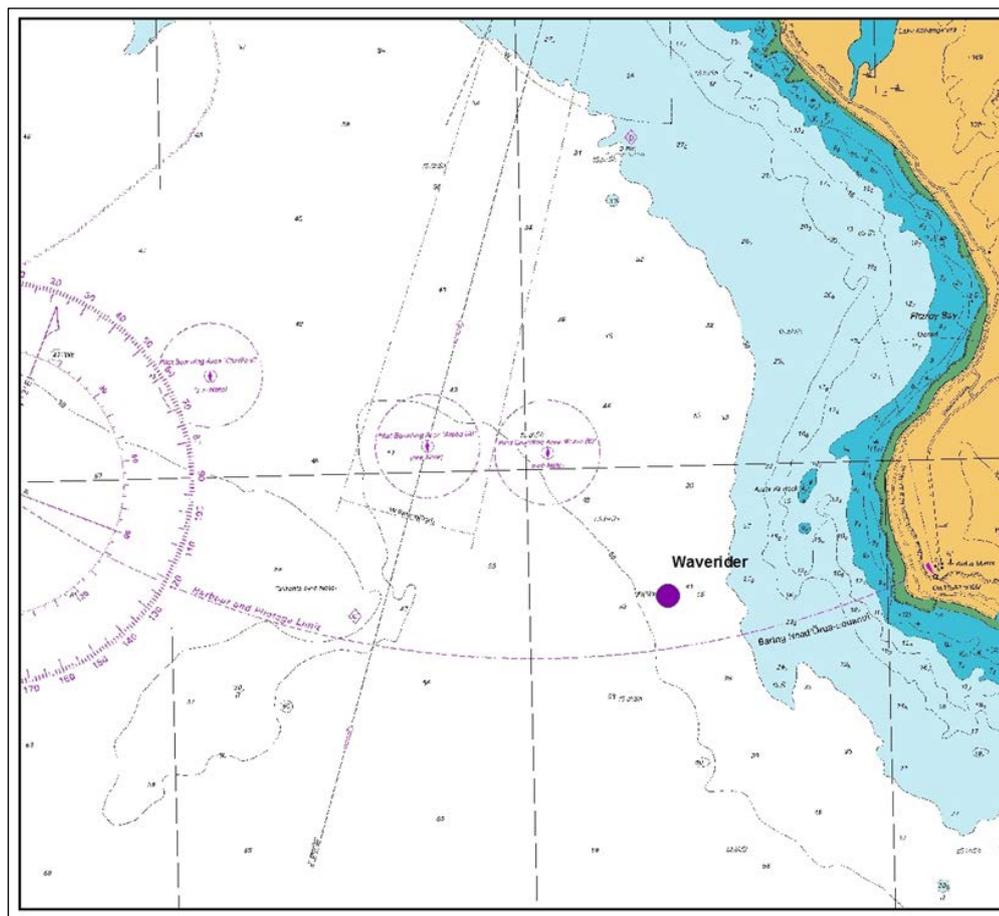
Figure 7: Location of Waverider at Baring Head

The buoy is situated in the proximity of pilot boarding stations Alpha, Bravo and Charlie. **Figure 7** shows the location of the buoy and these pilot boarding areas. The buoy reportedly has a data processing delay of up to 30 minutes, but is used to aid master's decision-making for arrival or departure.

The outer pilot boarding areas are located 3 miles south of the harbour entrance. The Alpha, Bravo and Charlie boarding areas (see **Figure 7**) are each used in different sea and weather direction conditions. The CentrePort pilotage service selects the best boarding position for the sea conditions on the day in question. As such the use of the three boarding areas is an inherent risk mitigator. A fourth boarding area, Delta, is located inside the harbour entrance and explained in the next section (Area B – Navigational use). Further information on use of boarding areas can also be found in **Section 6**.

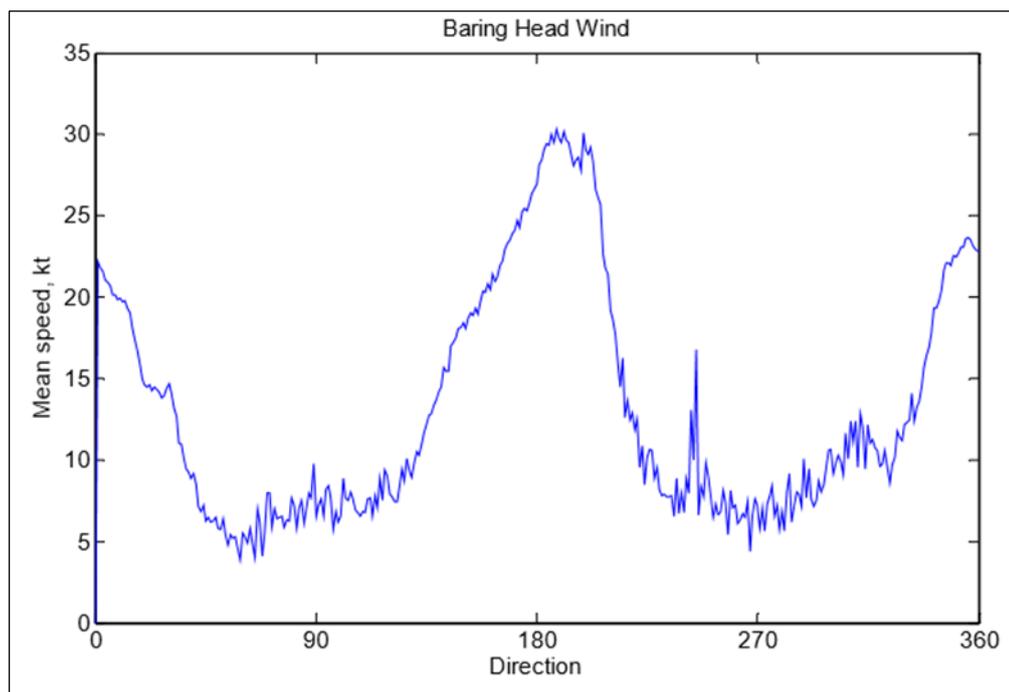
**Figure 8: Mean Wind Speed as a Function of Wind Direction - Baring Head**

There appears to be contradictory evidence as to which weather direction is the dominate in Wellington. It will not be news to Wellingtonians to find that Northerlies and Southerlies regularly occur. Most data sets suggest the southerly is prevalent at Wellington. For this risk study, data recorded at Bearing Head by NIWA has been referenced, which suggests Northerlies are more frequent at that location, with a mean speed of up to 30 knots. Southerlies though produce the highest windspeed as fronts pass through. **Figure 8** illustrates this report, using windspeed and direction data from the period from 1998 to 2015.

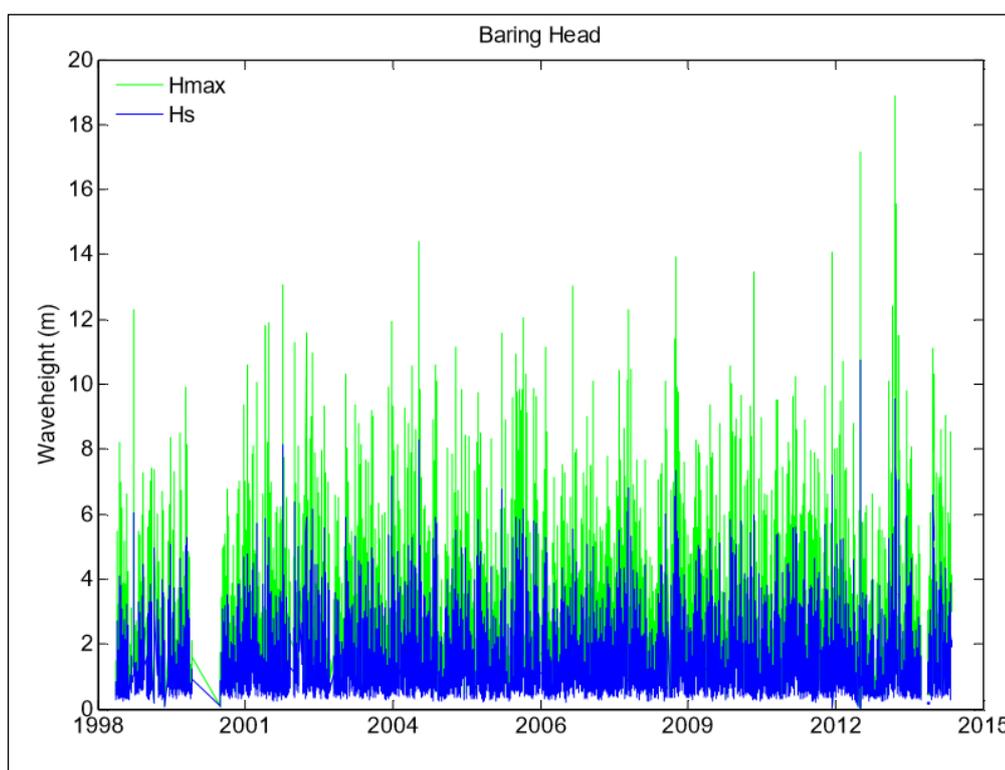
**Figure 9: Baring Head Waverider - 1999 to July 2014, Significant & Max Waveheight**

Generally, winds from the South result in a heavy sea and swell, which during gales sometimes break across the entrance. **Figure 9** shows wave height readings ranged from 1998 to 2015 (again Bearing Head). The wave conditions are not always favourable and can be extreme for a short time. This extreme accounts for 1% of the time where a significant wave height ( $H_s$ ) exceeds 4.5m. In some cases (rare), individual waves exceed 10m in height, have a very short period but last for only a short space of time. The buoy though has recorded waves in excess of 14 metres during southerly quarter gales. The Waverider records individual waves ( $H_{max}$ ) as a single statistical point from a spectrum over 30 minutes.

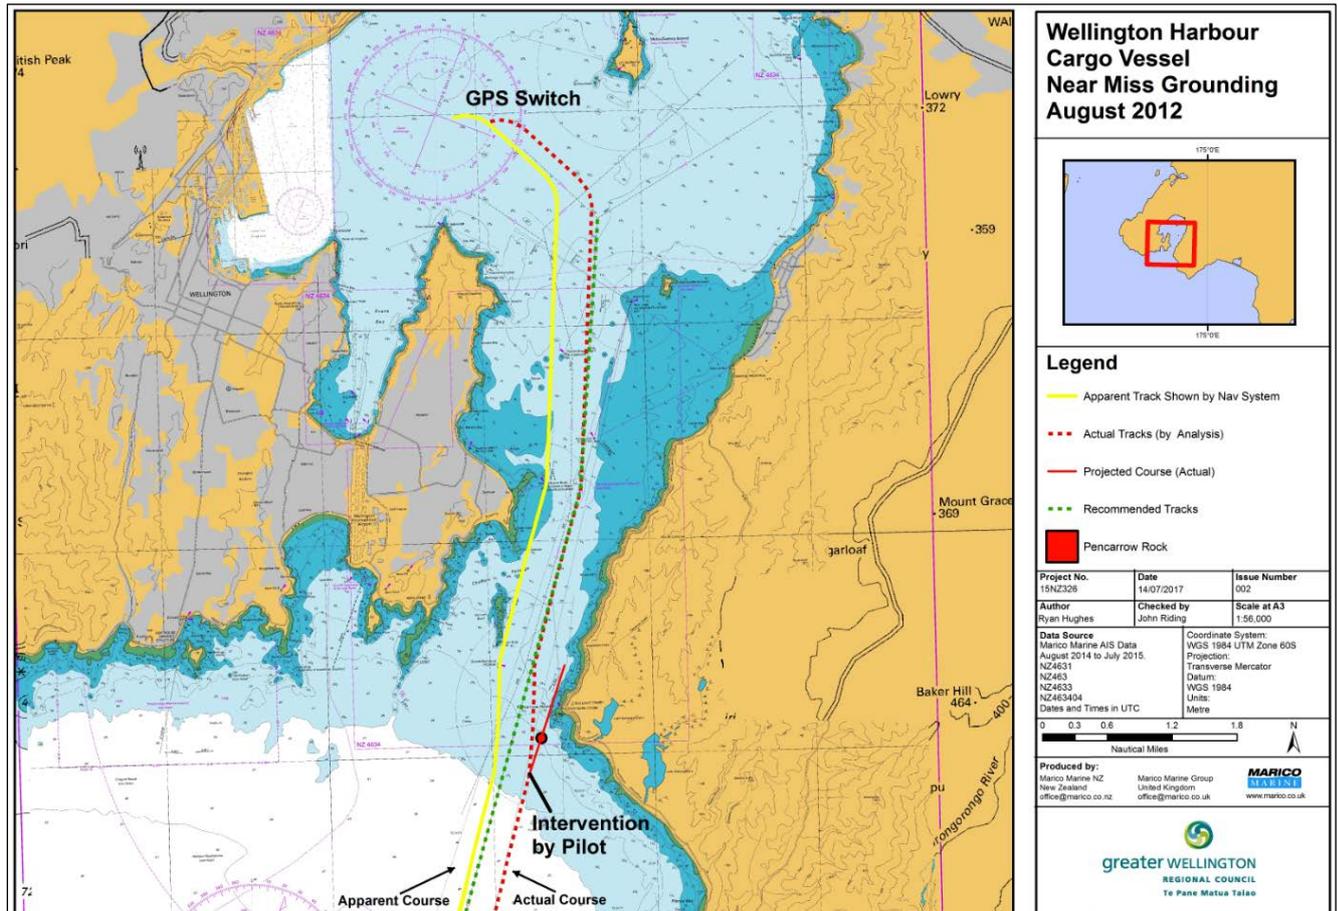
**Figure 10: Near Miss Grounding at Wellington Harbour (2012)**

**Figure 10** illustrates the recorded ship’s track output from the (incorrect) GPS and illustrates a near grounding situation. The apparent course of the vessel is an illusion and the recorded track in the approaches is 600m to port of the vessels true track. The actual track taken by the pilot has been reproduced by applying a 600m offset.

Incidents that occur in the Wellington Harbour incident profile reflect the key risks. Close encounters involving both commercial and recreational vessel types occur frequently in areas that include charted recommendation tracks. The near miss grounding (**Figure 10**) that occurred in 2012 is a perfect example of the unsafe navigation of a cargo vessel and indicates ISM compliance failures.

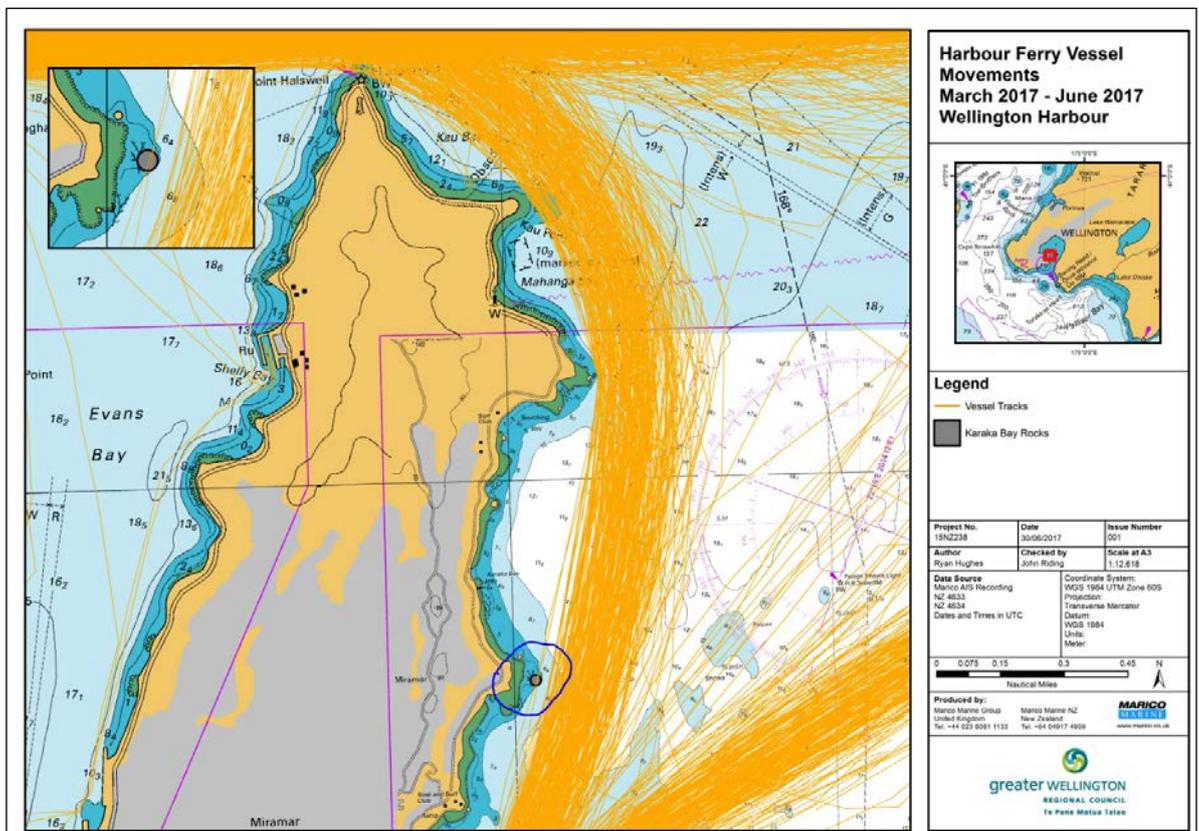
Figure 11 : Isolated Grounding of Cross Harbour Ferry Service – 2017

On March 1, 2011 a ferry was disabled by heavy breaking seas in Worser Bay with two people taken to hospital for treatment to minor injuries). This incident prompted the operator to fit Class B AIS transponders to enable rapid assistance. In April 2017 a case of significance was recorded in the incident database, affecting the cross-harbour ferry service... One of the catamarans on the service to and from Seatoun, appears to have struck an isolated rock approximately 100m off Karaka Point. The ferry had a capacity of 100 people. The track record of the vessel is shown at **Figure 11** and shows a near miss had occurred earlier. The vessel reportedly suffered aft hull and rudder damage in the incident.

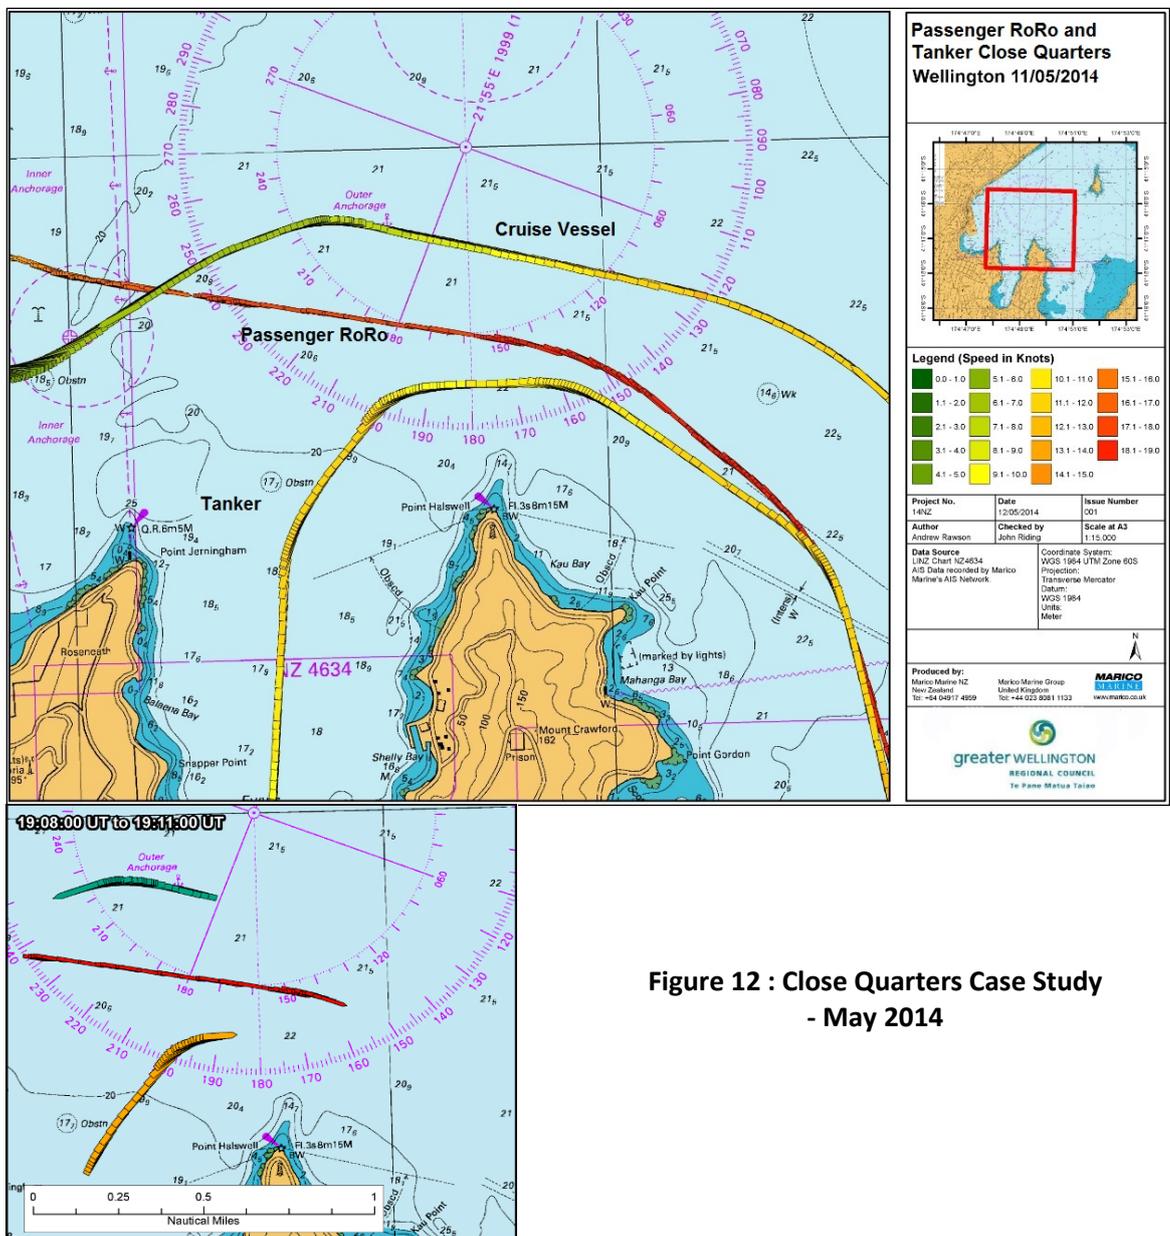
Figure 12 : Close Quarters Case Study  
- May 2014

With respect to **Figure 12**, it should be noted that such a close quarters situation was influenced by an inbound cruise vessel. The minimum approach of 0.29nm was achieved by the tanker turning close to Point Halswell. Large ships are slow to turn and such traffic situations are avoidable by traffic planning, the sequencing of which can only be delivered by a traffic management centre with the harbour overview.

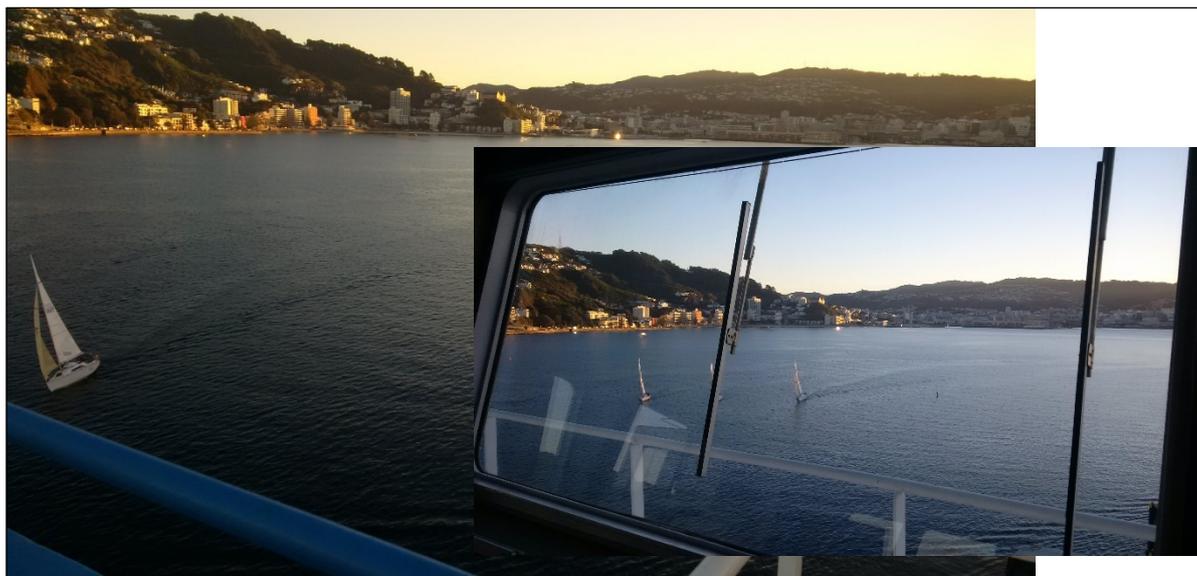
**Figure 13: Sailing Activity in Lambton Harbour Closing to a Constrained Vessel**

Occasionally, large vessels experience conflicts with recreational craft in the berthing approach at Aotea Quay. There can also be similar "close quarter" events with small craft in Lambton Harbour; **Figure 13** references a sailing cruiser race passing close to the track of an inbound container vessel, which has limited ability to manoeuvre.

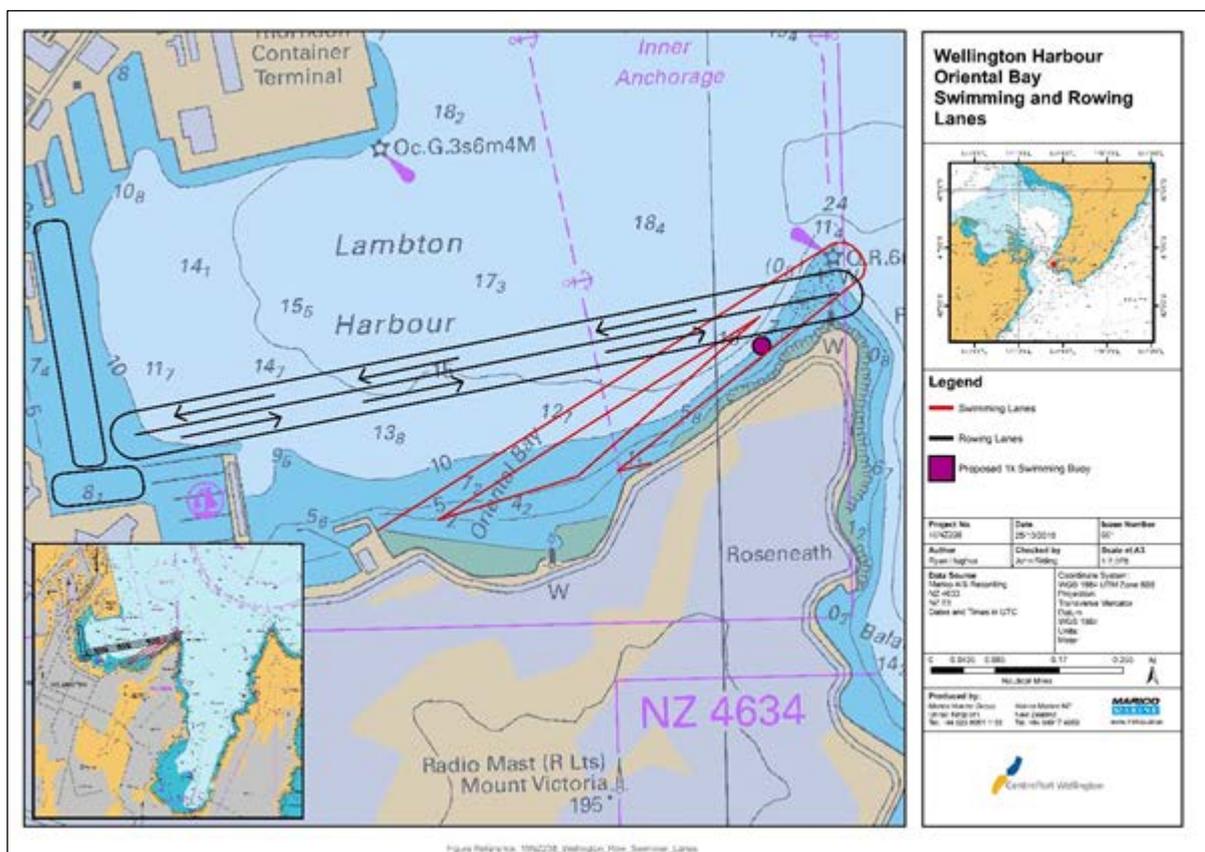
Figure 14: Recommended Swimming and Rowing Lanes - Oriental Bay

Oriental Bay is popular with swimmers and rowers, with both groups utilising the area for training and races. Lanes have been designated for each activity. However, the lanes used by both groups, have an area of crossover and thus potential for conflict, **Figure 14**. These lanes are not a part of bylaws and used for both rowing and swimming as they are each ideal training distances for the respective sports. A swimming buoy was proposed for installation in 2016 outside of the current

**Figure 14, Section 3.4.4** shows a plot the recommended lanes for rowers and swimmers, which cross Oriental Bay. Although these are presently informal, they reflect the reality of an overlap of present

The layout of the two lane orientations above is shown as a repeat of **Figure 14**. Both activities wish to use the same area and the incident that occurred was probably inevitable. The harbour masters department is to install a swim turning buoy (indicated by the red mark on Figure 38) to provide an alternative to Point Jerningham lighthouse, but it appears to Authors that either the activities need to be separated by timing, or the activities need to be separated by design. A risk such as this, where head injury of a swimmer can occur, needs to be isolated as opposed to mitigated.

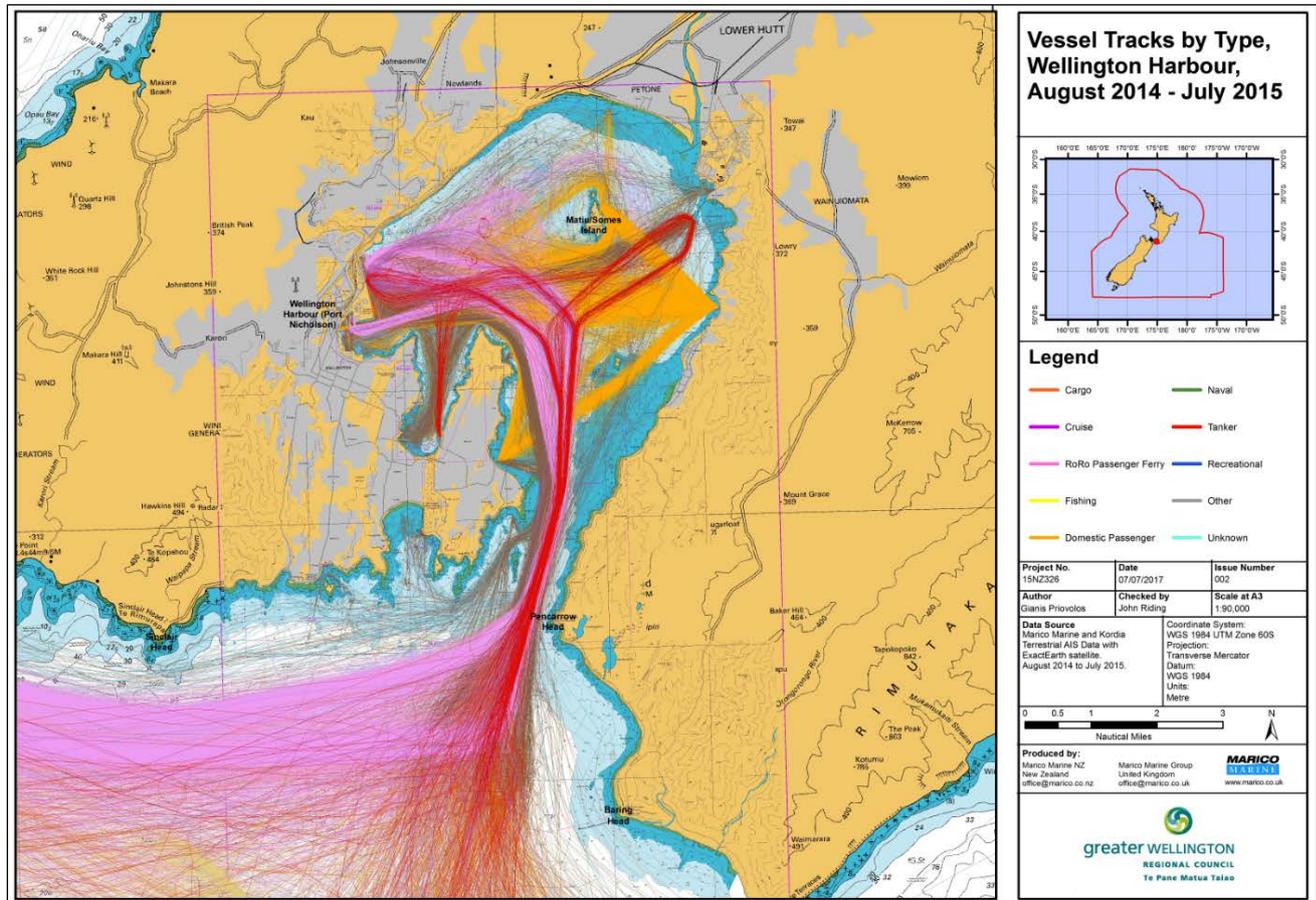
Figure 15 : All Vessel Tracks by Type – Wellington Harbour

**Figure 15** illustrates the combined tracks of all vessels with AIS transponders using Wellington Harbour from August 2014 – July 2015. This data period has been selected as it represents traffic levels prior to the earthquake that caused serious damage to CentrePort wharves and facilities. The data period is representative and the plot presents vessel type by differing track colours.

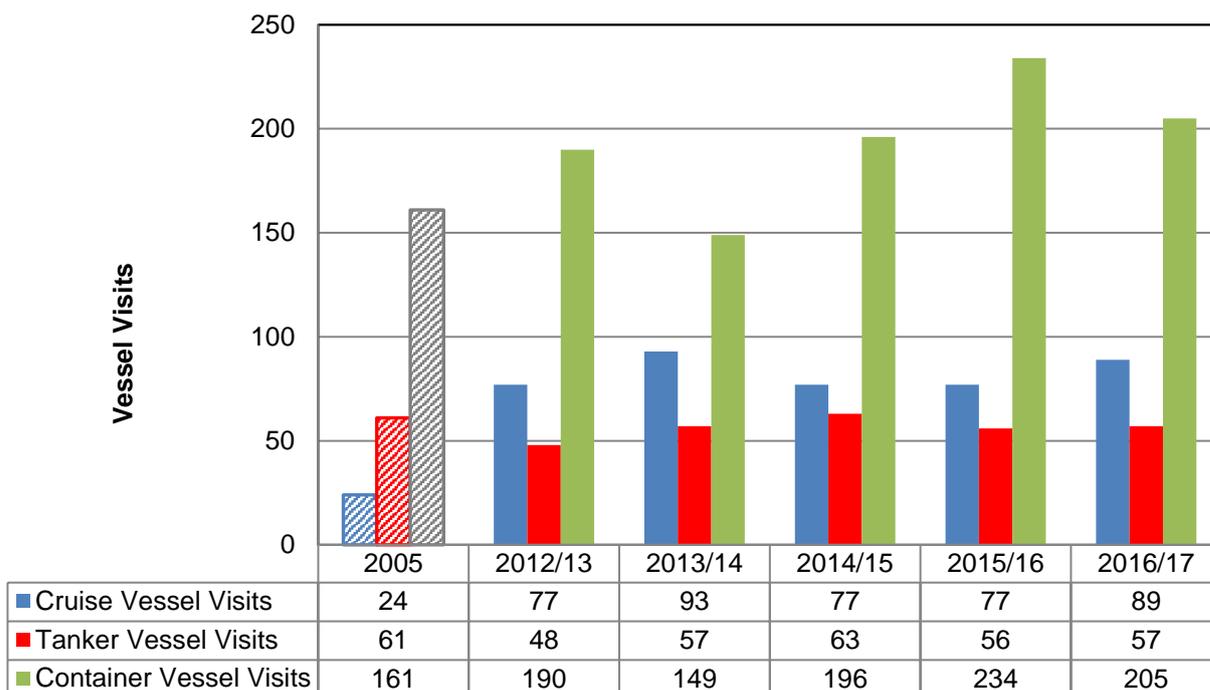
Figure 16: Vessel Movements Comparison by Vessel Type - 2005 as Baseline

**Figure 16** provides a breakdown of commercial movements to the CentrePort berths. Data uses 2004-2005 figures as a baseline. Traffic has been broken down by Cruise, Tanker and Container vessels. The data period is based on the cruise season, which occurs across the summer months.

The data shows just how much cruise vessel visits have increased, with Wellington almost mirroring the New Zealand cruise industry growth in recent years (meaning almost all cruise vessels arriving in New Zealand are also calling at Wellington). Tanker and container vessel visits have remained at comparable levels to one another since 2005. Container vessel movements had decreased significantly since the November 2016 earthquake but are increasing rapidly towards previous levels after September 2017, when the TCW2 berth became operational again. In the 2017/2018 financial year, Centreport recorded handling 85,755 TEU containers, with a return to pre-quake volumes expected in the next financial year.

**Table, 7**, below, separates out the total number of piloted vessel visits and Cook Strait ferry arrivals at Wellington Harbour, using 2004 – 2005 as the baseline year, shown pictorially in **Figure 16**. The number of piloted vessels peaked at 2004 – 2005, but the fall off in numbers since is related to the increase in ship size, not a fall in cargo through the port (See **Figure 17**, later). The number of passenger ferry movements increased above the baseline from 2007 to 2016.

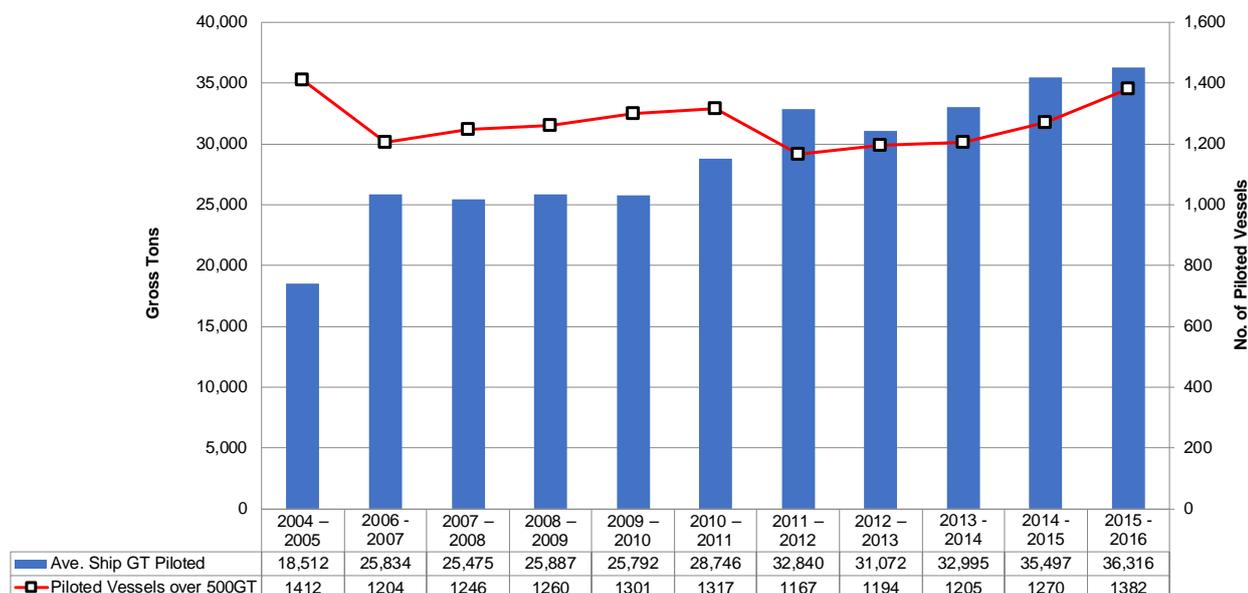
**Figure 17: Average Piloted Vessel Gross Tonnage - 2008 to 2016 (Baseline 2005)**

Figure 17, below shows this pictorially.

Figure 17 shows that the average size of piloted vessels visiting Wellington Harbour has increased significantly (96%), from a baseline of 2005. This reflects a general trend in shipbuilding to larger capacity vessels. The fact that the size increase represents almost double is something of note<sup>26</sup>.

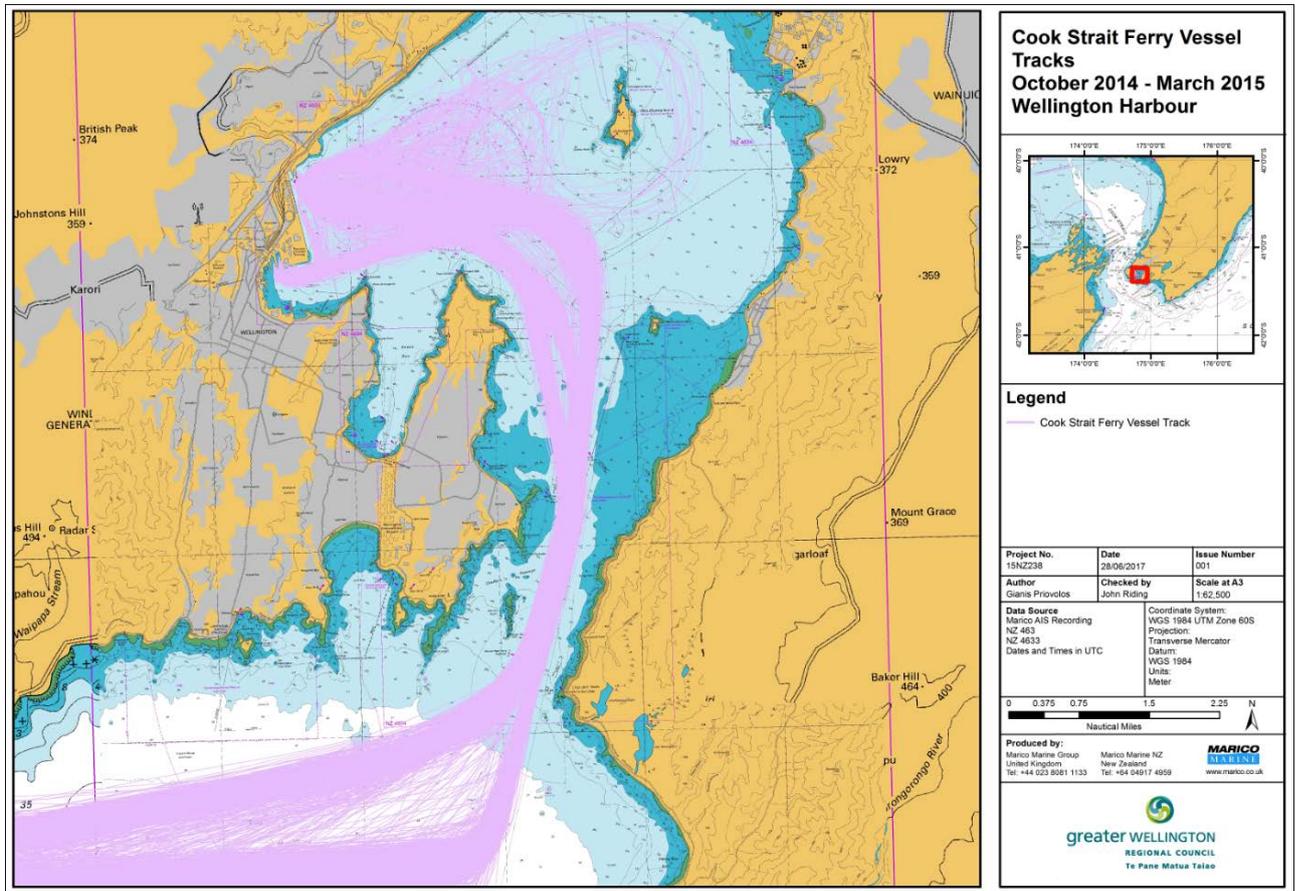
**Figure 18 : Cook Strait Passenger RoRo Tracks**

current maximum length is 186m. A record of tracks for all of these vessels are illustrated in **Figure 18**.

Passenger RoRo ferries make several round trips each day through Wellington Harbour waters and, as such, contend with other vessels, and each other, for space in the Wellington Harbour approaches. Ferries show good compliance overall with the Wellington Harbour recommended routes, which minimise the likelihood of close quarters incidents, providing some separation of inbound and outbound traffic.

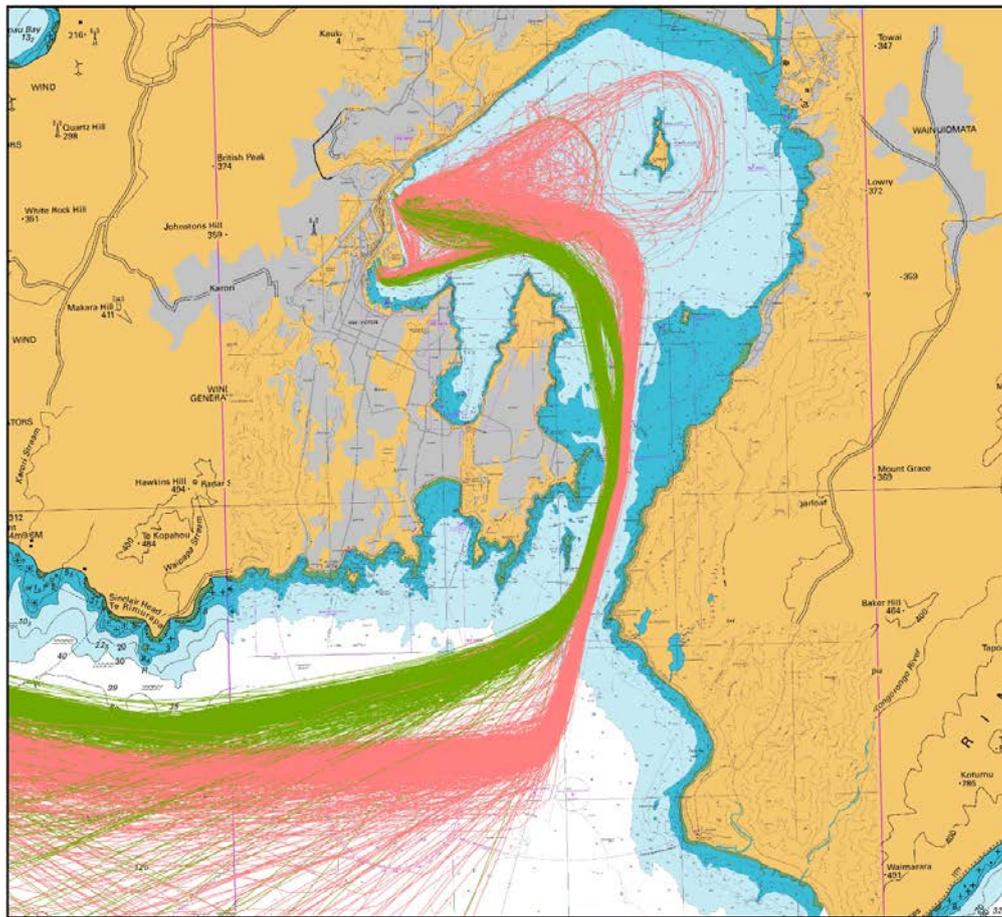
**Figure 19 : Cook Strait Ferry Tracks - Inbound and Outbound**

**Figure 19** shows a separation of inbound and outbound tracks and shows a majority of inbound vessels take an approach aligning with the harbour leads, following the recommended route into Wellington. Passages within the harbour also show a variance across different passenger RoRo vessels and the same ship can take different routes outbound, both sides of Falcon Shoal<sup>27</sup>. There is some track variance by RoRo ferries when inbound at the Harbour approaches.

**Cook Strait Ferry Vessel Tracks, Inbound and Outbound, October 2014 - March 2015**
