# GREATER WELLINGTON REGIONAL COUNCIL

## WELLINGTON HARBOUR NAVIGATIONAL RISK ASSESSMENT

Report Number: 15N2328  
Issue: 04  
Date: 31 August 2018

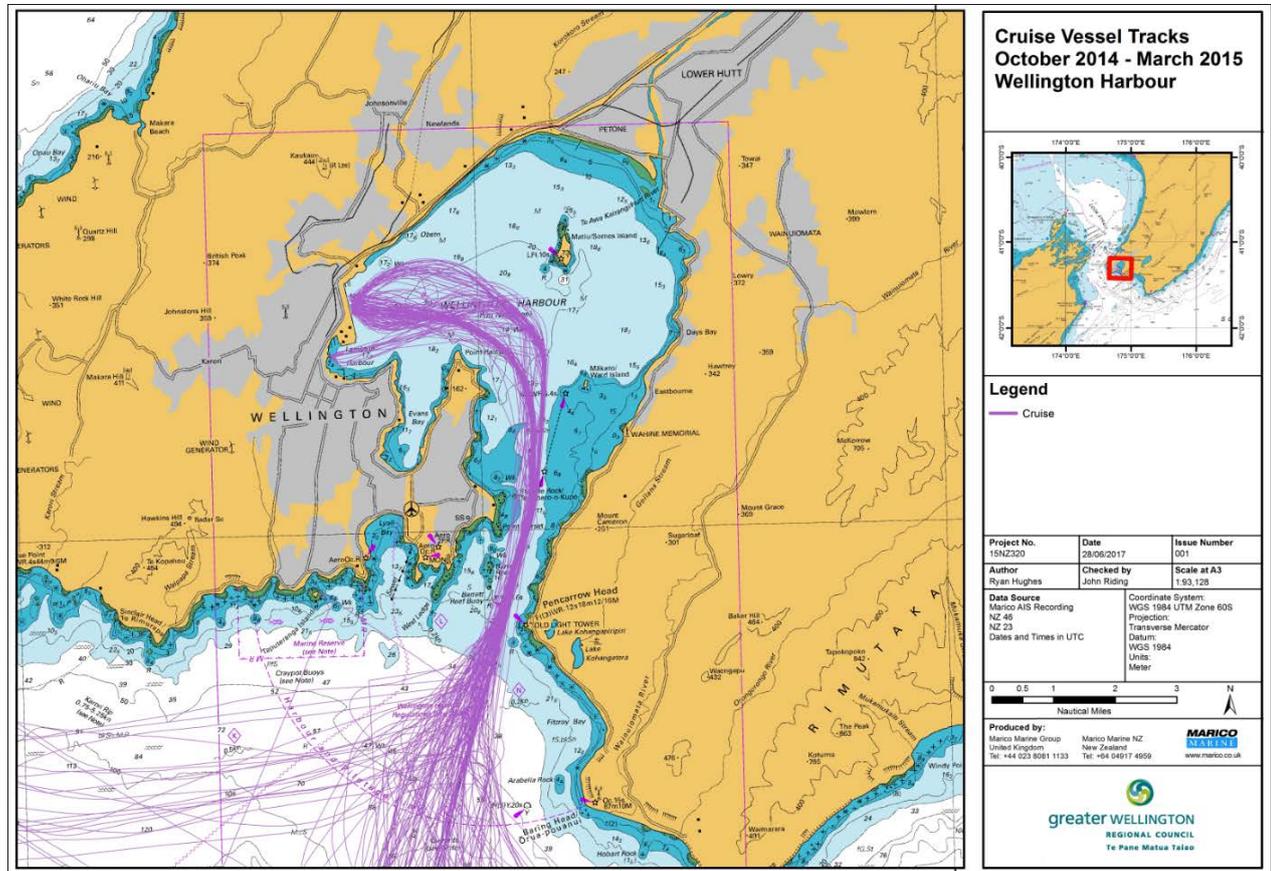
Figure 20 : Cruise Vessel Tracks

**Figure 20** presents tracks of cruise vessels using the harbour. It confirms that most cruise vessels berth at Aotea Quay, which can experience multiple arrivals in any one day. Smaller cruise vessels only berth at Queens Wharf, in the centre of Wellington (the jetty has size limitations). The largest vessel to enter Wellington Harbour during October 2014 - March 2015 was the cruise ship *Voyager*

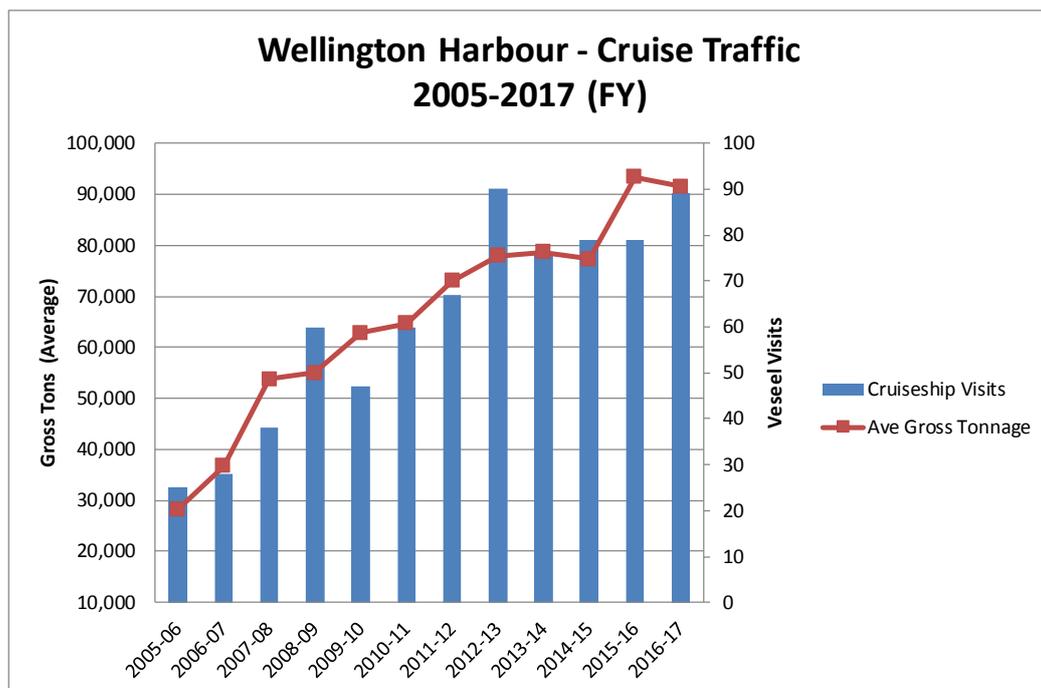
**Figure 21: Cruise Vessel Percentage Change of Cruise Vessels Relative to 2005**

**Figure 21** shows the increase in cruise vessel visits over the time period since the last risk assessment. Few would have predicted in 2005 that cruise vessel visits would rise from about 20 visits per summer season to close to 100 visits of the 2017-8 season. **Figure 21** also shows how these vessels have risen in size over the period of interest. The change in average Gross Tons is presented to measure change in vessel size. It should be noted that vessel length, which is relevant to rate of swing for piloting and manoeuvring, has also dramatically increased. Cruise vessels are though more manoeuvrable than was the case in 2005-6. Examples of improvements are:-

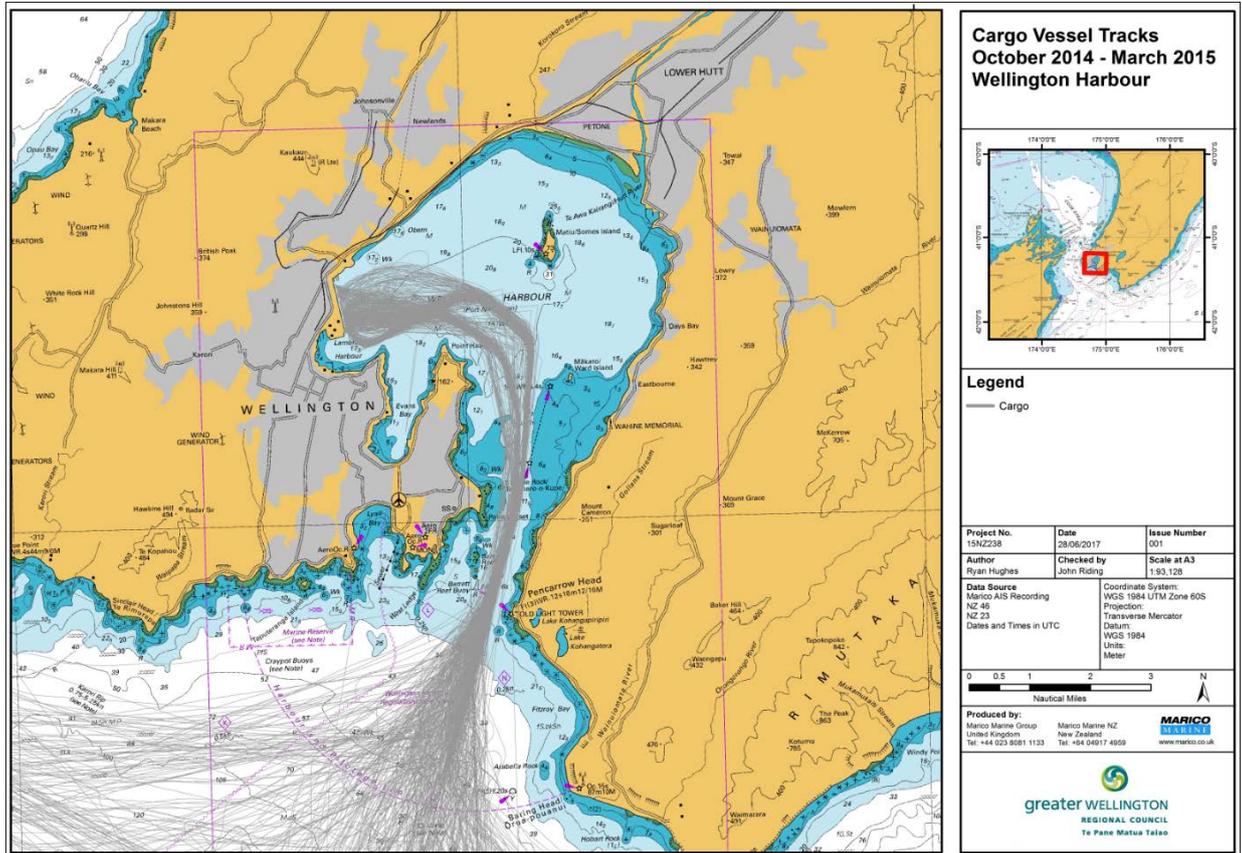
**Figure 22 : Plot of Cargo Vessels - Wellington Harbour**

Like other reporting vessels, cargo vessels are required to follow the recommended harbour routing when entering Wellington Harbour, following the instigation of Bylaw 6.1.4 by the GWRC. Vessel tracks of Cargo Vessels using Wellington Harbour are illustrated in **Figure 22**.

Figure 22 represents the tracks of mostly bulk carriers and container vessels, with occasional car carrier arrivals. Almost all cargo vessels carry pilots and tracks show their direct access to Aotea Quay and good compliance with the Wellington harbour recommended transit routes.

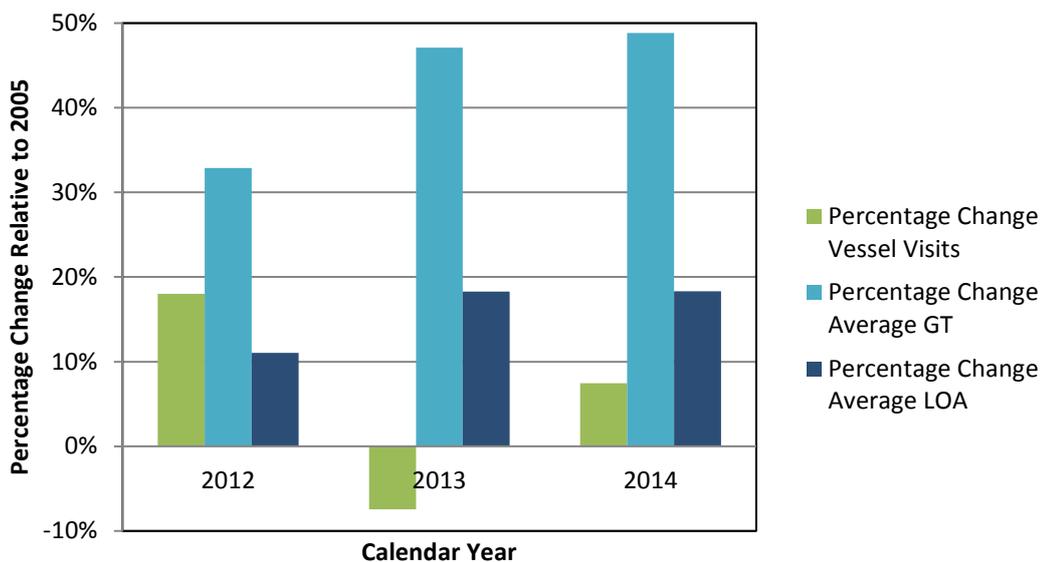
Figure 23: Percentage Change in Container Vessel Size - 2005 Baseline

**Figure 23** uses 2005 as a baseline year to show that although the number of container ship calls has been slowly falling, their size has been growing dramatically in terms of GT, but with only a marginal increase in length (20%). This is because the beam of containerships has risen significantly since 2005, with containers carried increasing. This has required the installation of container handling cranes with longer reach, but has also increased windage of the vessels when berthing. Centreport has prudently purchased a second tug for this reason.

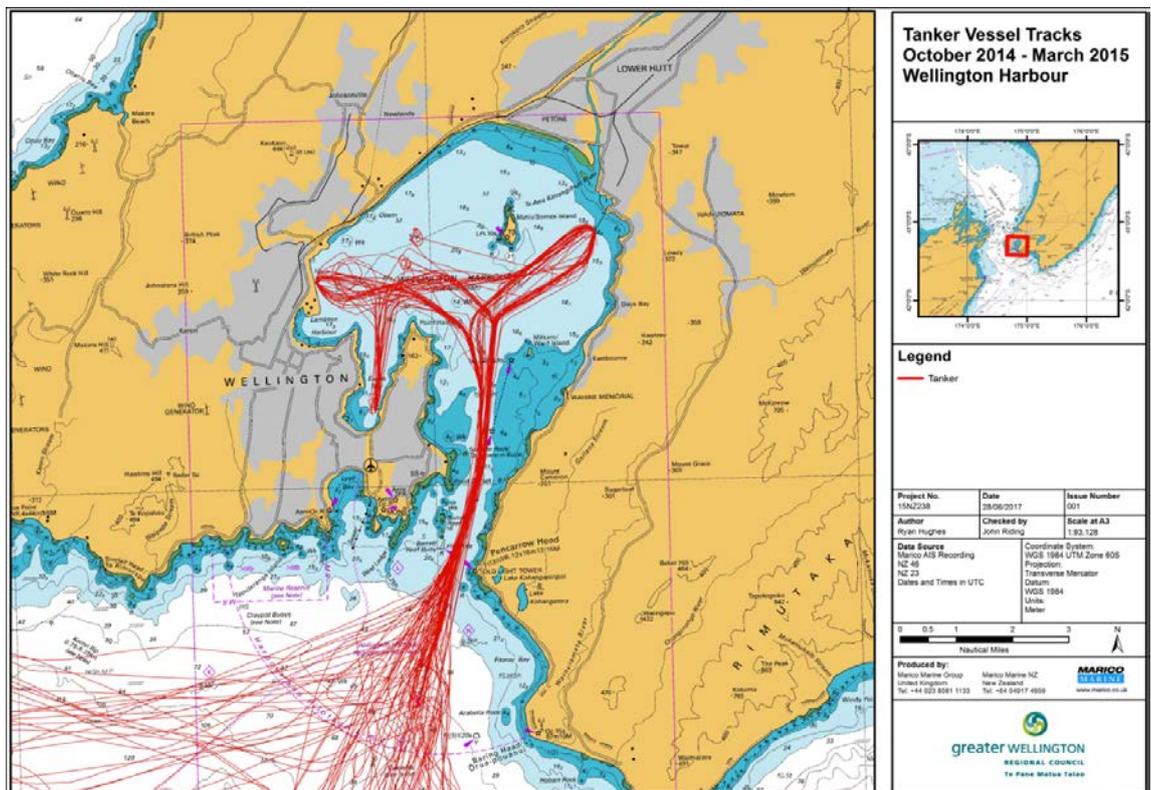
**Figure 24 : Tanker Vessel Tracks**

The tracks for all Tanker vessels using Wellington Harbour, 2014-2015 are illustrated in **Figure 24**.

There are three locations within the harbour which can work tanker cargoes, Burnham Wharf (Evans Bay), Aotea Quay, and Seaview Terminal. The terminal at Aotea Quay handles diesel and light fuel oil; Evans Bay for avgas and the Seaview terminal handles petrol, diesel, and any chemicals – **Figure 25** shows a tanker alongside Seaview. Tankers, like other large vessels, are required to follow the recommended routes through the harbour, the routes towards the main wharves are now published on nautical charts, with their use empowered by Wellington Regional Council navigation bylaws. The recommended routes are publicly available and found in both in the navigational bylaws and can be

downloaded from the CentrePort Website<sup>33</sup>. The track plot from ships AIS transmissions shows that tankers do, on the whole, follow these to their respective terminals. Tankers using Wellington are mostly small in comparison with tankers trading internationally; the berths at Burnham and Seaview limit the size ships that call here. The majority of the cargo is light fuel oil, petrol, diesel and avgas. There are occasional visits by gas carriers however these are for bunkers and do not work cargo. An example of the size of such vessels (taken from the October 2014 – March 2015 vessel data set) is “*Chembulk Wellington*”, which at 8,270 Gross Tons (14,300 tonnes deadweight) and length 125 metres, is small by 2017 standards. Tankers of this size fit the Wellington terminals and berth infrastructure well.

9. Tankers show tracks which route tankers to the specialist terminals handling their cargoes.
10. Wellington Harbour mitigates some navigational hazards by the Bylaw requirement for large vessels to transit via recommended routes. Plots constructed using data from October 2014 – March 2015 (i.e. Prior to the Kaikoura earthquake) indicate that vessels comply well with these routes.

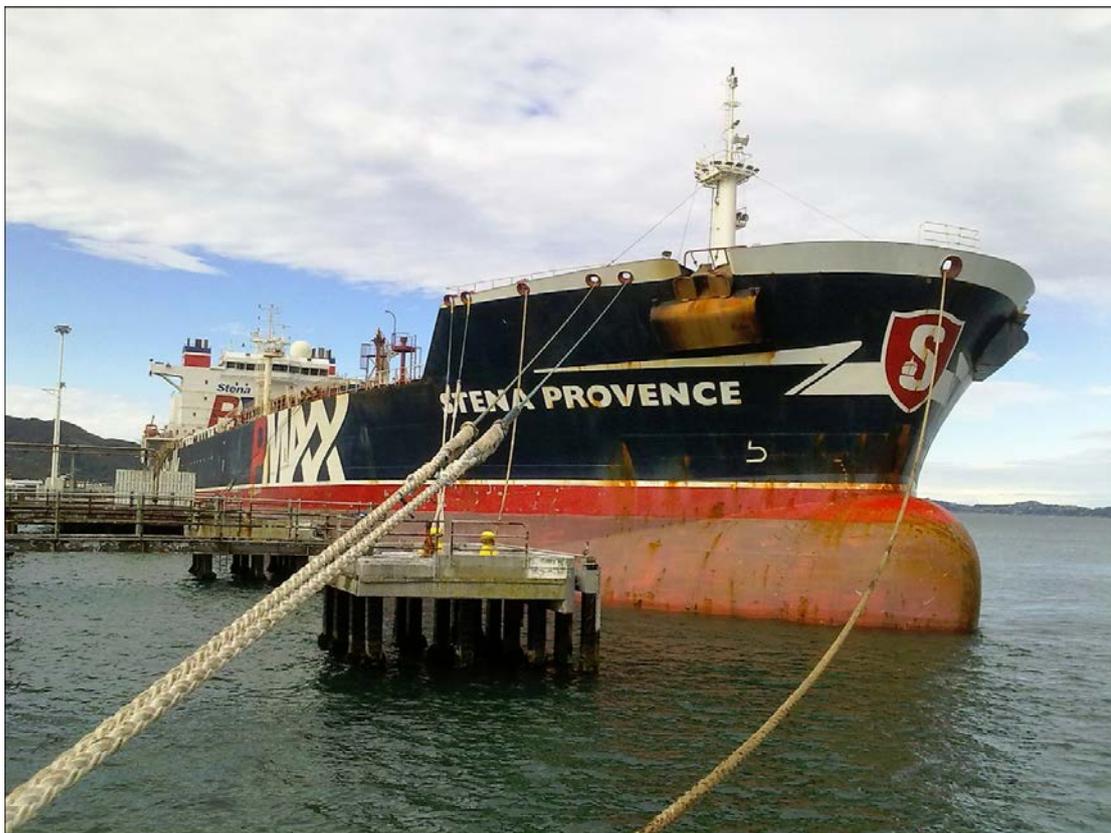
Figure 25 : Tanker Alongside Seaview Terminal – 36,168 GT 183m Length, 40m Beam

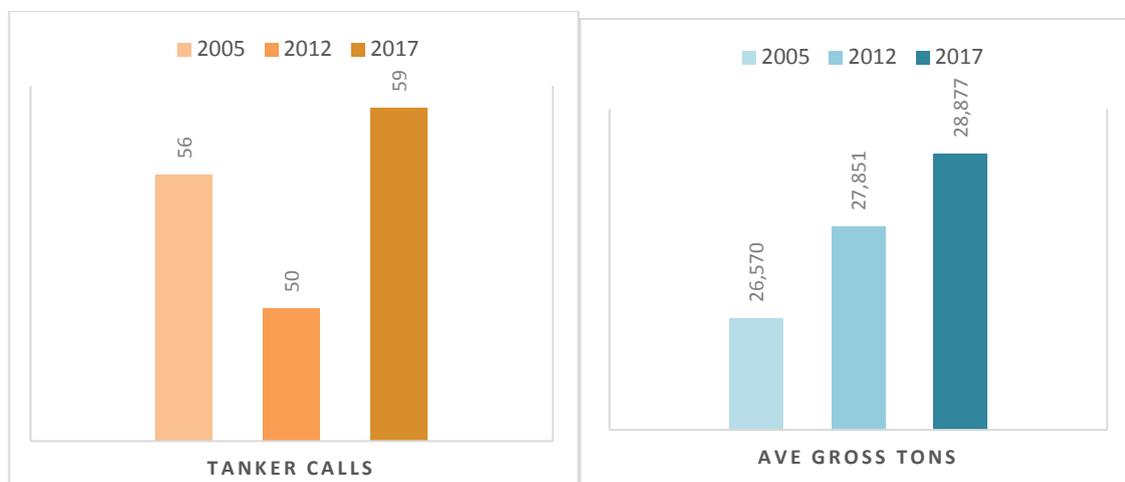
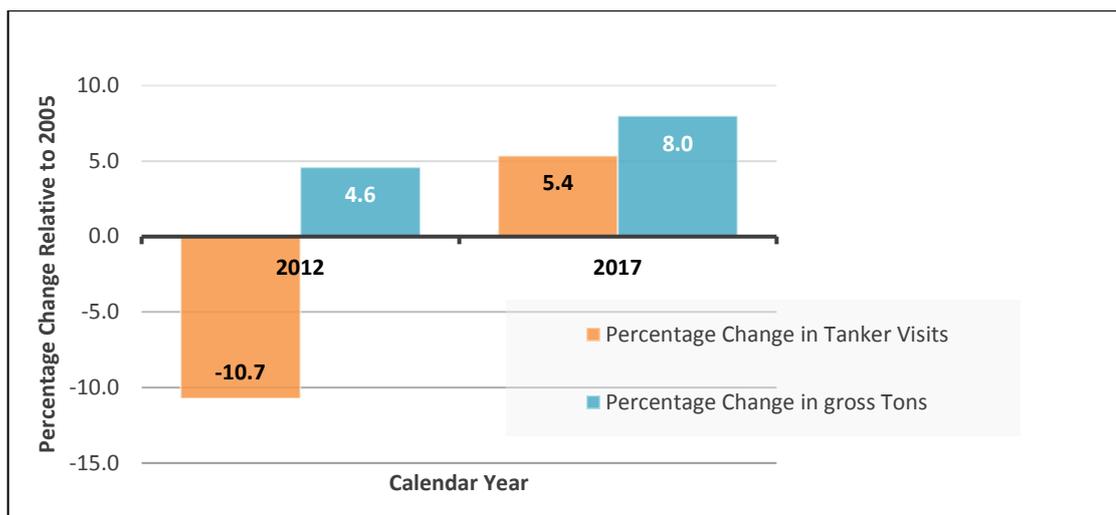
Figure 26: Changes in Tanker Traffic 2012 and 2017 Relative to 2005

Tanker movement analysis has also used 2005 as the baseline, with sample years of 2012 and 2017 being analysed. **Figure 26** shows this in 3 separate images, with number of tanker calls and average Gross Tons, with percentage changes below. Tanker visits by number have varied with slight fall during 2012. . There is a marginal growth overall in the number of tanker visits of 5.4%. However, the size of tankers visiting (Gross Tons) has increased almost year on year, with an average increase of 2000 gross tons between 2005 and 2017. Although this is a marginal increase of 5.4%, larger vessels such as *Stena Provence* at 36,168GT are visiting, against a historical average of 28,877 GT. It is clear that both visit numbers and the size of cargo parcels delivered have increased.

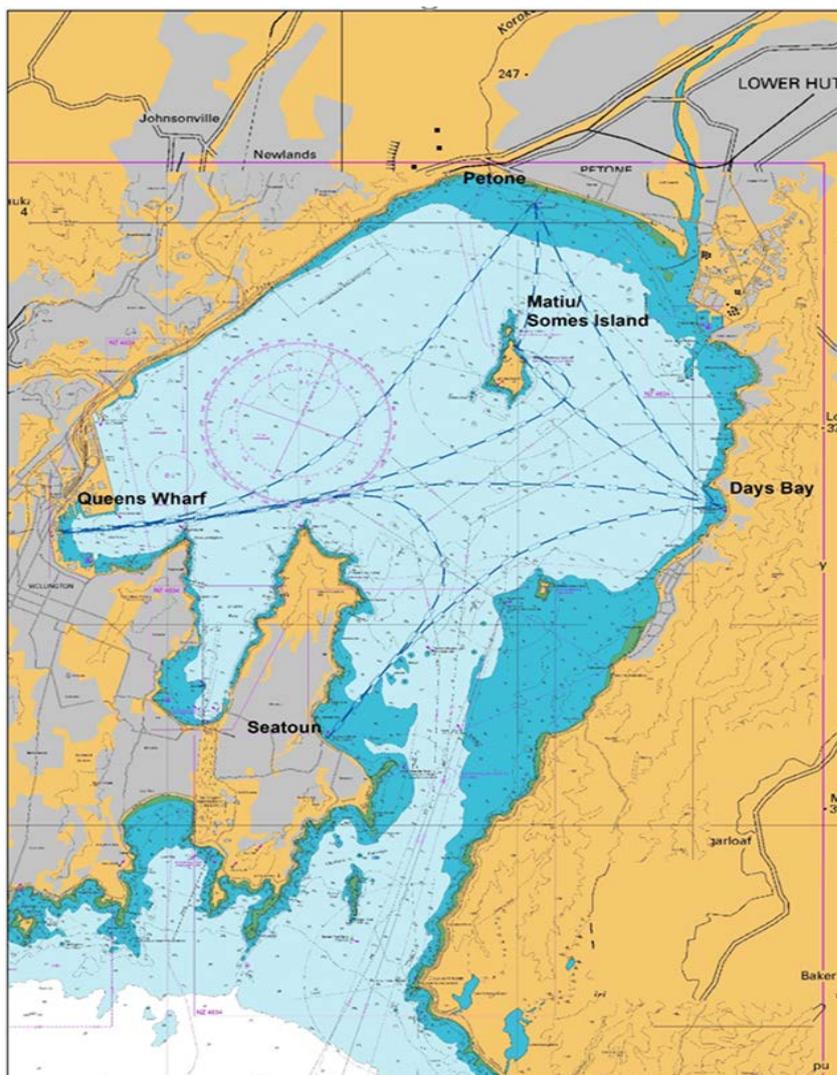
**Figure 27: Chartlet Showing Cross Harbour Passenger Ferry Routes**

The harbour ferry service is part of the public transport network that connects the inner harbour area to Wellington destinations. A cross harbour ferry service has been operating within the Harbour for nearly 30 years, transporting passengers between Queens Wharf and Days Bay. Overall, it has a good safety record. This service has added calls to Matiu/Somes Island, Petone, Days Bay and Seatoun. The weekday and weekend schedule comprise 16 and 8 return cross harbour trips respectively. The main ferry jetty is located at Queens Wharf, Wellington with connections to Days Bay, Seatoun and Somes Island on a daily basis. A service to Petone was added at weekends but was suspended due to wharf damage. The service is weather dependant and cancellations occur on safety grounds, especially during the winter period. The routes of the harbour ferry are illustrated in **Figure 27**.

Currently, the ferry service operates two catamarans. *City Cat* carries 91 passengers with service speed of about 20 knots. *Cobar Cat* has a capacity of 99 passengers, service speed 22 knots. Both vessels carry AIS transponders, allowing Beacon Hill to monitor the ferry's movements and helping large vessels to be aware of these relatively small craft.

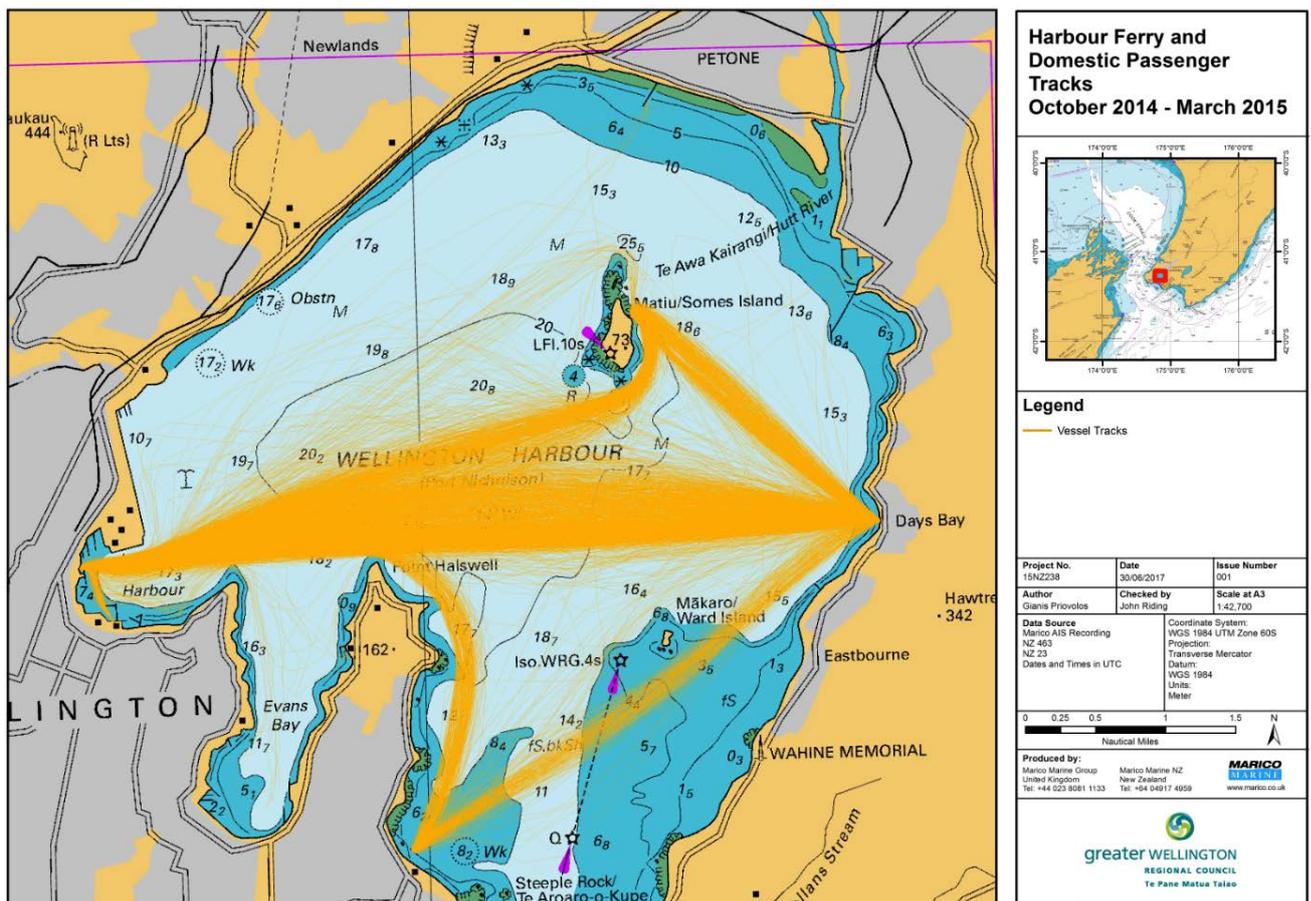
**Figure 28 : Harbour Ferry Domestic Passenger Tracks**

The tracks for all Harbour Ferries operating in Wellington Harbour are illustrated in **Figure 28**, below. The number of cross harbour transits by commuter ferries has risen significantly since the 2006 navigational risk assessment. The Seatoun transit link is firmly established and the cross harbour ferry routes have developed into an integrated part of the Wellington passenger transport system. The plot shows a mostly clear definition of routes, although when it comes to the main harbour basin, there is considerable traffic spread associated with harbour ferries.

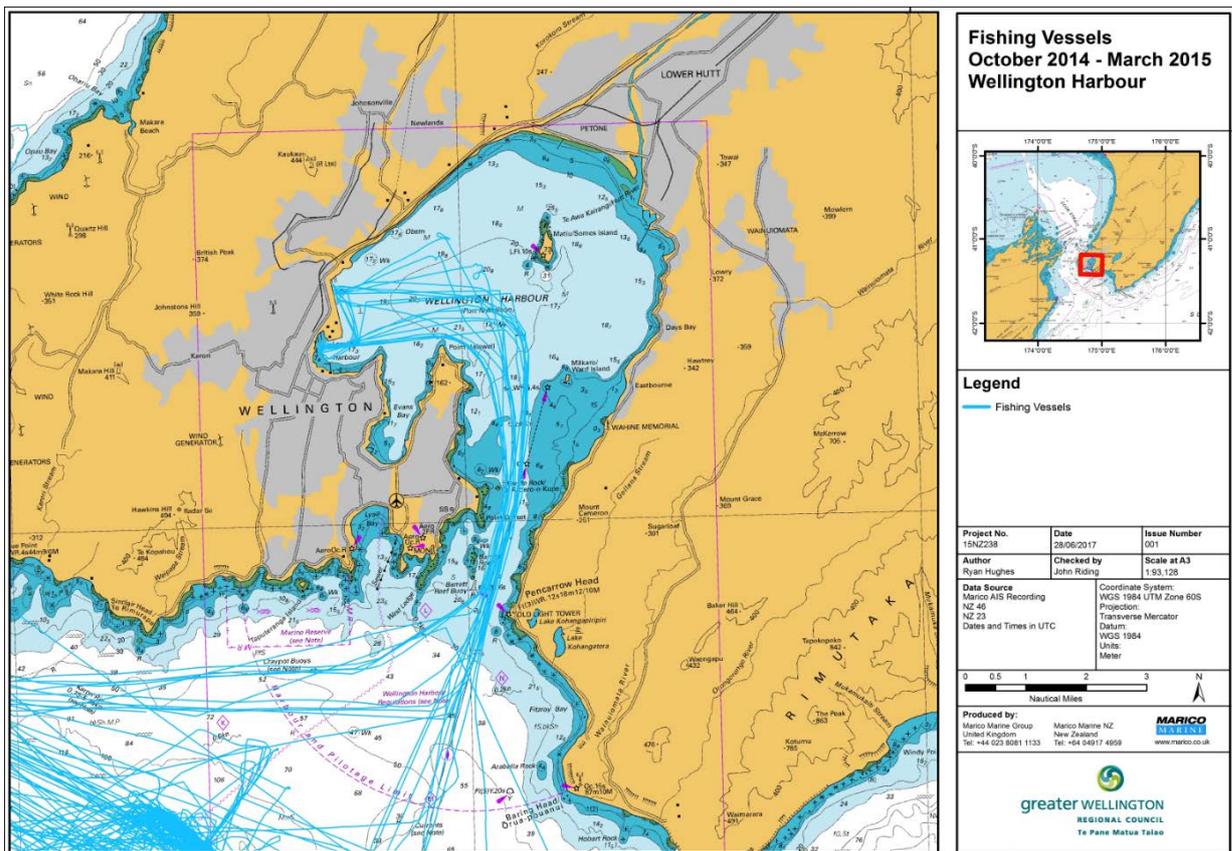
Figure 29 : Commercial Fishing Vessel Tracks

Figure 29, illustrates the tracks of Commercial Fishing Vessels fitted with AIS transponders, transiting Wellington Harbour. Wellington has a small fleet of commercial fishing vessels based in Island Bay, Evans Bay, Seaview Marina and the inner harbour wharves. These are not fitted with AIS transponders. Larger fishing vessels, which are generally fitted with AIS transponders, berth at Aotea Quay. Fishing in the Wellington Area occurs year-round, including along the Southern Coast and in the Cook Strait. The track records show that in 2017, larger fishing vessels are a small part of the overall harbour traffic, although it should be noted that the majority of the local vessels are not recorded (no AIS transponders).

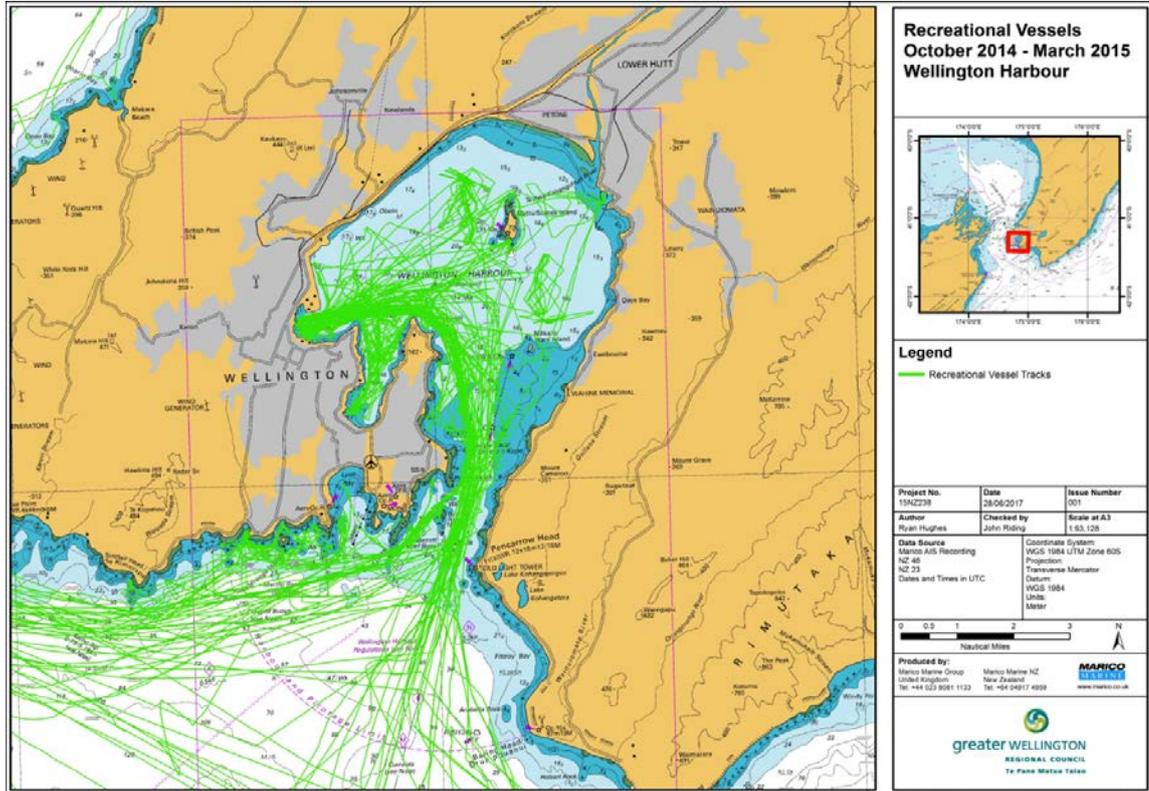
Figure 30 : Recreational Vessel Tracks (AIS transponder fitted)

The tracks for recreational vessels, fitted with AIS transponders, that use the Wellington Harbour waters are illustrated in **Figure 30**. As such, it should be noted that a majority of recreational craft are not recorded and radar coverage does not extend into Lambton harbour. Recreational vessels and craft make up an increasing part of marine traffic in Wellington Harbour, few are fitted with AIS, although this is slowly increasing. Such use is not as dense as Marlborough Sounds or some of the harbours in the North. However, Wellington does represent an estimated 12% of NZ recreational vessel owners based within it. Recreational vessels may berth within the Harbour at Chaffer's (Lambton Harbour), Evans Bay and Seaview marinas.

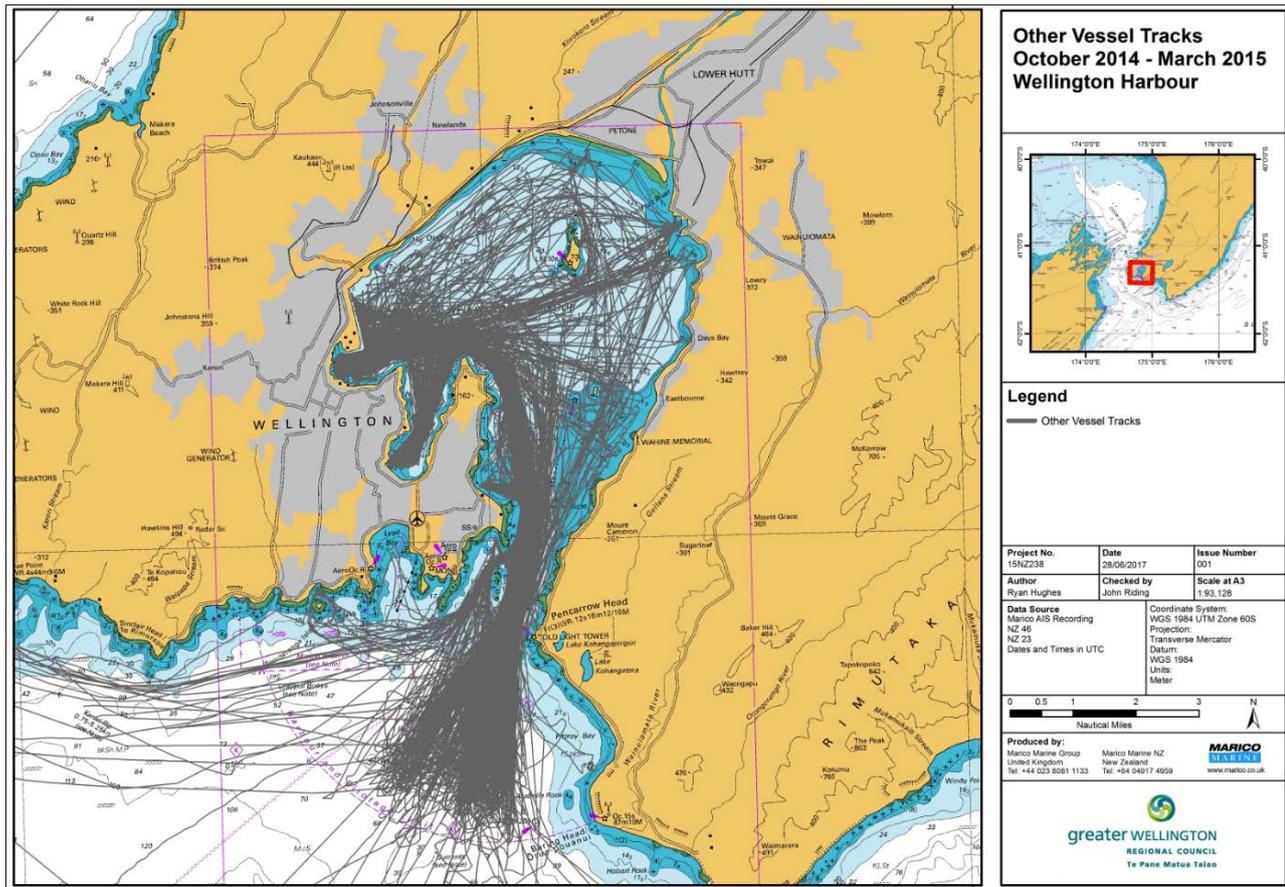
Figure 31 : “Other” Vessel Tracks

The tracks of vessels listed as “Other” are illustrated in **Figure 31**. This includes: pilot vessels, law enforcement vessels, offshore support vessels, offshore tug supply vessels, port tenders, research/survey vessels, search and rescue vessels, service ships, towing vessels, diving operations vessels and workboats. These comprise the vessel traffic not included in previous subsections, and have been amalgamated into a single vessel group. The extents of the pilot vessel deployment for boarding vessels in the harbour approaches is evident in this traffic plot.

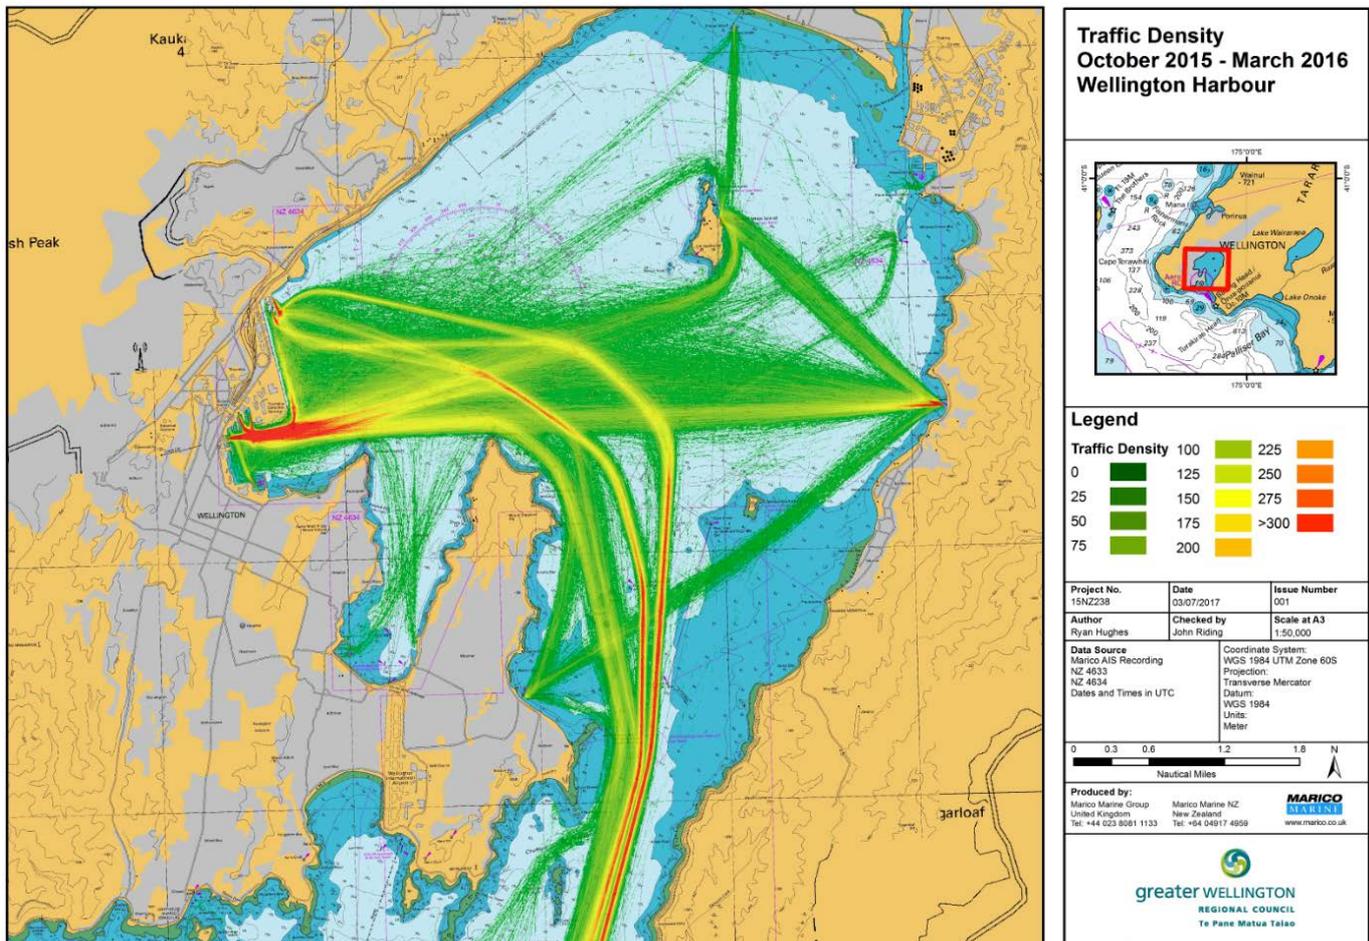
Figure 32: Traffic Density Plot - Wellington Harbour

Figure 32 illustrates the shipping traffic routes through Wellington Harbour by track density. The plot highlights where routes lie by using a density count of the number of vessels overall passing through a point location. It should be noted that vessel traffic in the entrance has to remain in the designated channel and traffic also in general follows the recommended harbour route well. The dominant vessel type is the Cook Strait passenger RoRos with these providing the highest number of inbound and outbound runs on a daily, monthly or annual basis. However, the rising importance of the cross-harbour ferry is also apparent, as are these services’ points of crossing the harbour recommended routes, or joining other established transits. Ferry routes to and from the central harbour to Somes Island, Days Bay and Seatoun terminals (jetties) are clear. There is a line of increased density running from the harbour entrance then inshore and to port of the recommended

routes. This is almost entirely the track record made by the CentrePort Pilot Launch, which steers well clear of headlands.

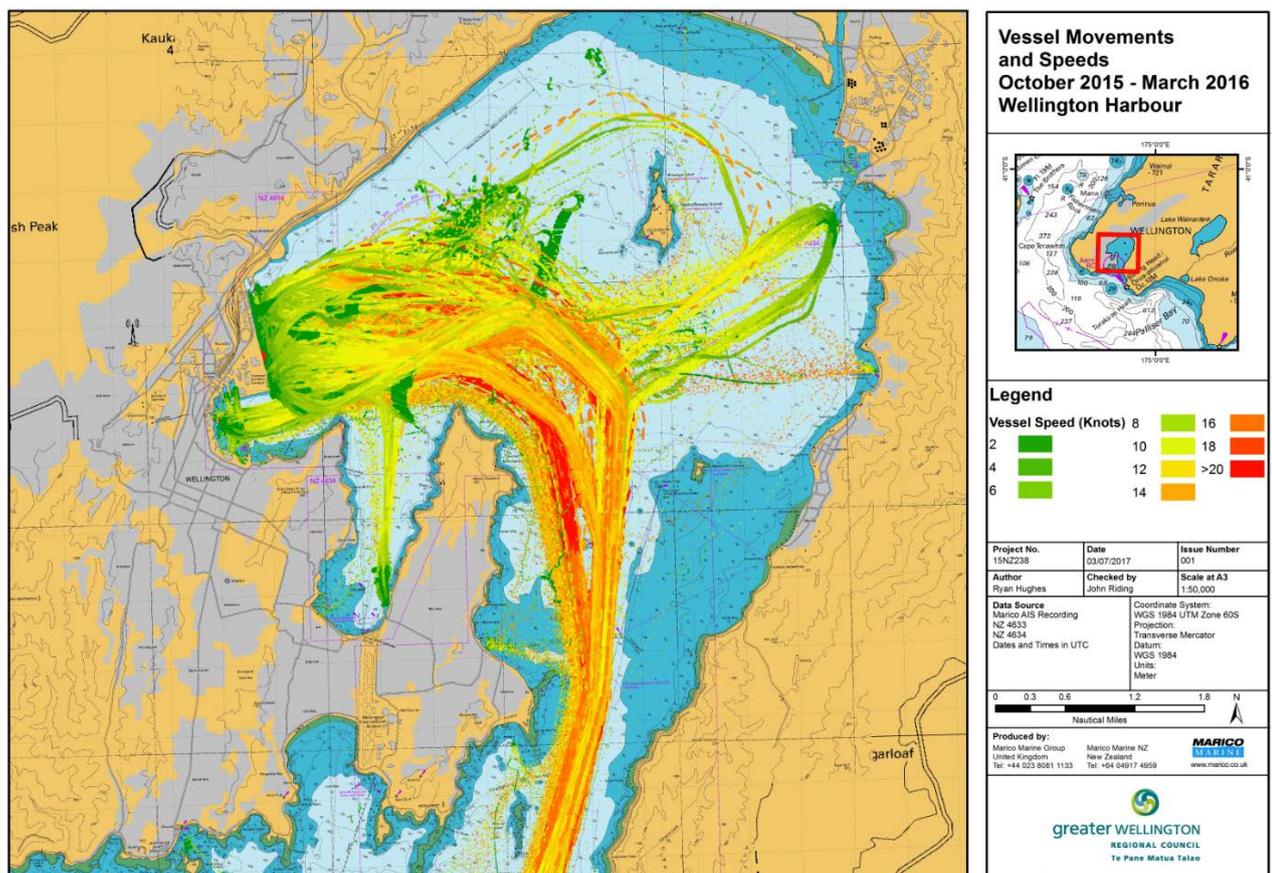
Figure 33 : Plot of Vessel Speed Variation in Wellington Harbour

Figure 33 presents speed analysis for Wellington Harbour. The passenger RoRo ferries provide the highest harbour speeds, especially outbound; This is understandable, given the need to maintain a passenger schedule. Tankers generally proceed at the lowest harbour speeds. The highest speed records are provided by police or coastguard operations with pilot vessel operations featuring in the

outer harbour areas. The new pilot launch (2017) has an increased operating speed of 25 knots, so will also feature in the future.

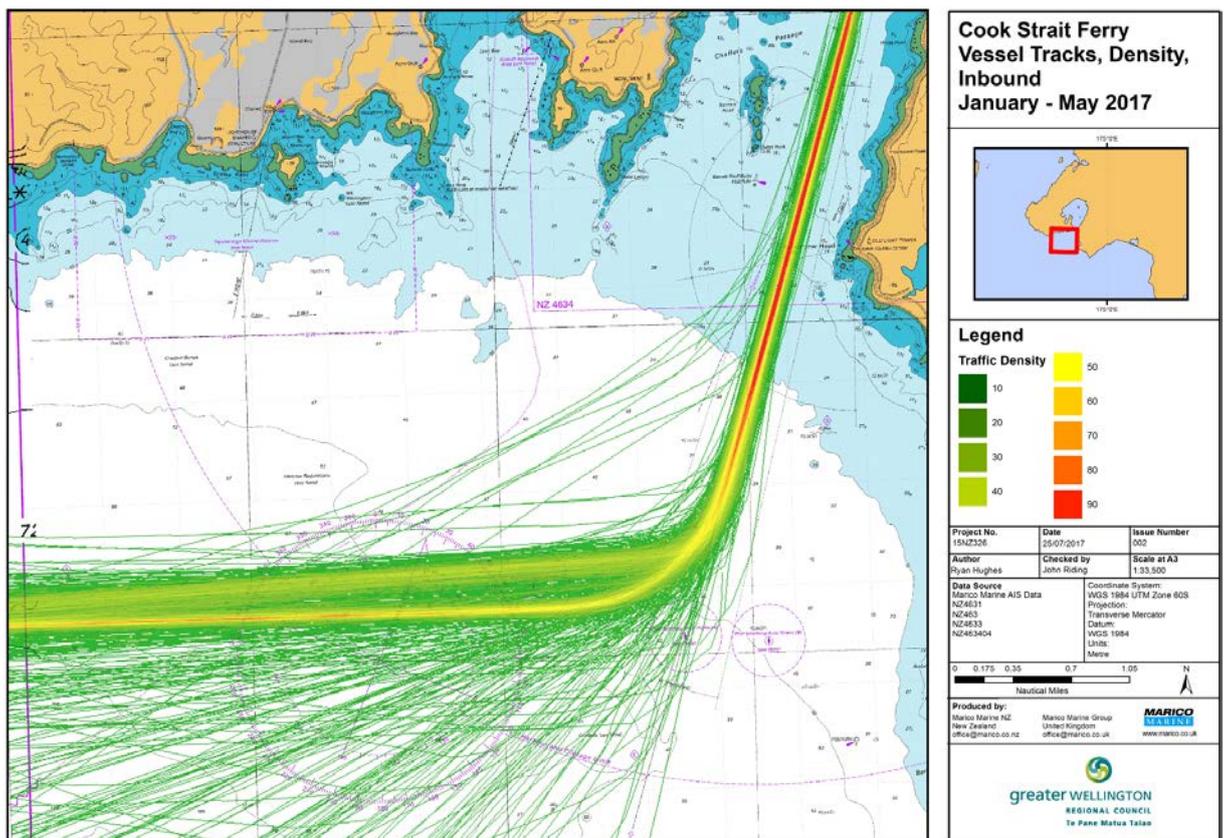
**Figure 35 : Inbound RoRo Ferries - Alignment with Leads and Recommended Route**

Any vessel on the harbour approach leads has good knowledge of any vectoring off the track. The further the leads are apart, the more sensitive they are. The Wellington leads are 1.3nm apart<sup>37</sup>, within IALA guidelines to be sensitive to a vessel aligned on them inbound. To test the system, track data for inbound RoRo ferries was extracted and plotted, using a density analysis technique to determine the percentage number of vessels that followed the same route. The results are shown in **Figure 35**, which presents a data period from January to May, 2017. The plot shows that there is generally good compliance by Passenger RoRos with the Harbour Master’s recommendations for harbour entry.

Although some tracks have deviated, taking a “short cut”, the majority of transits are accurately aligned. There could be reasons such as poor sea conditions or traffic to explain the small number of recorded short cuts – non-standard vessel transits are reported by Beacon Hill and followed up by the Harbour Master’s department. There is no doubt that navigational precision and therefore bridge team BRM practices have improved since the 2006 risk assessment. The area of highest track density offshore is made by the transits of just one of the two Cook Strait operators, showing a consistency of harbour approach across more than one of their vessels. The fact that the

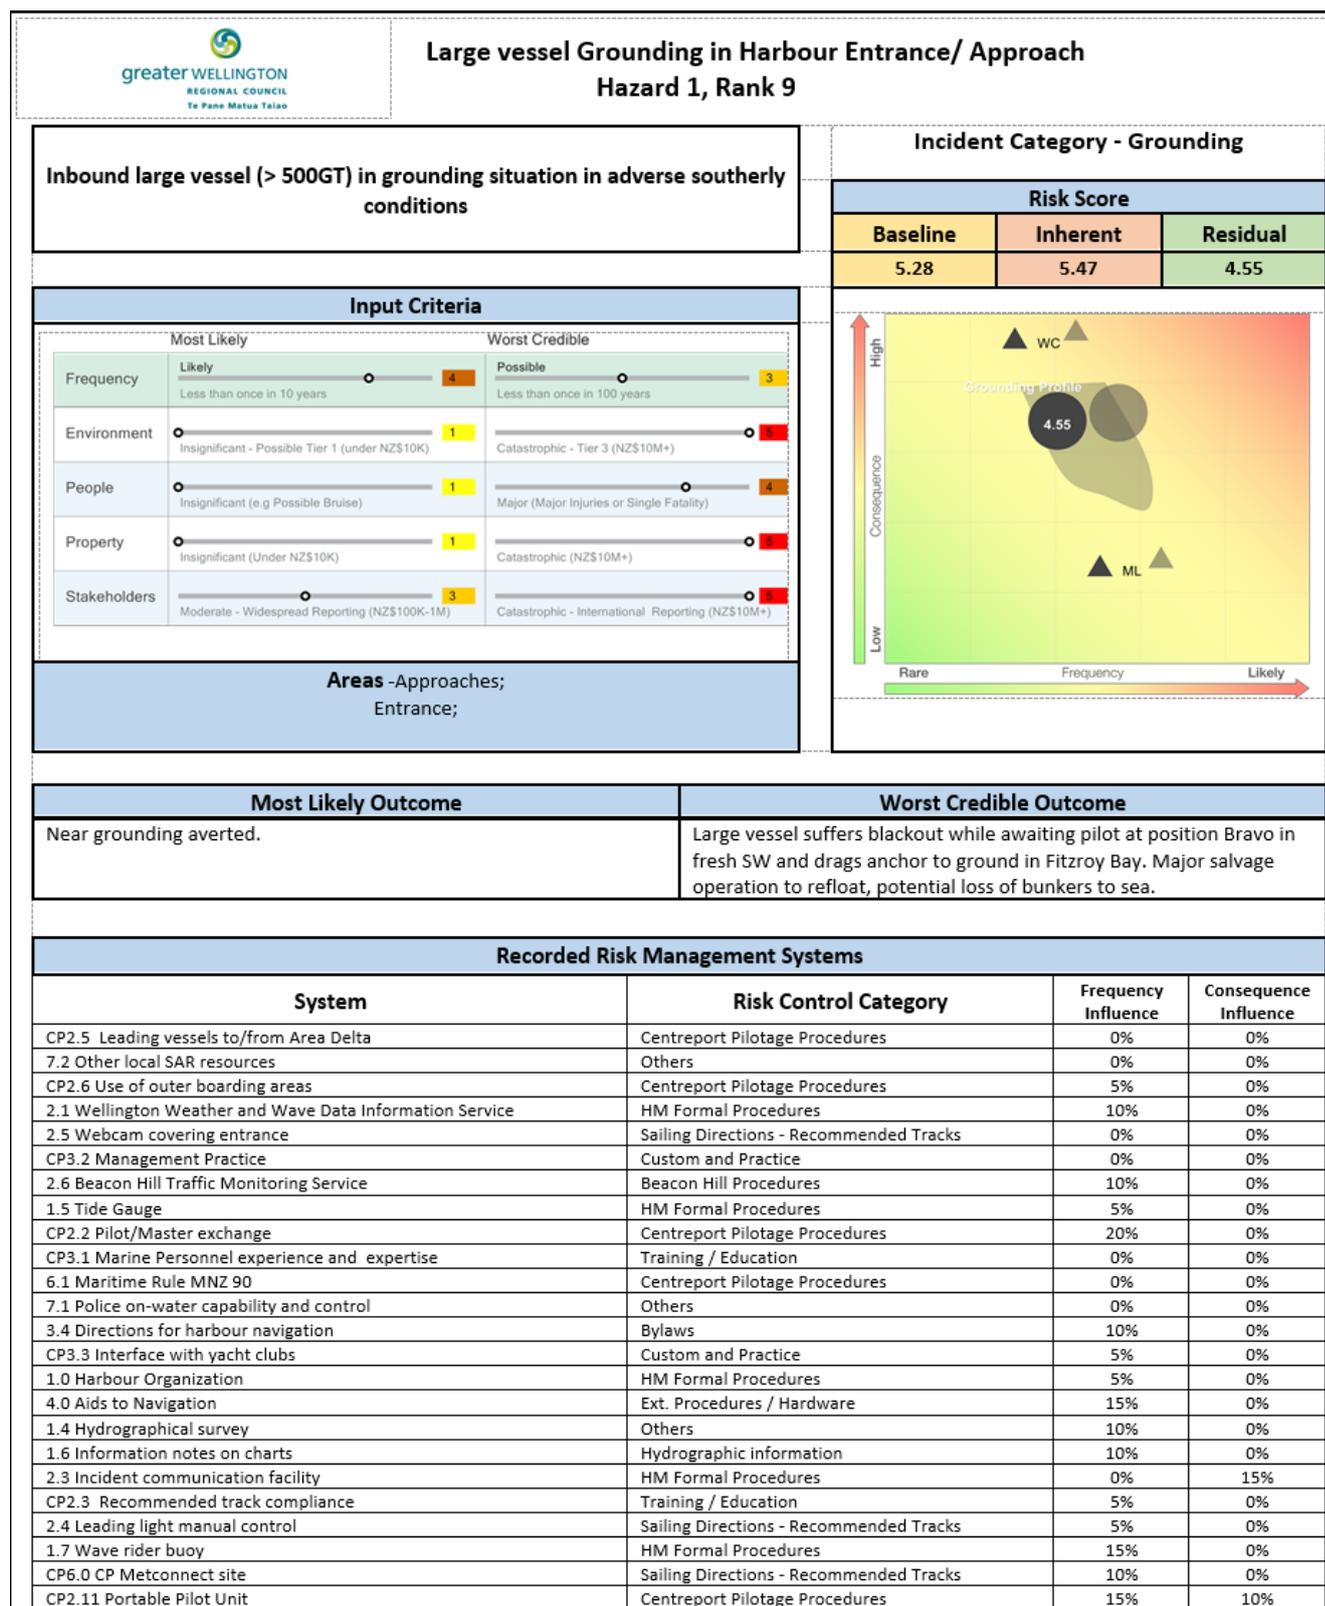
**Figure 36 : Single Hazard Report – Large SOLAS Vessel Grounding**

The AAL BRISBANE incident (See **Section 3.1.6**) showed how some confusion in the Wellington approaches can easily lead to a serious grounding. The 1981 grounding of PACIFIC CHARGER and the rudder failure of SEA HARVEST in 2003 into Fitzroy Bay, shows that the probability of grounding of a large vessel has a return period at Wellington of about 20 years. The Hazman II software can record such a return period accurately. **Figure 36** shows the risk record associated with a large vessel grounding. It ranks at 9 and as such should be considered equally as important as any other grounding in the harbour. It shows how much the Wellington Harbour system cannot afford to be complacent.

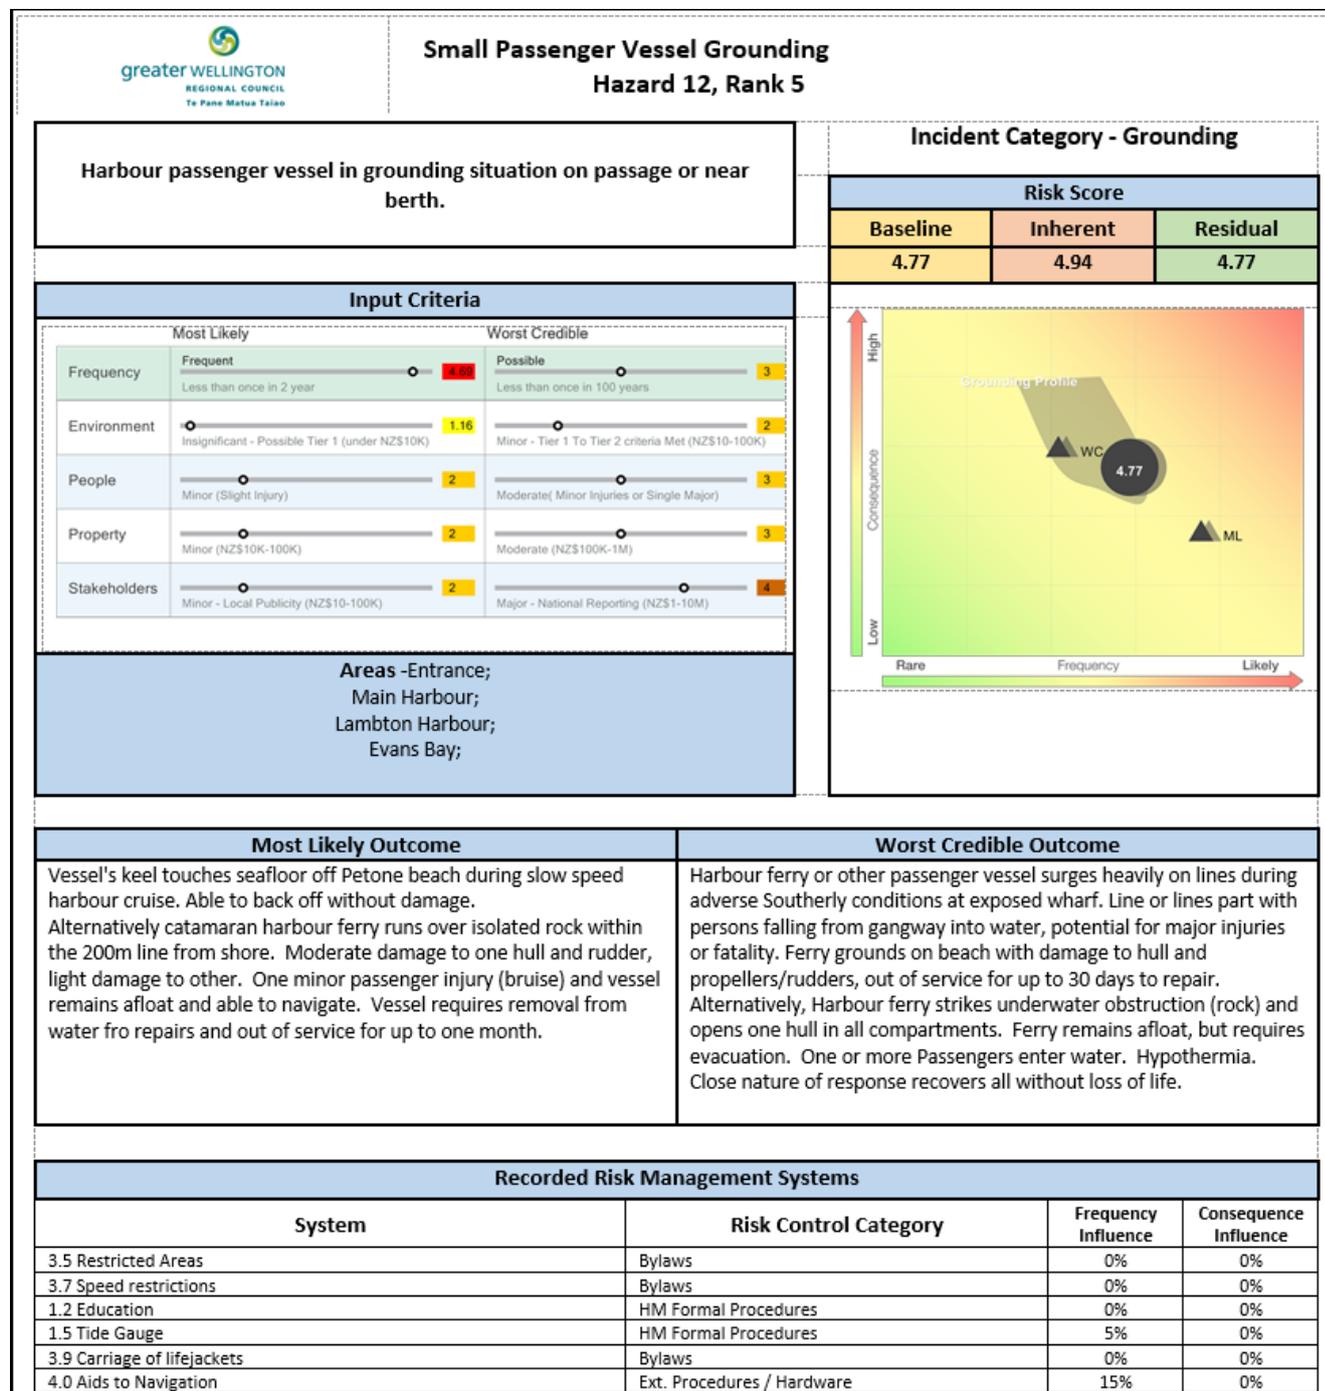
Grounding of a small passenger vessels is ranked at no.5 and the hazard summary is shown at **Figure 37**.

**Figure 37 : Single Hazard Record - Small Passenger Vessel Grounding**

Some further analysis of the cross Harbour ferry operation has been undertaken, **Figure 37**. Closer examination of the track records for March-June 2017 show a spread of tracks along the Miramar
