# GREATER WELLINGTON REGIONAL COUNCIL

## WELLINGTON HARBOUR NAVIGATIONAL RISK ASSESSMENT

Report Number: 15N2328  
Issue: 04  
Date: 31 August 2018

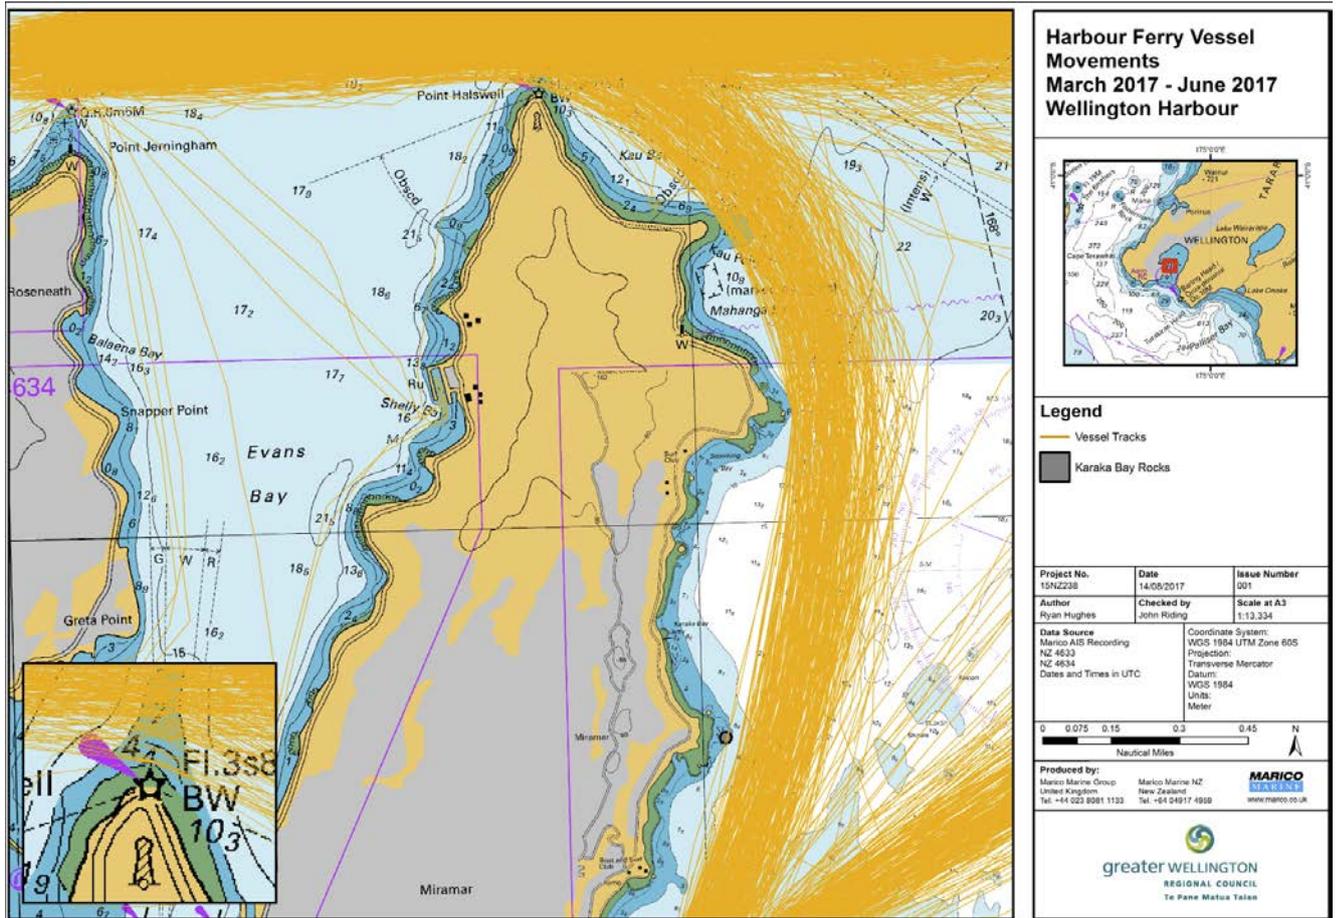
Figure 38 : Cross Harbour Ferry Tracks - Miramar Coastline

The insert in the plot is a zoom onto the Point Halswell area and shows transits of the harbour ferry passing close, accepting that an error allowance is needed for the potential error in transmitted AIS data. The 5 knot rule within 200m of coastline is relevant and a detached view from Authors is that a grounding at speed was likely – this being with the benefit of data analysis. From a risk perspective, the position of this grounding hazard at rank 5 is justified by the evidence. The inherent risk score of 4.96 is still within the ALARP criteria, but may well be an optimistically scored risk, given the evidence of some further track data investigation.

There will be benefit from skipper training and a good Safety Management System will be able to use the information above to improve and develop. **Figure 38** shows the plotted tracks.

The layout of the two lane orientations above is shown as a repeat of **Figure 14**. Both activities wish to use the same area and the incident that occurred was probably inevitable. The harbour masters department is to install a swim turning buoy (indicated by the red mark on Figure 38) to provide an alternative to Point Jerningham lighthouse, but it appears to Authors that either the activities need to be separated by timing, or the activities need to be separated by design. A risk such as this, where head injury of a swimmer can occur, needs to be isolated as opposed to mitigated.

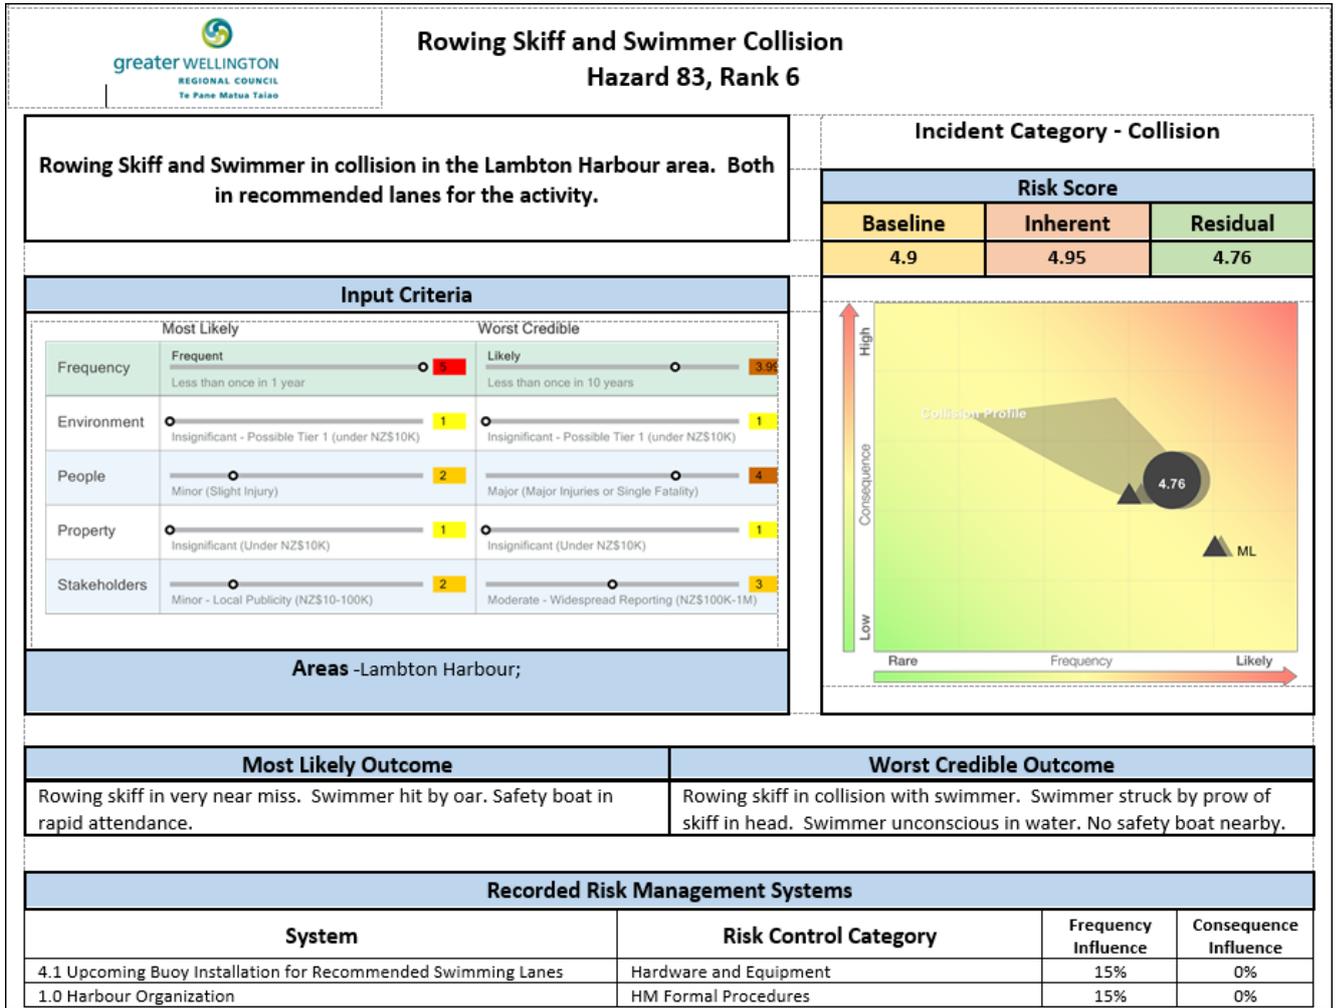
harbour usage at Point Jerningham. The Risk record of this hazard, Rank 6 is shown in **Figure 39**. Its ranking is related to the incident record.

**Figure 39 : Rowing Skiff and Swimmer Collision**

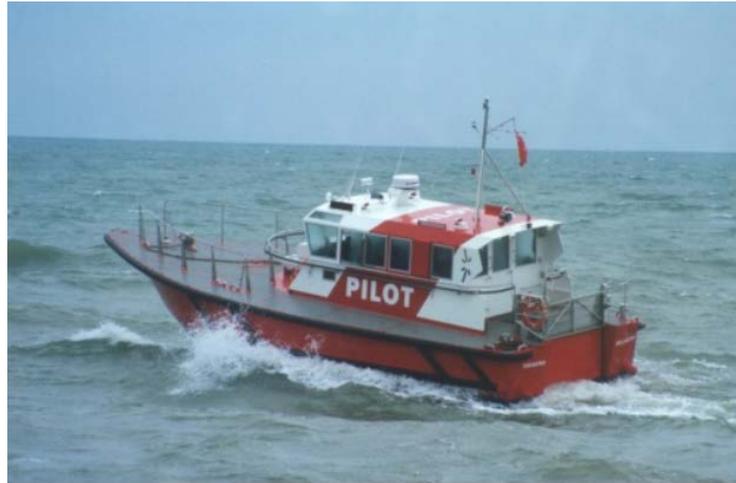
**Figure 40 :Wellington Pilot Boat, Tarakena.**

The single hazard result (Hazard 19, Rank 3) for the 2016-7 risk assessment is shown at **Figure 40**, below. With an inherent risk score of 5.34. With all the mitigation in place with the present standard of pilot boats in use, a residual score of 5.16 has resulted. On one hand, these risks are not in the unacceptable range, but on the other they provide a risk score (5.16) the upper end of the ALARP criteria. Where personal injury potential (HSAWA) criteria are considered, options to ensure risk mitigation need to be considered. There are already operational limits in place for the current pilot boat during adverse weather conditions, which the risk assessment took into account. The high risk is not due just to the use of a RHIB as backup, it is the fact that the pilotage service needs to board further out in 2017, than it did in 2006. The present pilot vessel can achieve that, but is short in length for the type of swell period that can take place at the designated pilot boarding locations offshore.

Pilot vessel crew fatigue was raised during risk assessment consultation. The pilot boat crew can face a complex day when the port is busy. There can be a number of pilot transfers occurring in sequence, which may not necessarily all be at the harbour entrance. Pilots are often transferred between one vessel after arrival to another vessel which may be shifting. This creates irregular working hours for pilot boat coxswain and crew. Rest periods are also therefore irregular. The new pilot boat has a design service speed of 24 knots, which is significantly greater than the existing vessel at 15 knots. This reduced the 45 mins transit time to the boarding area significantly. The improved speed should increase the availability and length of rest periods for the pilot boat crew. The risk scoring has taken account of this, see again, **Figure 40**.

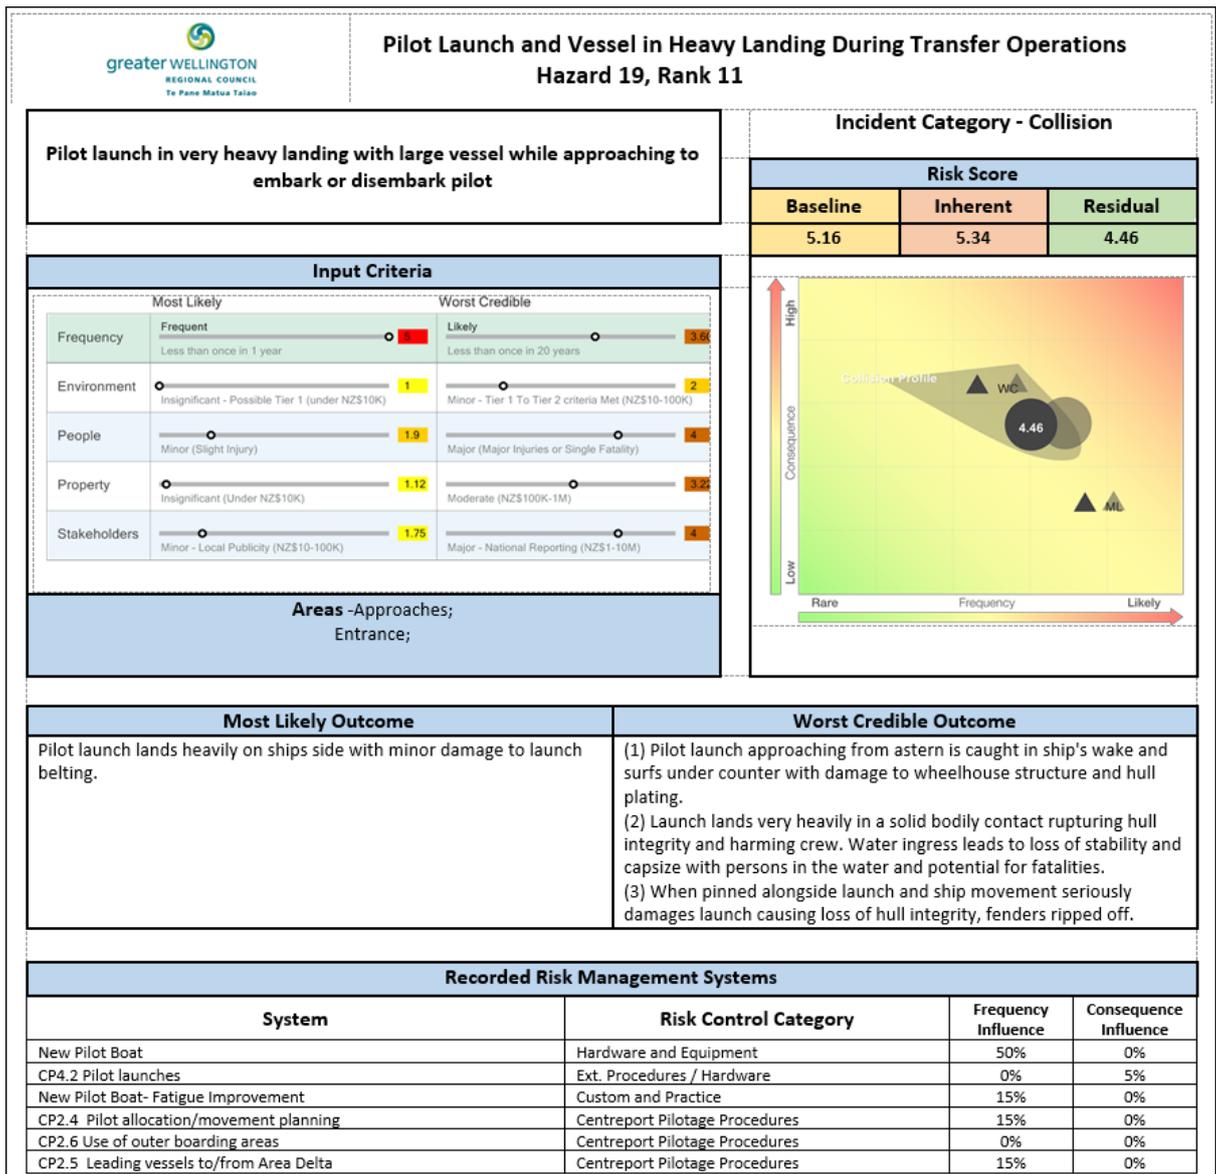
**Figure 41 : Pilot Boat Collision Risk - New Procurement**

Given the delivery, this hazard was run again in the Hazman II software<sup>42</sup>. The risk reduction effect of procuring a pilot boat more suited to the environmental conditions at Wellington harbour

entrance is also shown in **Figure 41**. It is an order of magnitude and an important delivery for Wellington Harbour and credit is due for this contribution to risk reduction.

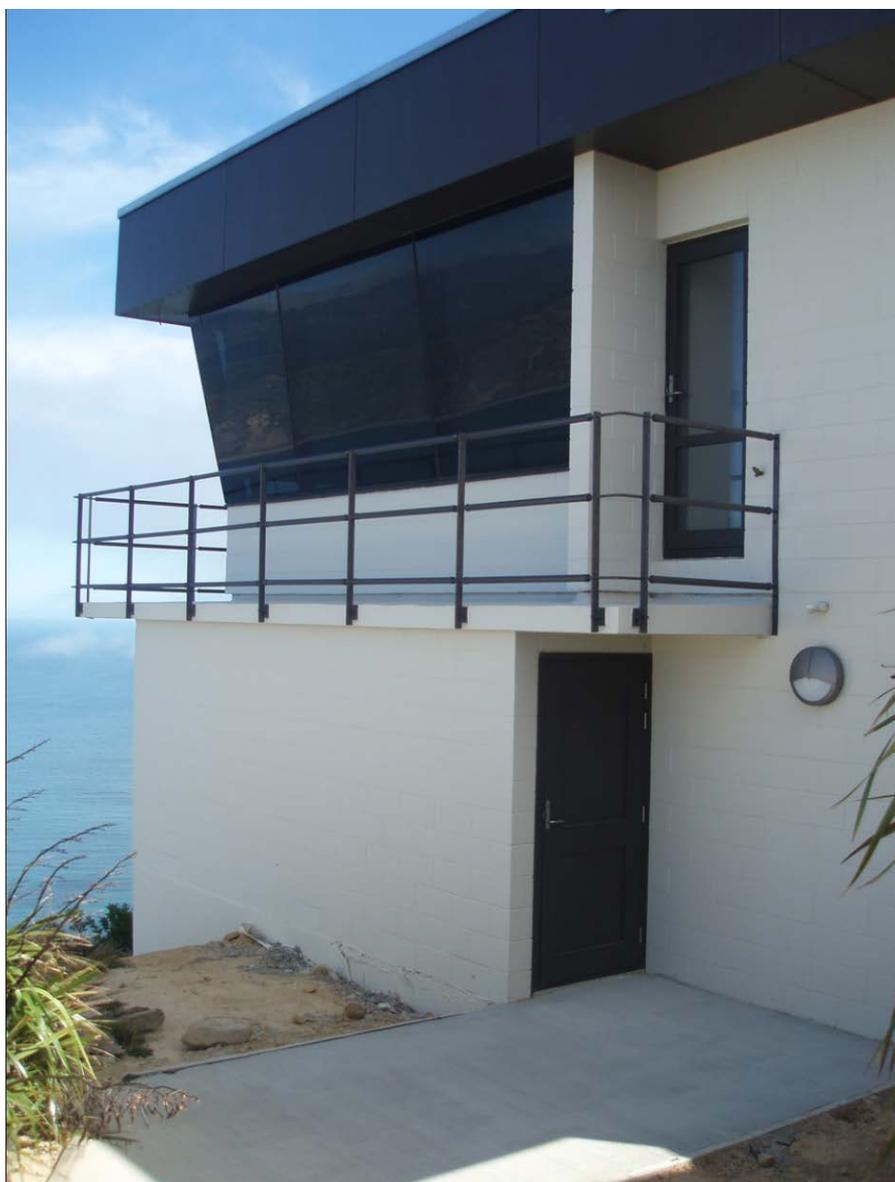
**Figure 42 :**  
**Beacon Hill Signal**  
**Station**

The 2006 risk assessment recognised the importance to Wellington Harbour of Beacon Hill, given harbour topography and large volume of PEC passenger RoRo vessels that represent the Cook Strait passenger services. Recommendations were made to upgrade the systems and services at the Beacon Hill traffic monitoring station, such that it could take a role in providing a modern traffic interface to the then developing VTS standard<sup>43</sup>. Council not only subsequently invested in both hardware and ship tracking software, by 2010 a whole new Beacon Hill operating station was designed and built, with an upgrade of all hardware and software facilities. This included the installation of a new radar, monitoring the approaches and entrance channel, AIS data reception and upgrading of the weather information system. The existing monitoring equipment was replaced with

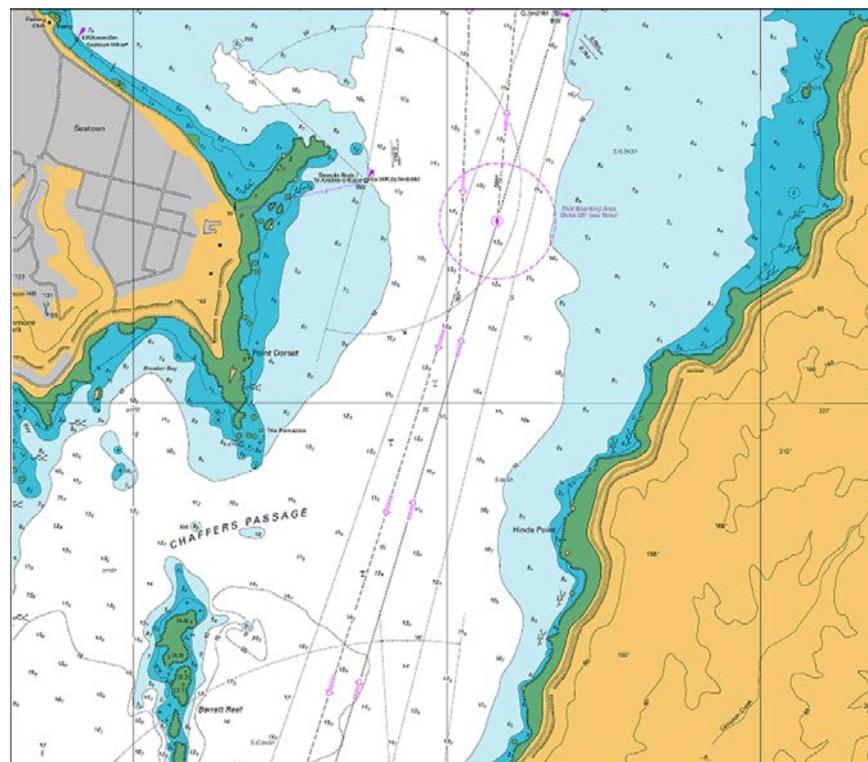
**Figure 43 : Delta Boarding Location**

**Section 5.7** introduced the Delta boarding position. A discussion of the arrangements for Delta needed to proceed after the report section discussing Beacon Hill improvements. Wellington has four pilot stations, three of which are shown in **Figure 7** and located within the harbour approaches. The forth, Delta, is located within more sheltered waters within the entrance and is designed for use on occasions when it is too rough to board an inbound vessel offshore<sup>49</sup> (**Figure 43**). To use Delta for boarding, a pilot has to lead a vessel into the harbour entrance channel and in doing so, pass some of the most important grounding hazards of the harbour. There are many harbour viewpoints around the world, risk based and pilot viewpoints, that frown over the leading of vessels. On the other hand

Wellington has always had the Delta boarding location for use in strong southerly conditions and the pilotage limit used to lie at the old compulsory pilotage lead. Pilots with long service at Wellington were thus trained for boarding at Delta and comfortable in its use, whereas pilots without such long service recognise the need to interface with and understand the bridge team before the hazards of the Wellington entrance are transited.

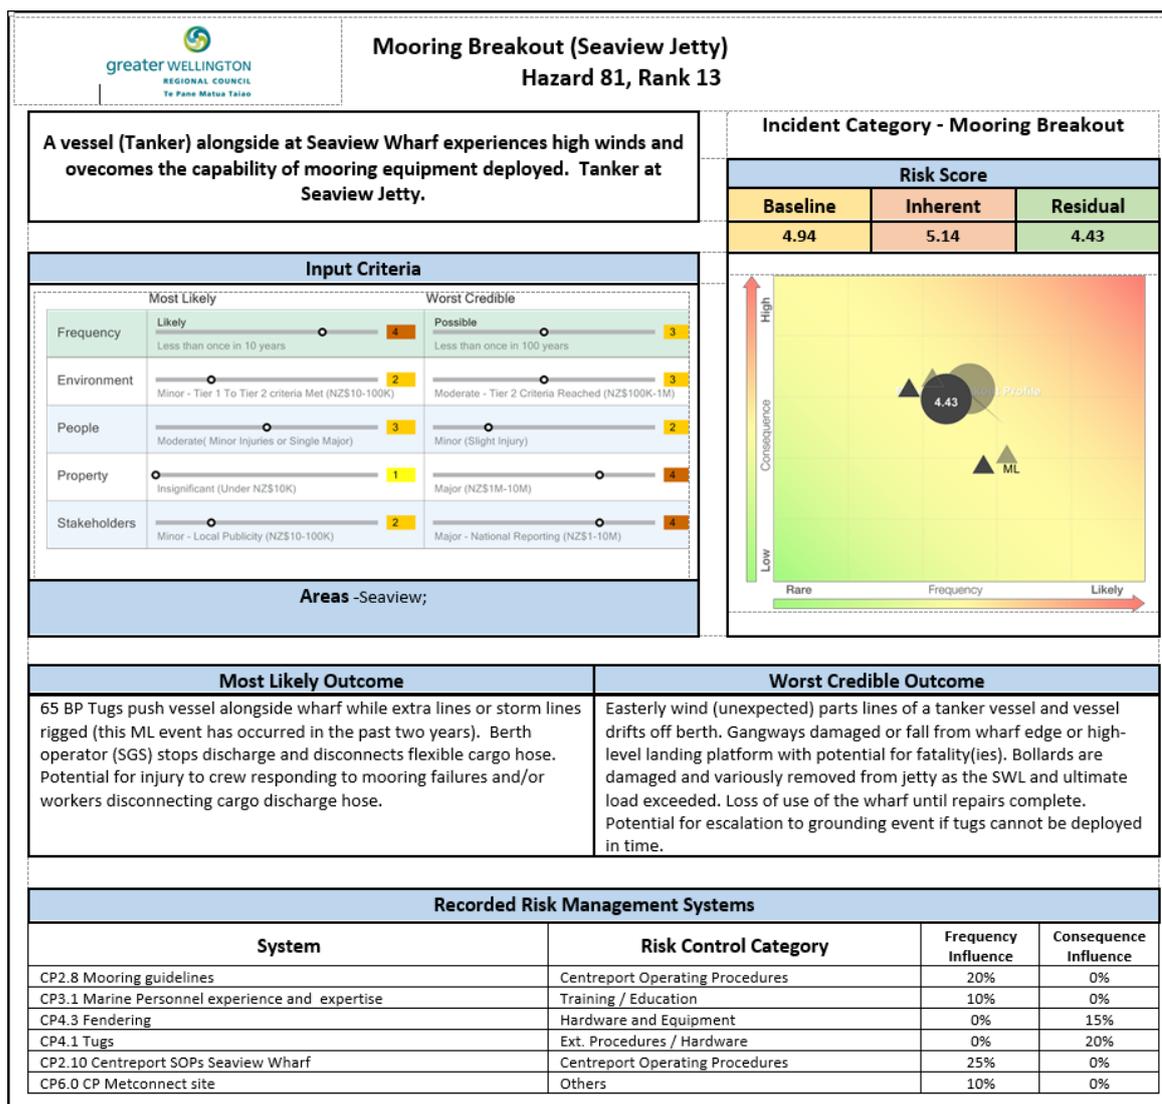
Figure 44 : Hazard Summary - Mooring Breakout Seaview Jetty

Mooring operations at the Wellington Harbour come with a series of risks that the CentrePort operation already recognises and has undertaken berth infrastructure assessments and mooring upgrade work already, with robust training for lines handlers. An example is the Mooring Breakout hazard at Seaview, **Figure 44**, which ranks 13 overall.

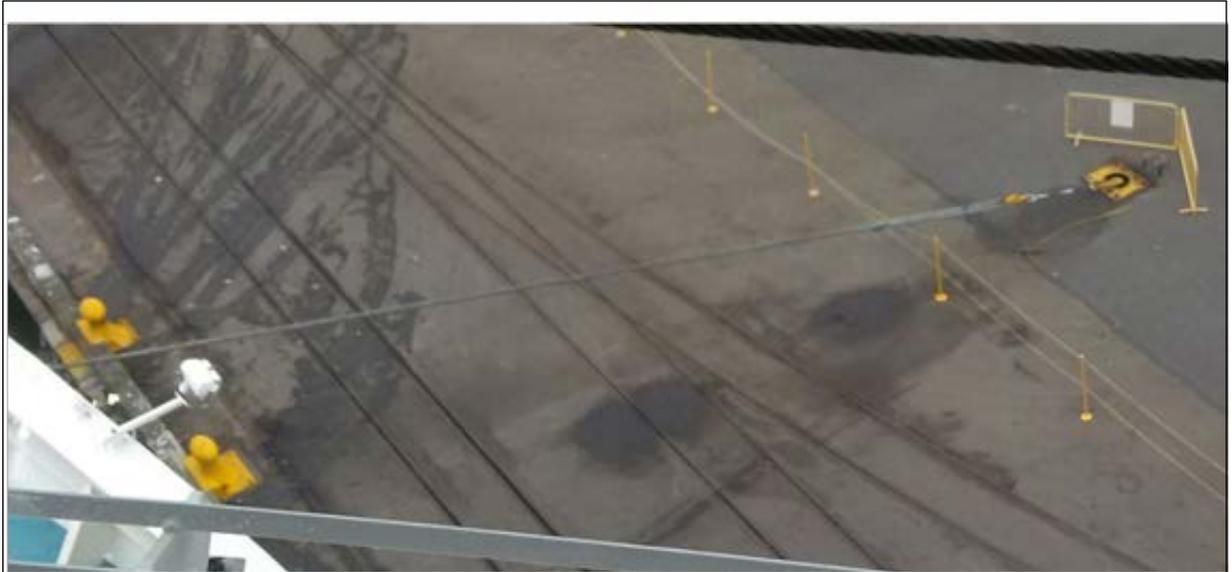
**Figure 45: Aotea Quay Improvements to Mooring Systems - Cruise vessels**

In recent years, a mooring breakout has occurred at Aotea Quay, involving a vehicle carrier with high hull area (windage). The mooring system has also undergone an important upgrade to accommodate the rise in cruise vessel visits and sizes. Cruise vessels provide large slab side and surface areas. Balconies also act as sails, especially when vessels are swinging<sup>55</sup>. The loads created by wind can be hundreds of tonnes (which changes with the angle of incidence to the wind). With a rising number of cruise vessel visits and a rapid increase in size, additional sunken mooring points, inboard from the quay face, were installed at the cruise vessel berths along Aotea Quay (see **Figure 45**), providing increased capability to withstand the high loads possible when large cruise vessels are berthed. The arrangement provides purchase at right angle to the vessel alignment alongside, which traditional mooring systems cannot achieve. Fenders on this wharf have also been renewed. The new bollards and fenders have significantly improved safety for cruise ship berthing and staying alongside. This is

Tankers also berth adjacent to the section of Aotea Quay designated for cruise vessels and the improvements to mooring security also benefit this ship type. Positive feedback about the improvements has been provided by Tanker masters serving on the NZ coastal service.

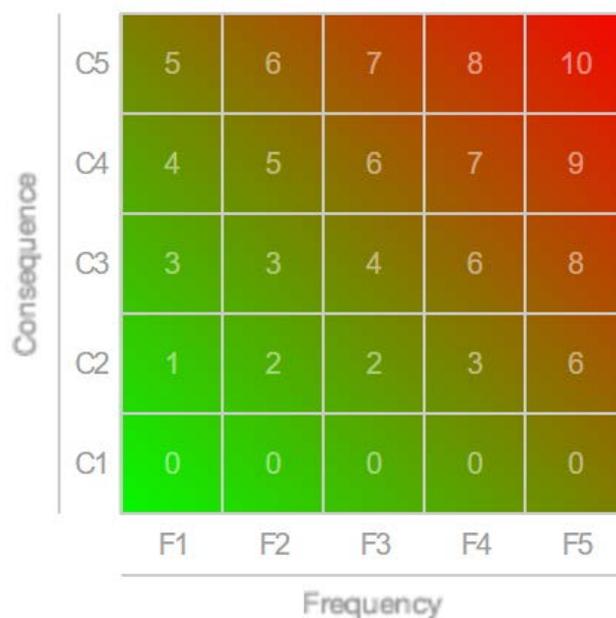
Figure 46 : Risk Matrix Used to Score this Risk Assessment
