WELLINGTON HARBOUR

PORT AND HARBOUR MARINE SAFETY CODE NAVIGATIONAL RISK ASSESSMENT

Prepared For : Greater Wellington Regional Council
and CentrePort Ltd
Report Number : 05NZ104
Issue : 1.1
: February 2006

MARICO Marine NZ Limited

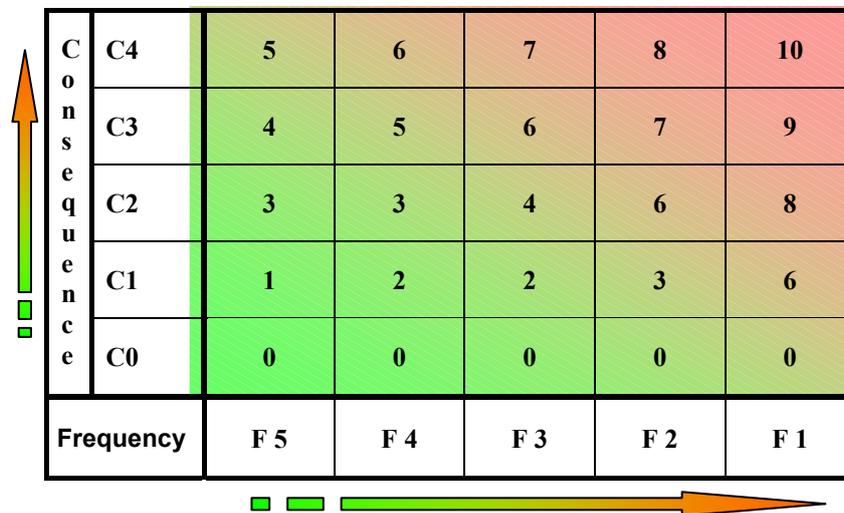
Table 1 - Risk Matrix

Using the risk matrix (**Table 1**, below) taken from **Annex A**, each hazard was scored against a scale of 1 to 10 for each of the four consequence categories within the NZ Risk Assessment Guidelines, forming part of the Port and Harbour Marine Safety Code (i.e. impacts on: Life; Property; Environment; Harbour Stakeholders).

C o n s e q u e n c e	C4	5	6	7	8	10
	C3	4	5	6	7	9
	C2	3	3	4	6	8
	C1	1	2	2	3	6
	C0	0	0	0	0	0
Frequency		F 5	F 4	F 3	F 2	F 1

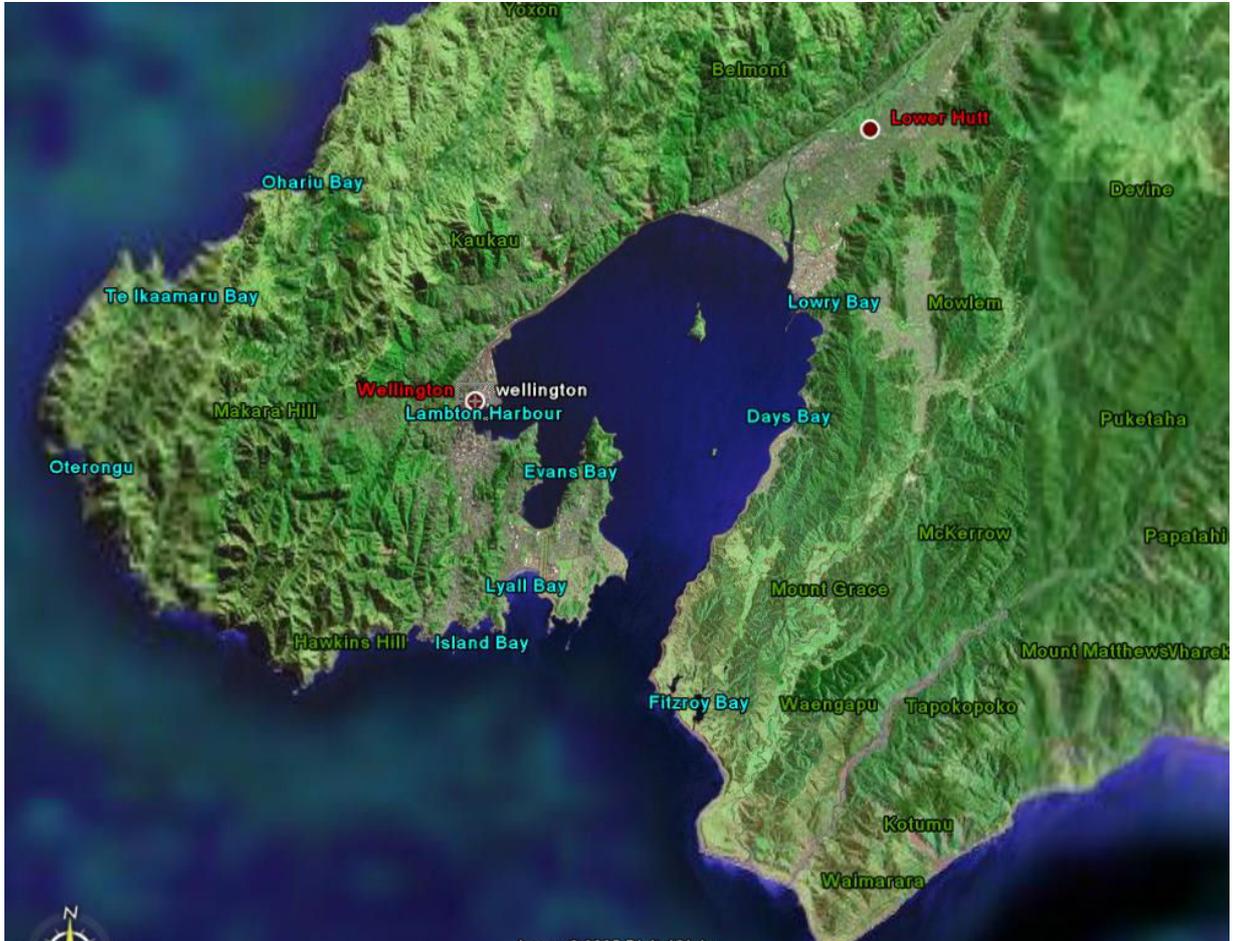
Figure 1 – Satellite Image of Wellington Harbour

Wellington harbour is a natural haven for shipping, with a roughly circular area of approximately 85 square kilometres and average depth of 14 metres, with a controlling depth of 11.3 metres at the bar near the harbour entrance. The entrance is also relatively narrow, protecting the inner harbour from most sea conditions. The general geography of the harbour is shown in **Figure 1**, which also references names of the various bays within the harbour. The layout of berths and topography into Evans Bay is shown in **Figures 2 & 3**. **Figure 2** shows an aerial view of the ferry finger berths in central Wellington, as well as Thorndon container terminal and general berths along Aotea Quay. **Figure 3** shows the Harbour looking SouthEast towards Lambton Harbour and Oriental Bay. The layout of Evans Bay can also be appreciated.

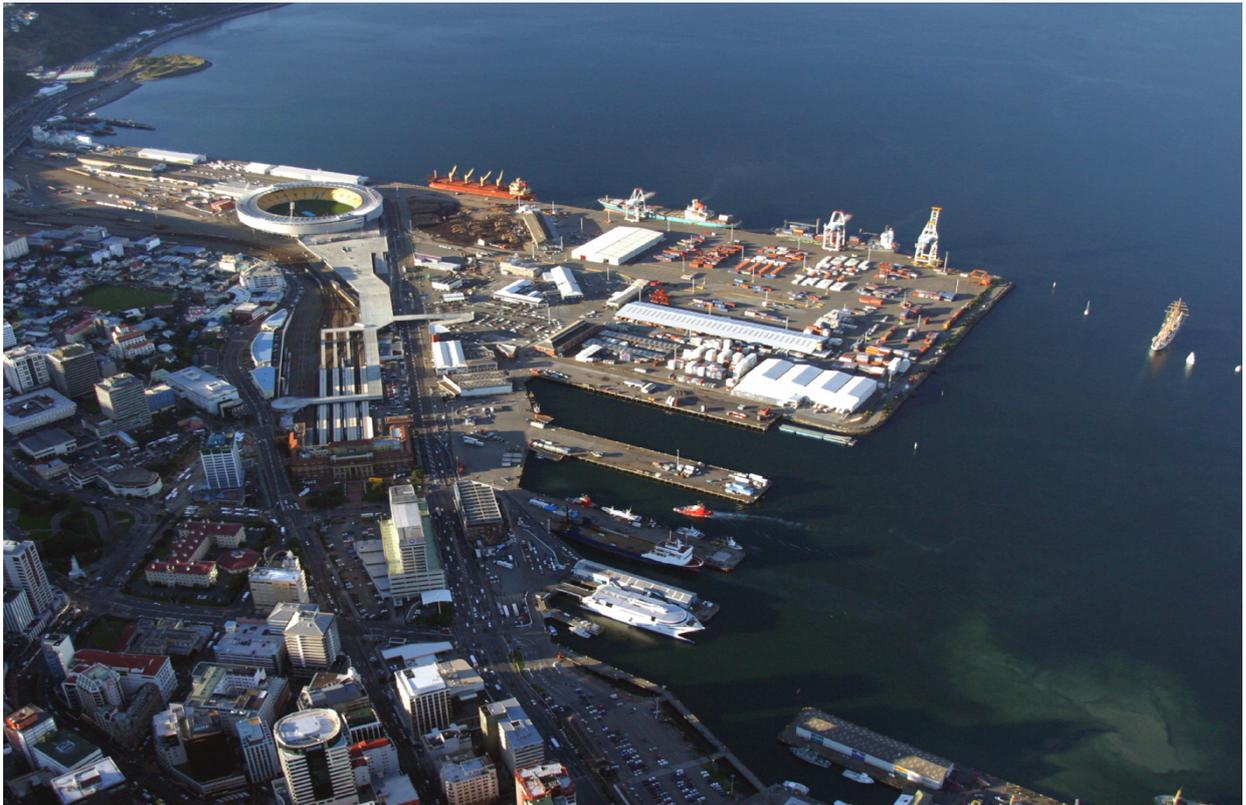
Figure 2 - General Layout of berths. The Ferry finger berths are shown at the bottom mid, with dedicated berths operated by Interisland Line shown in the top left corner of the picture. The layout of Thorndon Container terminal can also be appreciated.

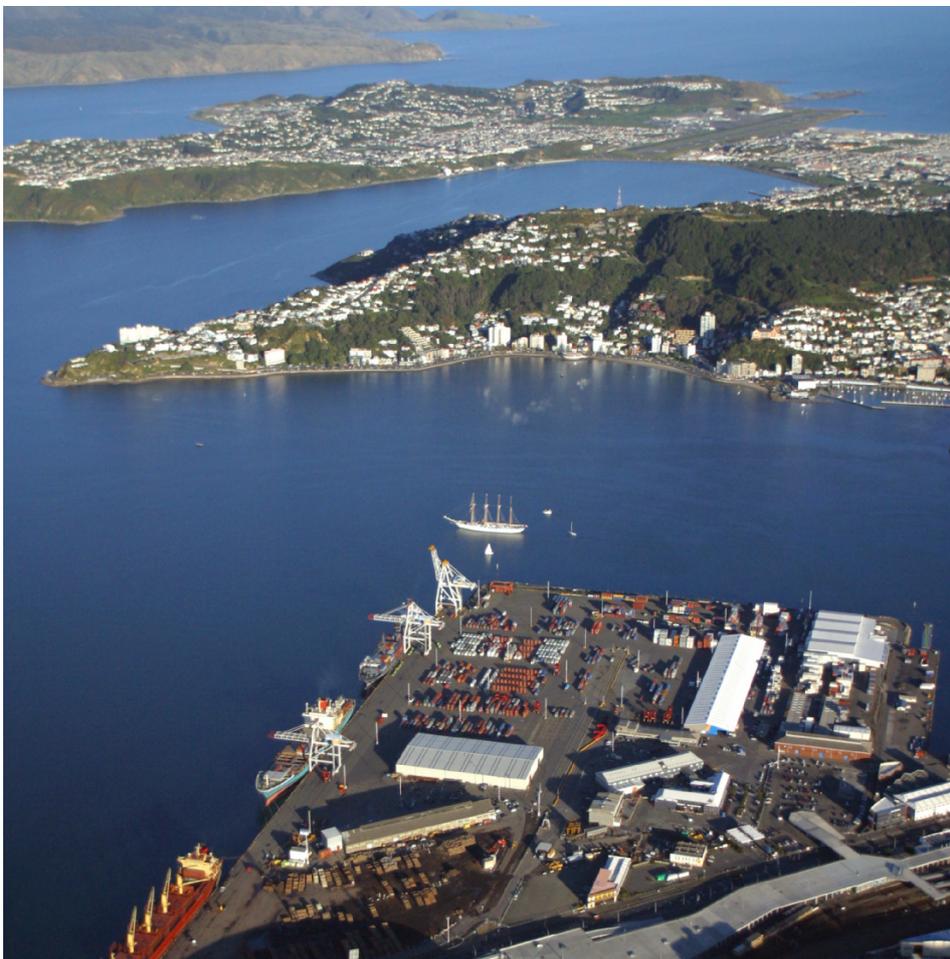
Figure 3 – View of Harbour looking towards Oriental Bay, with Lambton Harbour mid right. Evans Bay (Tanker Terminal) and the Harbour Entrance.

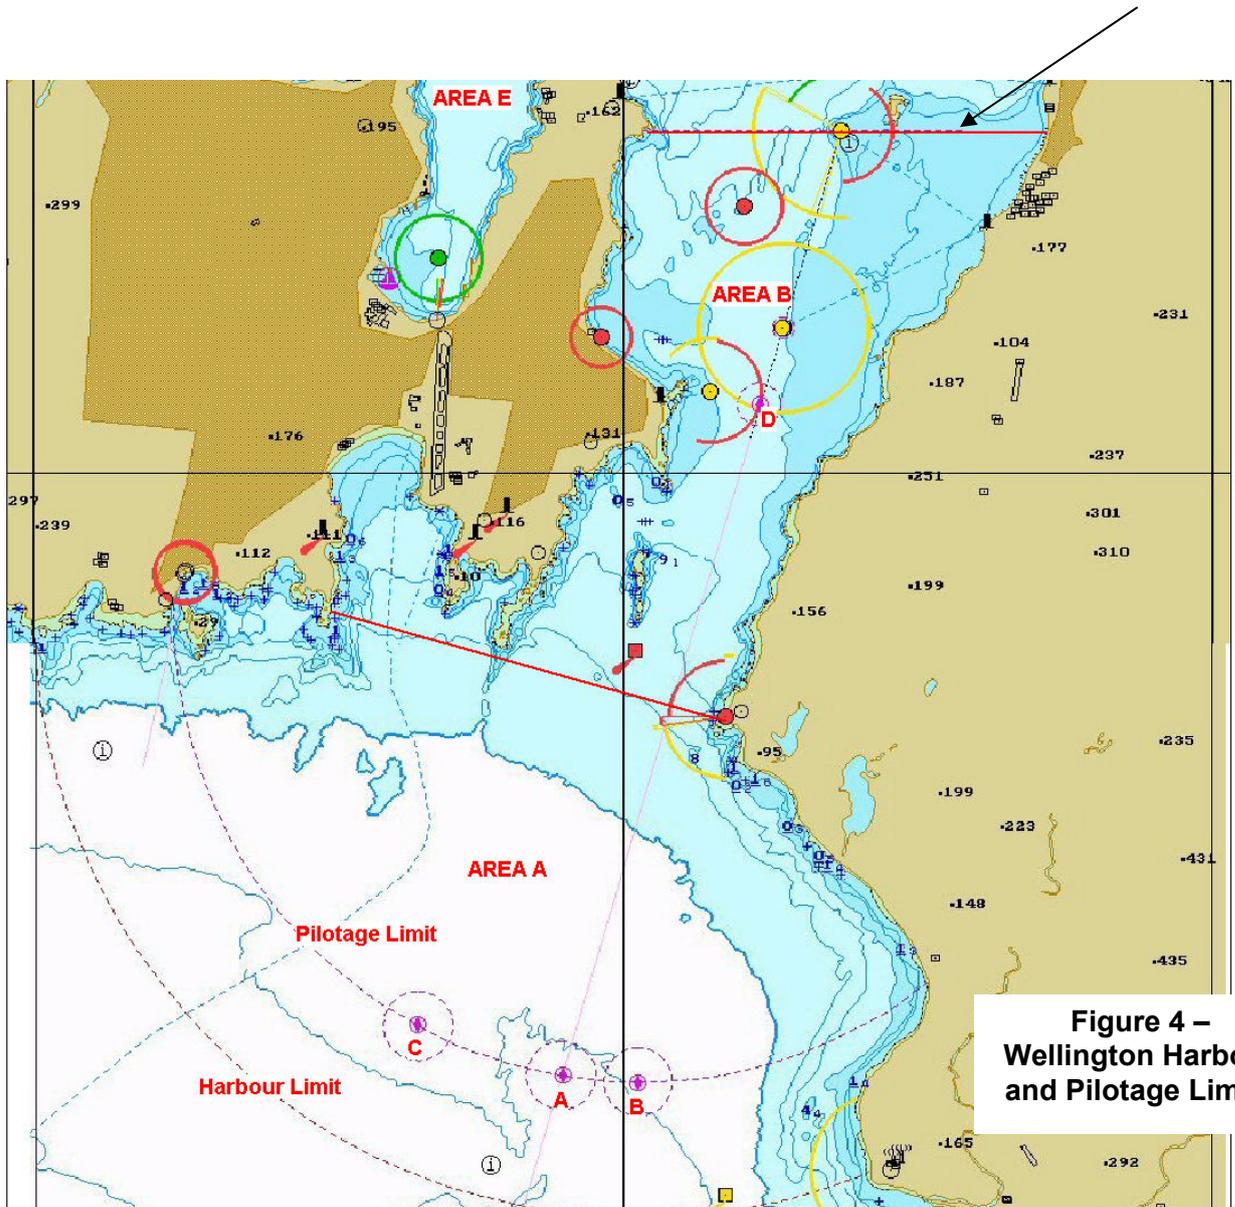
Figure 4 –
Wellington Harbour
and Pilotage Limits

The Wellington Harbour Limits are shown in **Figure 4**, which remain as originally gazetted. The limit is an arc extending 3.85 nautical miles from Outer Rock – this line still being a reference point for commencement of vessel charters (which is common worldwide). The Regional Council Bylaw Jurisdiction is in approximately the same location, extending to three miles from the waters edge from the Otaki River round to Cape Palliser. It is the Bylaw Jurisdiction that empowers regulation within harbour limits (with pilotage being regulated by Maritime Rule 90), this jurisdiction being entered as a vessel crosses the arc of Pilotage Jurisdiction.

The outer limit of the present Pilotage Jurisdiction is an arc of 3NM radius centred on Outer Rock. Three designated boarding areas, A, B, C are located on this arc, each of which is relevant for boarding in different sea or weather conditions. However, the outer limit of jurisdiction is not the commencement of compulsory pilotage; this commences at a line running from Point Gordon through the Rear Lead to the eastern shore (depicted on **Figure 4**). Vessels over 500 tonnes, unless a valid pilot exemption certificate is held by the master, must proceed under the advice of a pilot northward of this line.

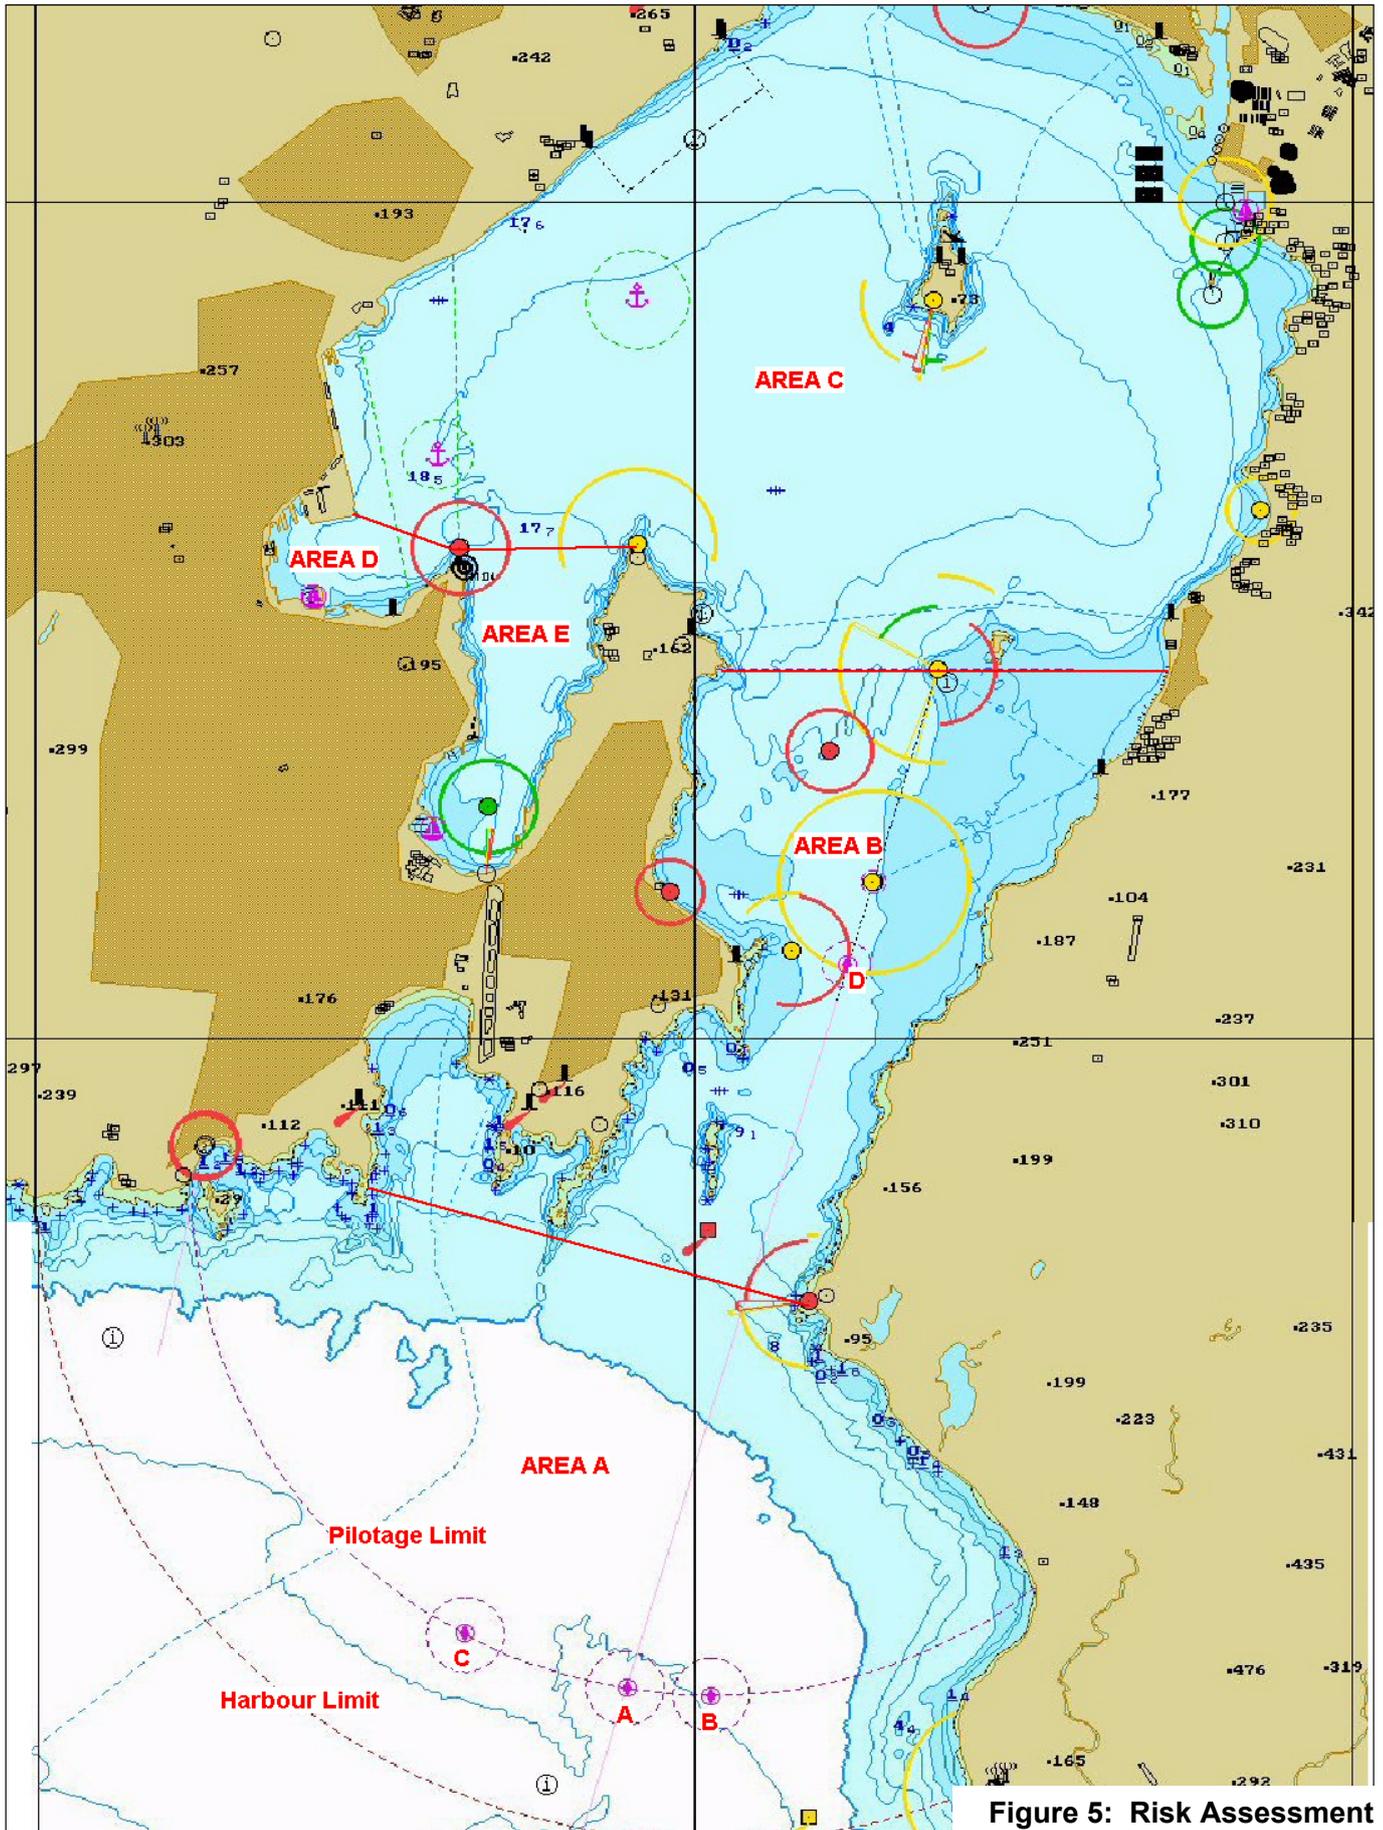
The risk Assessment Areas are shown in **Figure 5**, below. Five areas were derived for Wellington. In summary, Area A represents the Harbour approaches and outer boarding areas. Area B represents the entrance channel; Area C represents the Waters of the Main Harbour; Area D represents Lambton Harbour and Area E represents Evans Bay.

Figure 5: Risk Assessment Areas for Wellington

A description of each area follows **Figure 5**.

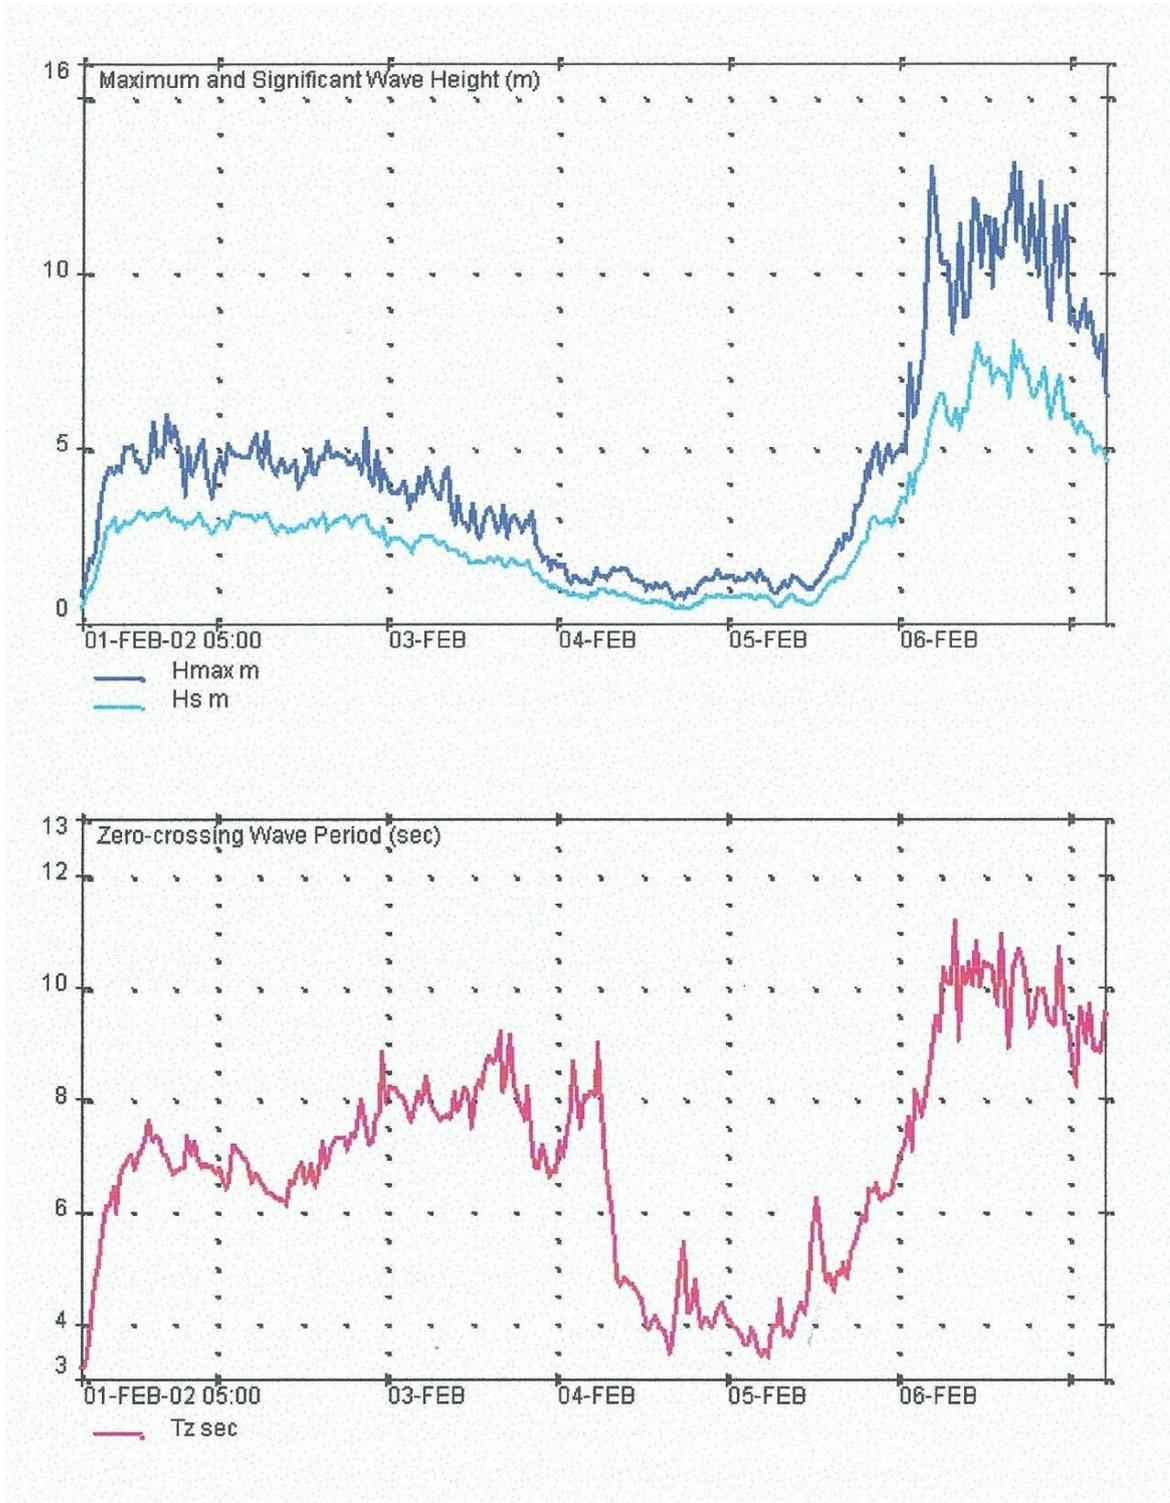
Depth of water is in excess of 30 metres is until approximately one mile south of the entrance. At this point the sea floor shelves relatively steeply to between 14 and 16 metres at the harbour entrance. Swell from the southerly quarter tends to become attenuated as it approaches the entrance with decrease of wavelength and increase in steepness as the coast is approached. The height and period of swell can change significantly in a short time as can be appreciated from **Figure 6**.

Figure 6: Wave data record taken from a wave rider buoy at Baring Head, showing the rapid change of wave height and period does occur off the Harbour Entrance.

Southerly winds blow over a greater fetch and are capable of generating large waves, to which a swell may also be added, with the net result of very high seas. A wave rider buoy is located off Baring Head which has provided wave data for a number of years and has recorded waves in excess of 14 metres during southerly quarter gales (note again **Figure 6**). There have been recorded instances where low powered and light draught cargo vessels have struggled for hours to make headway; some have been blown about or have elected to return to the shelter of the harbour. A vessel returning in such circumstances is likely to retain little ability to control its entrance transit.

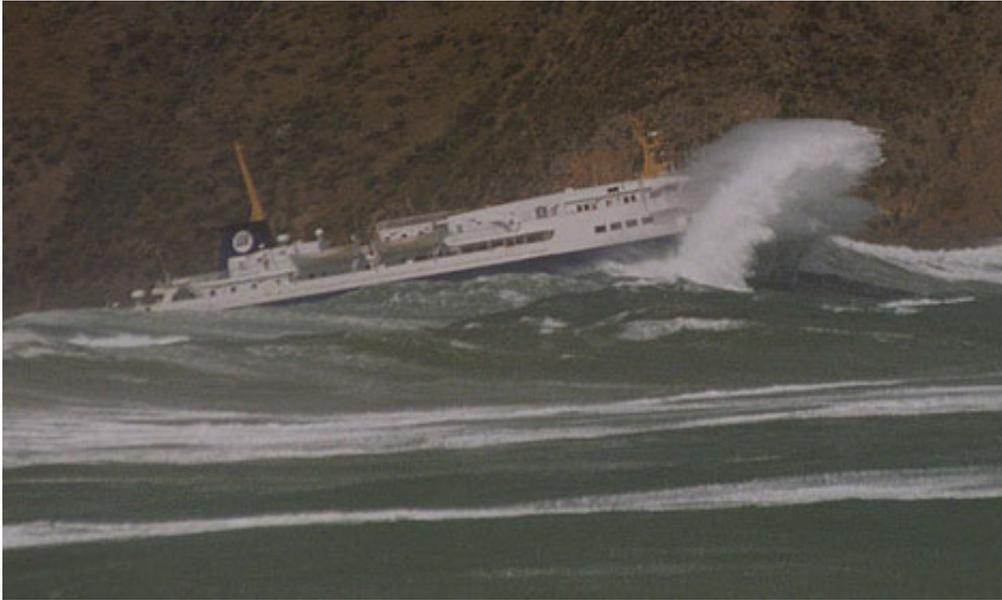
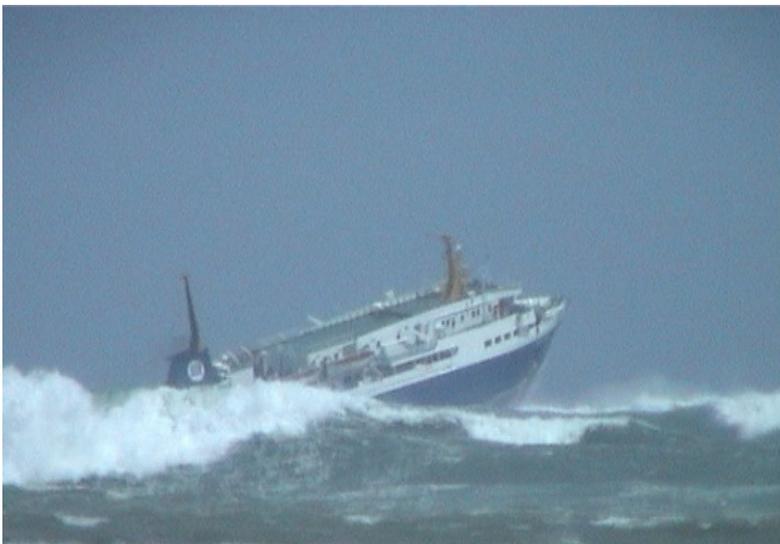
Ferries transiting the entrance in severe southerly gales can experience severe pitching. Photographs (**Figures 7& 8**) showing an 84m Cook Strait ferry transiting the entrance on Waitangi Day, 2002, in waves reported at around 14 metres, illustrates the difficulties of the entrance.

**Figures 7& 8:
Cook Strait Ferry
Transiting the
entrance in seas
reported to be about
14m.**

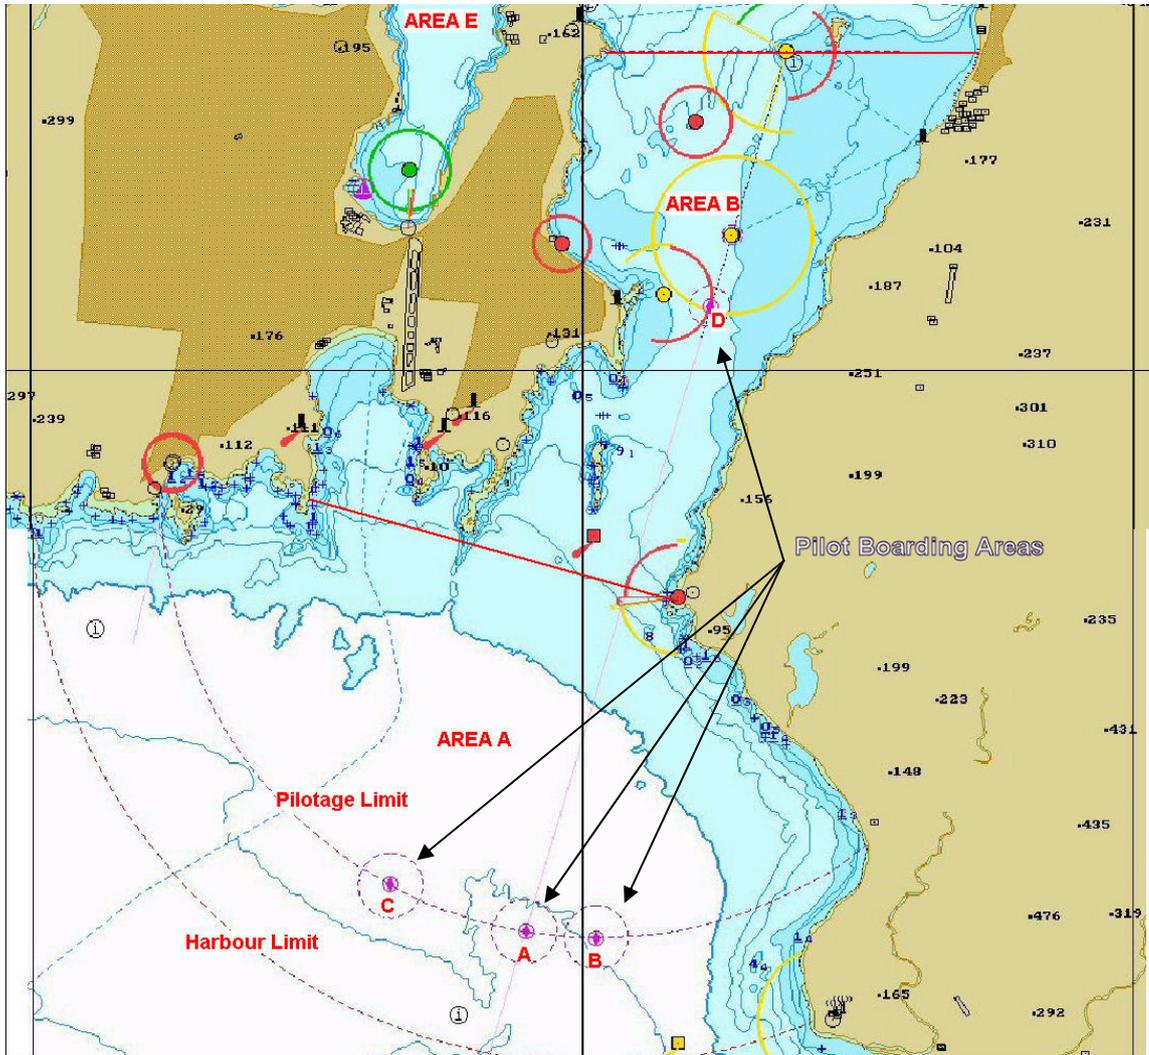
Four Pilot Boarding Areas are designated within the Wellington Pilotage District and located both within and outside the harbour entrance (shown on **Figure 9**). Areas 'Alpha', Bravo' and 'Charlie' are outer areas, located at the seaward extremity of the Pilotage Limit and approximately 3 miles south of the entrance. These are placed on and to either side of the line of the leads

(Alpha is on the line of the leads)¹³. An inner boarding area, 'Delta', is located in the entrance channel approximately 0.5 mile south of the front Lead.

Figure 9: Pilotage Jurisdiction and Boarding Areas

The outer limit of the Wellington Pilotage District is marked on NZ4633 as an arc centred on Outer Rock of three miles radius and is therefore 0.85 miles inside Wellington Harbour Limits. Thus the Pilotage District is approximate only with the Regional Council Harbour Bylaw area of jurisdiction, pilotage being the jurisdiction of Maritime New Zealand. However, as introduced in section 4.1, the limit of compulsory pilotage is inside the entrance¹² and the outer limit of pilotage jurisdiction in reality provides only guidance for boarding. This is taken further to a recommended solution in section 13.5. **Figure 9**, below, repeats the limits of pilotage jurisdiction and shows the four designated boarding areas, all outside the compulsory area.

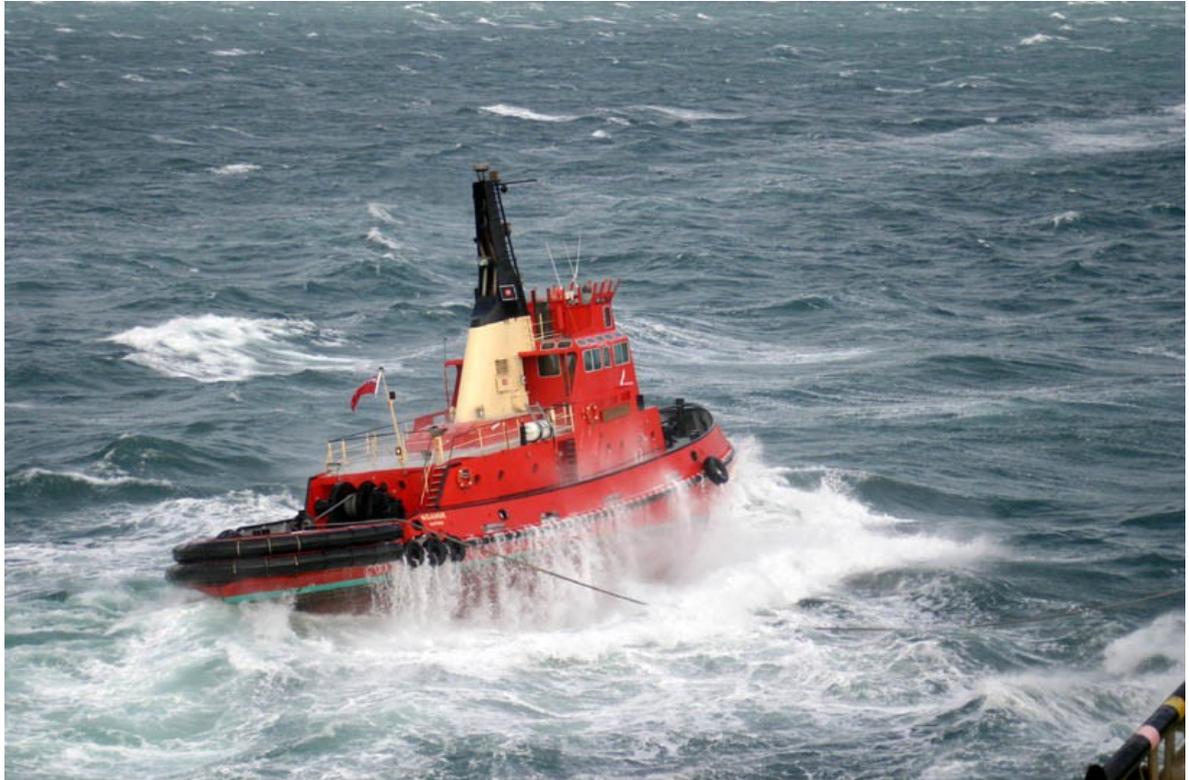
Figure 10: One of Wellington’s Tugs Deployed in Windy Conditions

Wellington’s tugs were prudent purchases by the Harbour Board and state of the art at the time, but 35 years ago vessels were also a lot smaller than today and had greater power to weight ratios of their own. They were built to handle generation one container vessels, at that time the largest vessels using the port. These vessels had a gross tonnage (GT) of about 25,000 tons. The port now accepts vessels up to 115,000 GT²² and laden tankers of 55,000 tonnes displacement. Authors are always cautious about tug recommendations as berthing larger vessels with lower powered tugs is often a case of no more than extended manoeuvring times, but given the rapidly changing weather conditions at Wellington, it is difficult to conclude that the present fleet is adequate for the tonnage using the port²³. Wellington has the lowest per-unit bollard pull in any New Zealand port handling large tonnage as well as the oldest tugs in regular service. To be fair, two tugs can

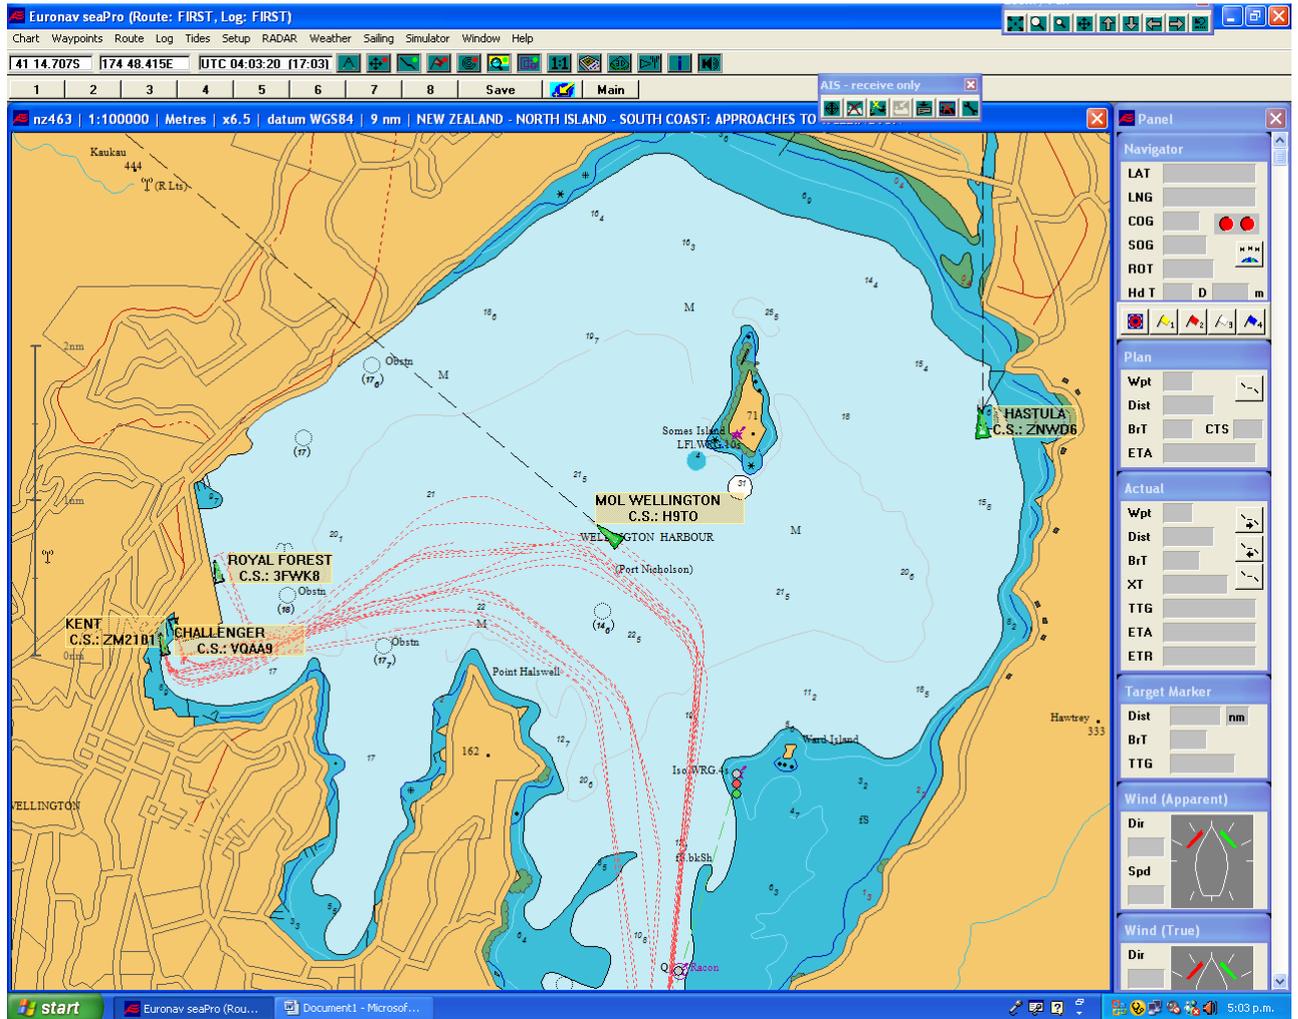
Beacon Hill is ready for an upgrade, (see also 11.1.2) both of equipment and staff training. AIS based systems overlaid on electronic charts have brought the entry level cost for a vessel traffic service down significantly. When overlaid with radar data, management of marine traffic can be very effective. However to achieve this, radar coverage of the inner harbour needs to be installed and AIS data integrated into the operator displays. This should be supplemented with CCTV camera technology. **Figure 11** shows how clear information can be once sources of information are integrated into a chart overlay. Speed, position and rate of turn information is readily accessible. Many vessel tracks can also be analysed statistically, providing powerful risk based information to the Harbour Planning system.

Figure 11 – Electronic Chart Record of Tracks of Large Vessels from AIS Recorded by Marico Marine (half day data).

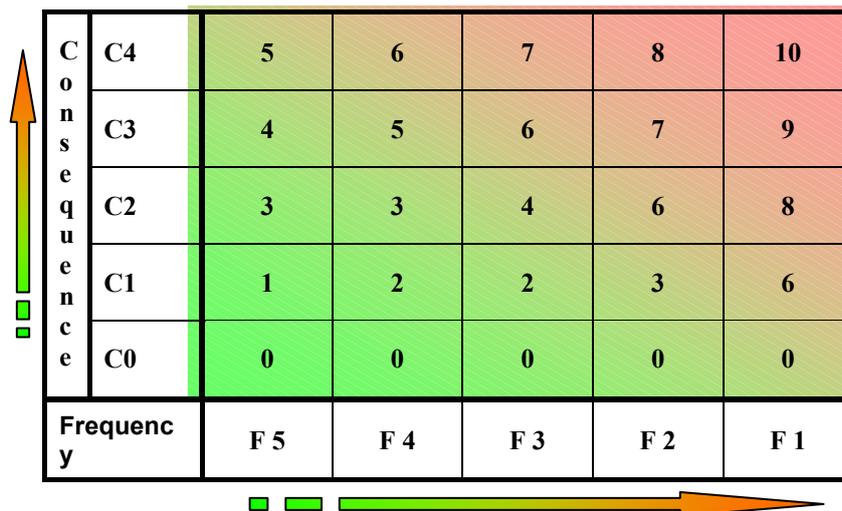
Risk Matrix Used to Score This Risk Assessment

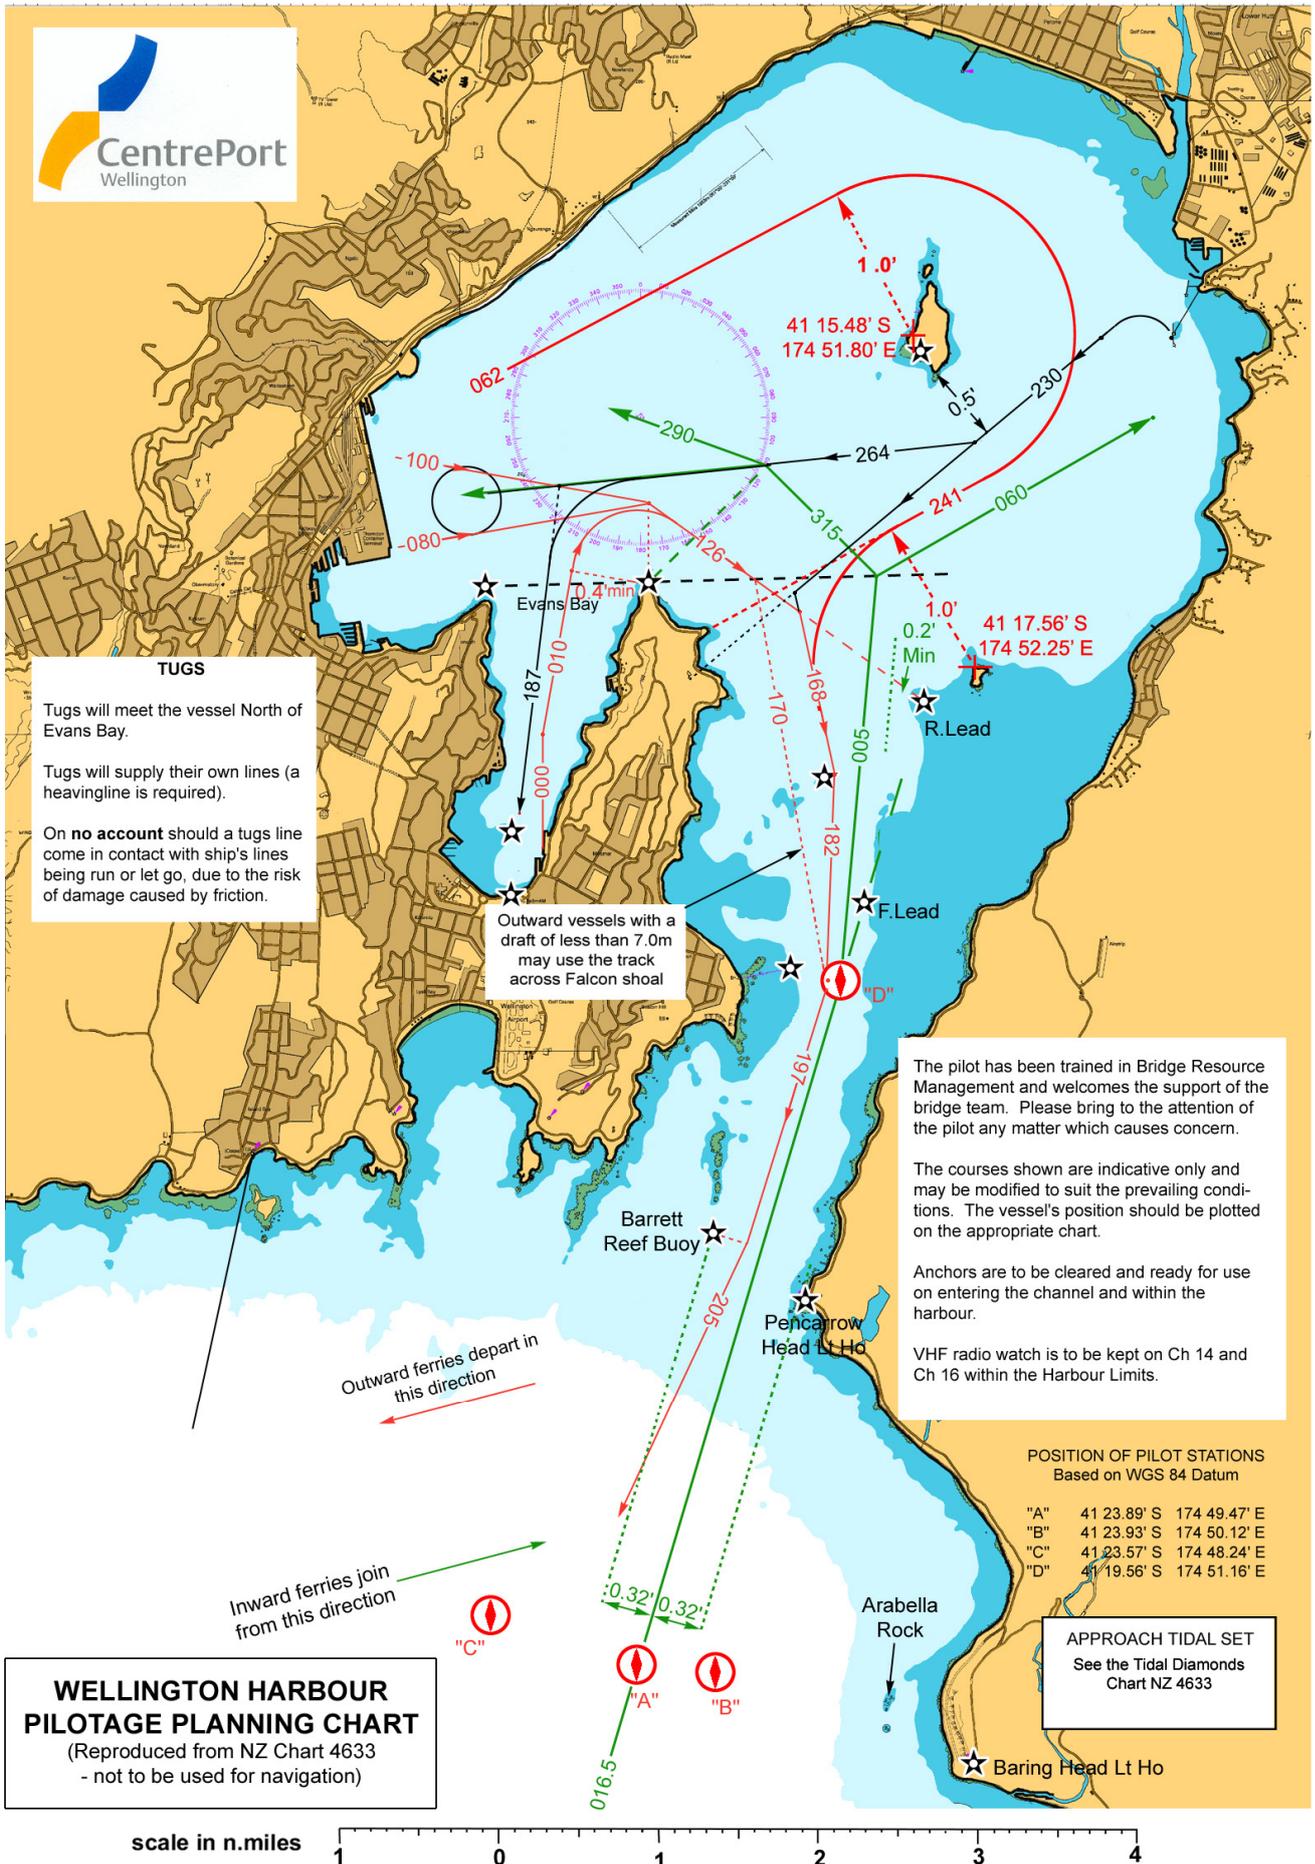
ANNEX C
PASSAGE PLANNING CHARTLET
FOR WELLINGTON

FIGURE B1 – PILOTAGE PLAN AND RECOMMENDED TRACKS FOR WELLINGTON HARBOUR
