# GREATER WELLINGTON REGIONAL COUNCIL

## WELLINGTON HARBOUR NAVIGATIONAL RISK ASSESSMENT

Report Number: 15N2328  
Issue: 03  
Date: 14 March 2018

**Author(s):** Ryan Hughes; John Riding; Dr Ed Ballard

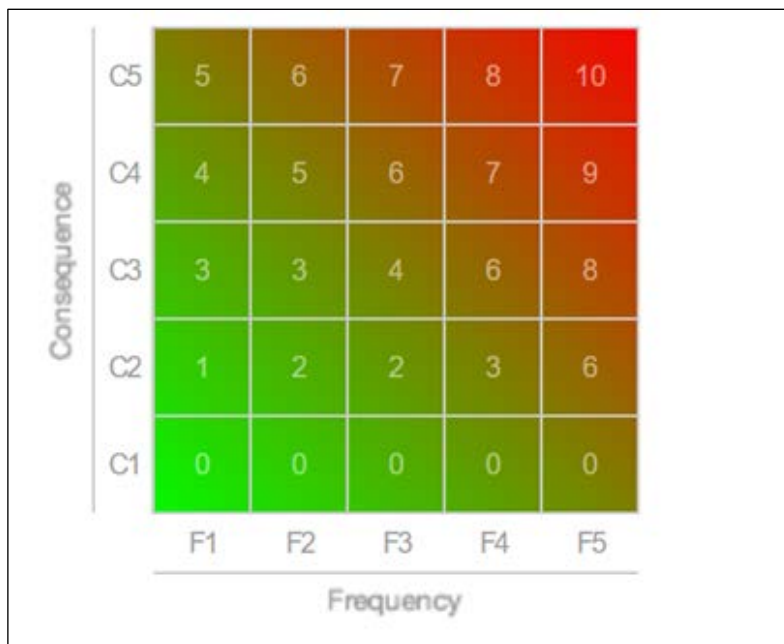
**Figure 5: Risk Matrix Used for Wellington Harbour**

The Wellington Safety Management System uses the risk matrix design as shown in **Figure 5**. Using this risk matrix, which is set up within the Hazman II software, each hazard was scored on a scale of 1 to 10 for each of the four consequence categories within the NZ Risk Assessment Guidelines (i.e. impacts on: People; Property; Environment; Stakeholders).

C5	5	6	7	8	10
C4	4	5	6	7	9
C3	3	3	4	6	8
C2	1	2	2	3	6
C1	0	0	0	0	0
	F1	F2	F3	F4	F5

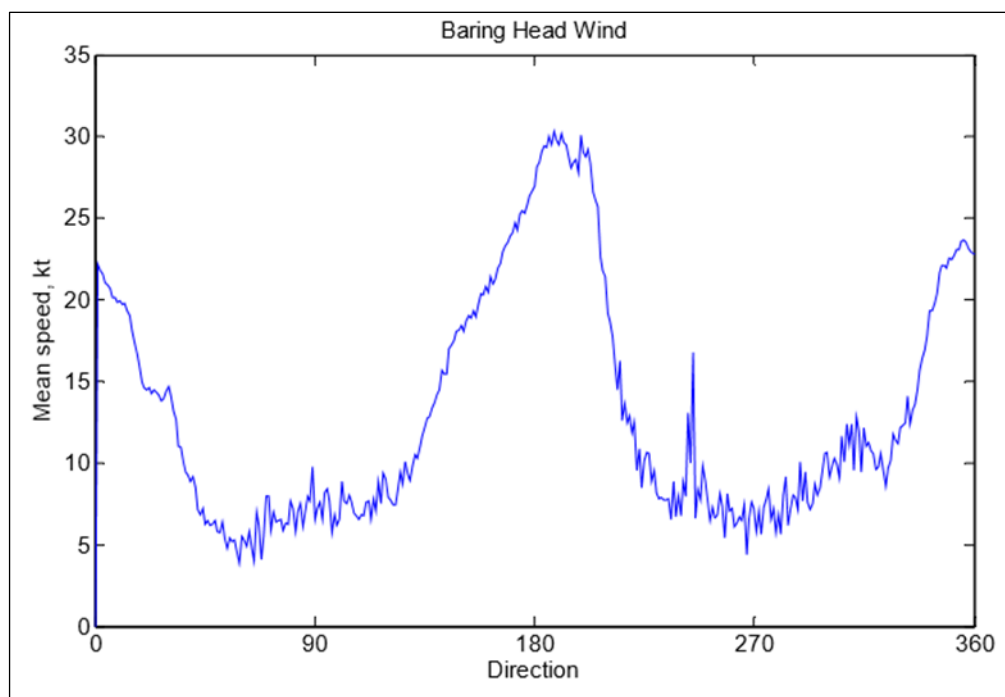
**Figure 8: Mean Wind Speed as a Function of Wind Direction - Baring Head**

There appears to be contradictory evidence as to which weather direction is the dominate in Wellington. It will not be news to Wellingtonians to find that Northerlies and Southerlies regularly occur. Most data sets suggest the southerly is prevalent at Wellington. For this risk study, Niwa data at Bearing Head has been referenced, which suggests Northerlies are more frequent at that location, with a mean speed of up to 30 knots. Southerlies produce the highest windspeed as fronts pass through. **Figure 8** illustrates this report, using windspeed and direction data from the period from 1998 to 2015. Overall, the fact that there is contradictory data, shows the unpredictability of Wellington entrance and the changeability of weather in the harbour approaches for transiting vessels. According to a wave analysis report for Wellington Harbour approaches<sup>15</sup>, the maximum recorded wind speed in this timescale has been 77 knots (sustained) in storm conditions.

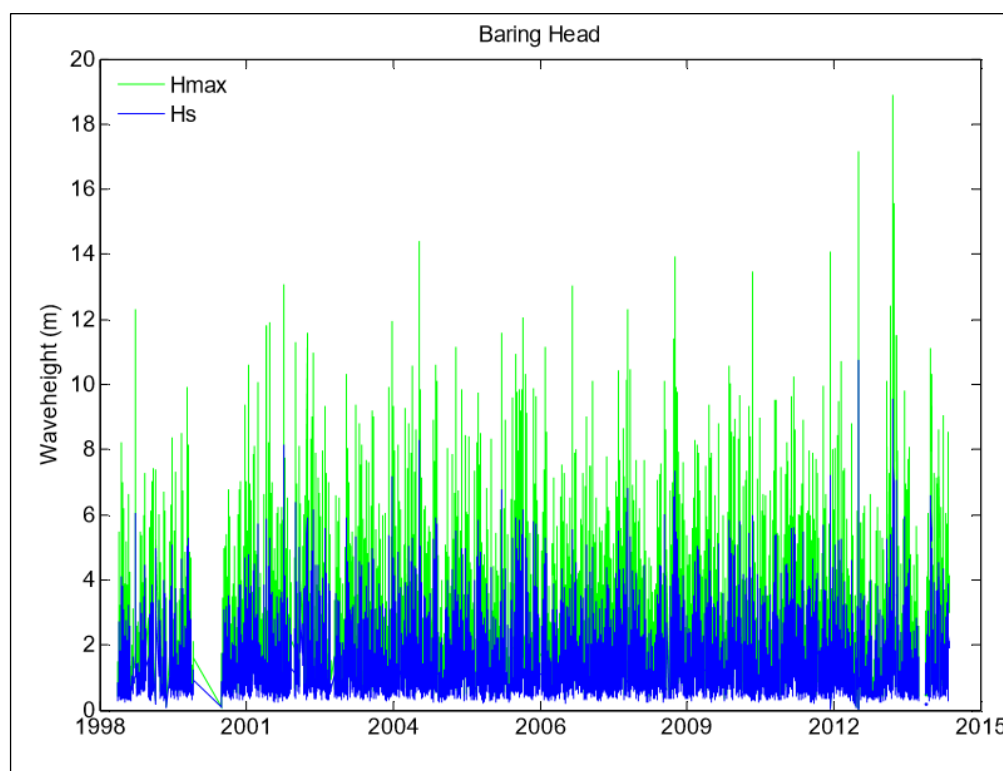
Figure 9: Baring Head Waverider - 1999 to July 2014, Significant & Max Waveheight

Generally, winds from the South result in a heavy sea and swell, which during gales sometimes break across the entrance. **Figure 9** shows wave height readings ranged from 1998 to 2015 (again Bearing Head). The wave conditions are not always favourable and can be extreme for a short time. This

extreme accounts for 1% of the time where a significant wave height ( $H_s$ ) exceeds 4.5m. In some cases (rare), individual waves exceed 10m in height, have a very short period but last for only a short space of time. The buoy though has recorded waves in excess of 14 metres during southerly quarter gales. The Waverider records individual waves ( $H_{max}$ ) as a single statistical point from a spectrum over 30 minutes.

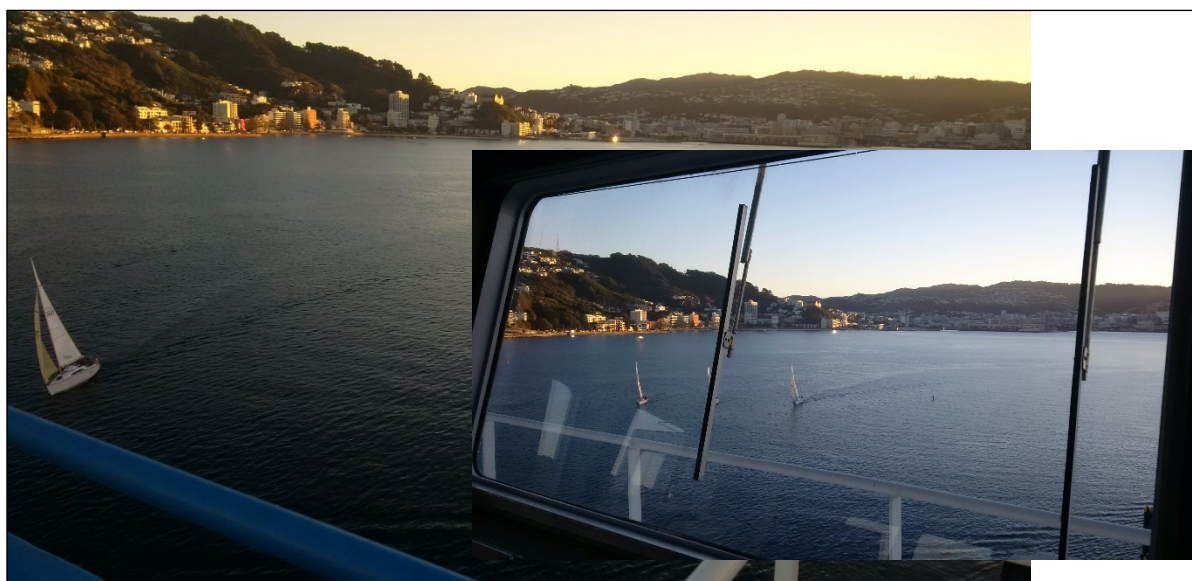
**Figure 13: Sailing Activity in Lambton Harbour (Cruisers)**

Occasionally, large vessels experience conflicts with recreational craft in the berthing approach at Aotea Quay. There can also be similar "close quarter" events with all manner of small craft in Lambton Harbour; **Figure 13** shows such an occasion (container vessel).

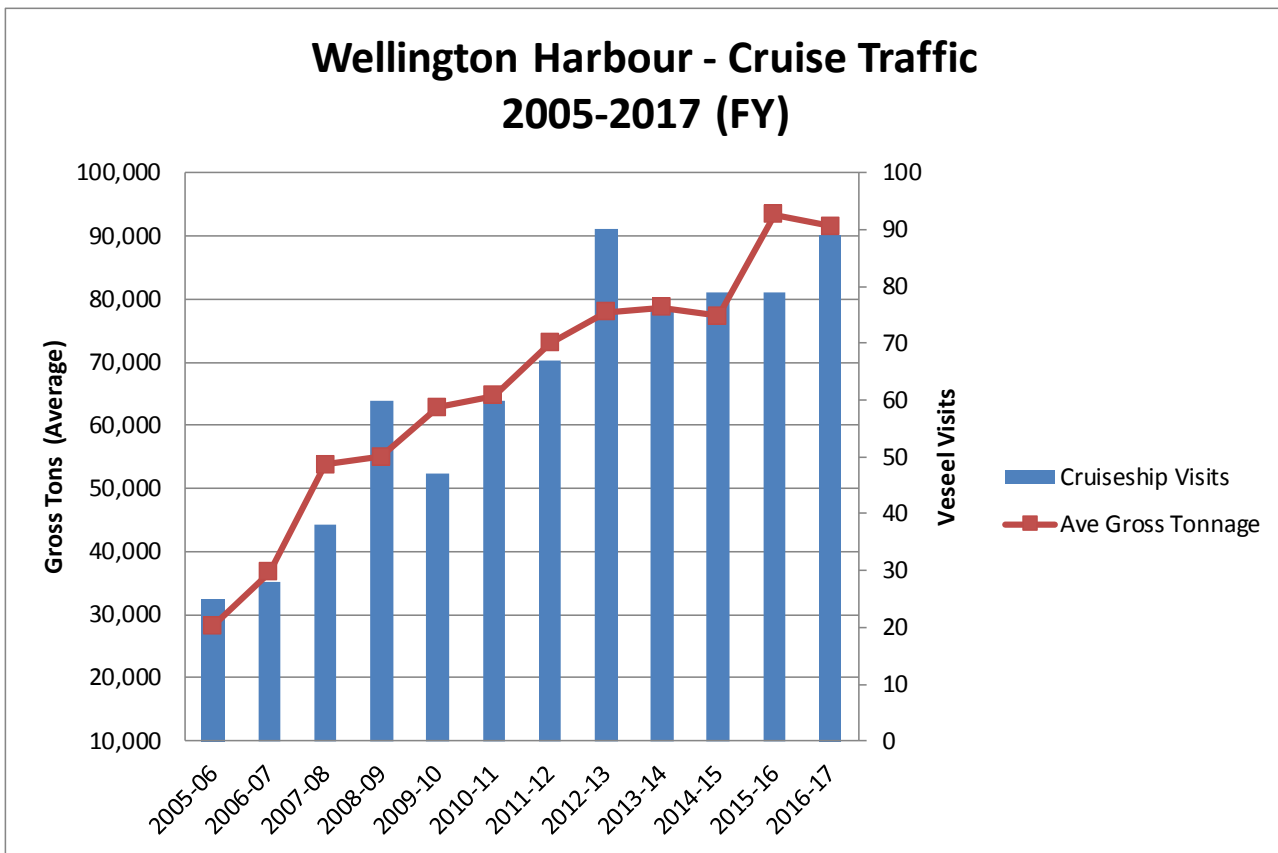
**Figure 21: Cruise Vessel Percentage Change of Cruise Vessels Relative to 2005**

**Figure 21** shows the increase in cruise vessel visits over the time period since the last risk assessment. This uses average Gross Tons as an indicator of the change in vessel size. It should be noted that vessel length, which is relevant to rate of swing for piloting and manoeuvring, has also dramatically increased. Cruise vessels are though more manoeuvrable than was the case in 2005-6 as azimuth thrusters have been developed, which

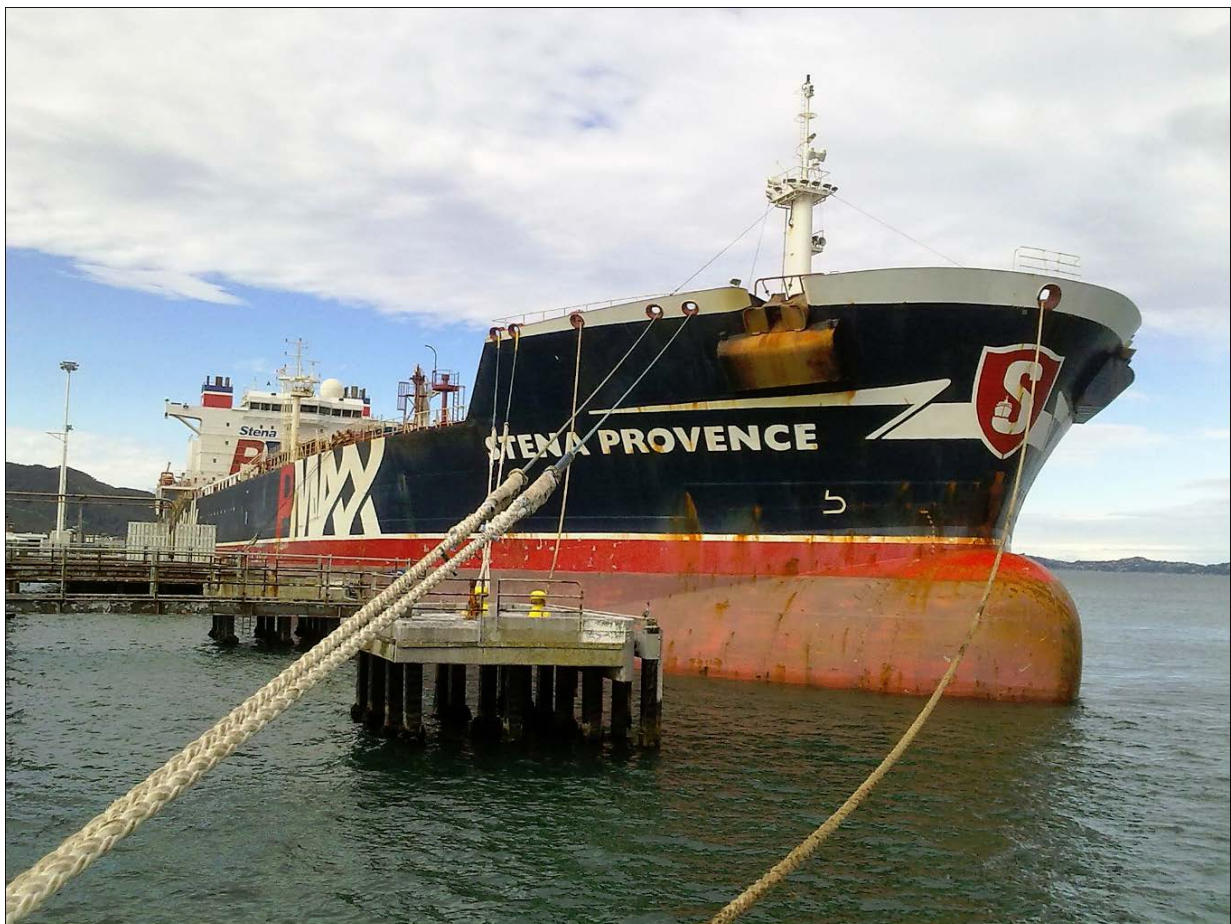
**Figure 25 : Tanker Alongside Seaview Terminal – 36,168 GT 183m Length, 40m Beam**

There are three locations within the harbour which can work tanker cargoes, Burnham Wharf (Evans Bay), Aotea Quay, and Seaview Terminal. The terminal at Aotea Quay handles diesel and light fuel oil; Evans Bay for avgas and the Seaview terminal handles petrol, diesel, and any chemicals – **Figure 25** shows a tanker alongside Seaview. Tankers, like other large vessels, are required to follow the recommended routes through the harbour, published on nautical charts, with their use proscribed by Wellington Regional Council navigation bylaws. The recommended routes are publicly available and found in both in the navigational bylaws and can be downloaded from the CentrePort Website<sup>31</sup>. The track plot from ships AIS transmissions shows that tankers do, on the whole, follow these to their respective terminals. Tankers using Wellington are mostly small in comparison with tankers trading

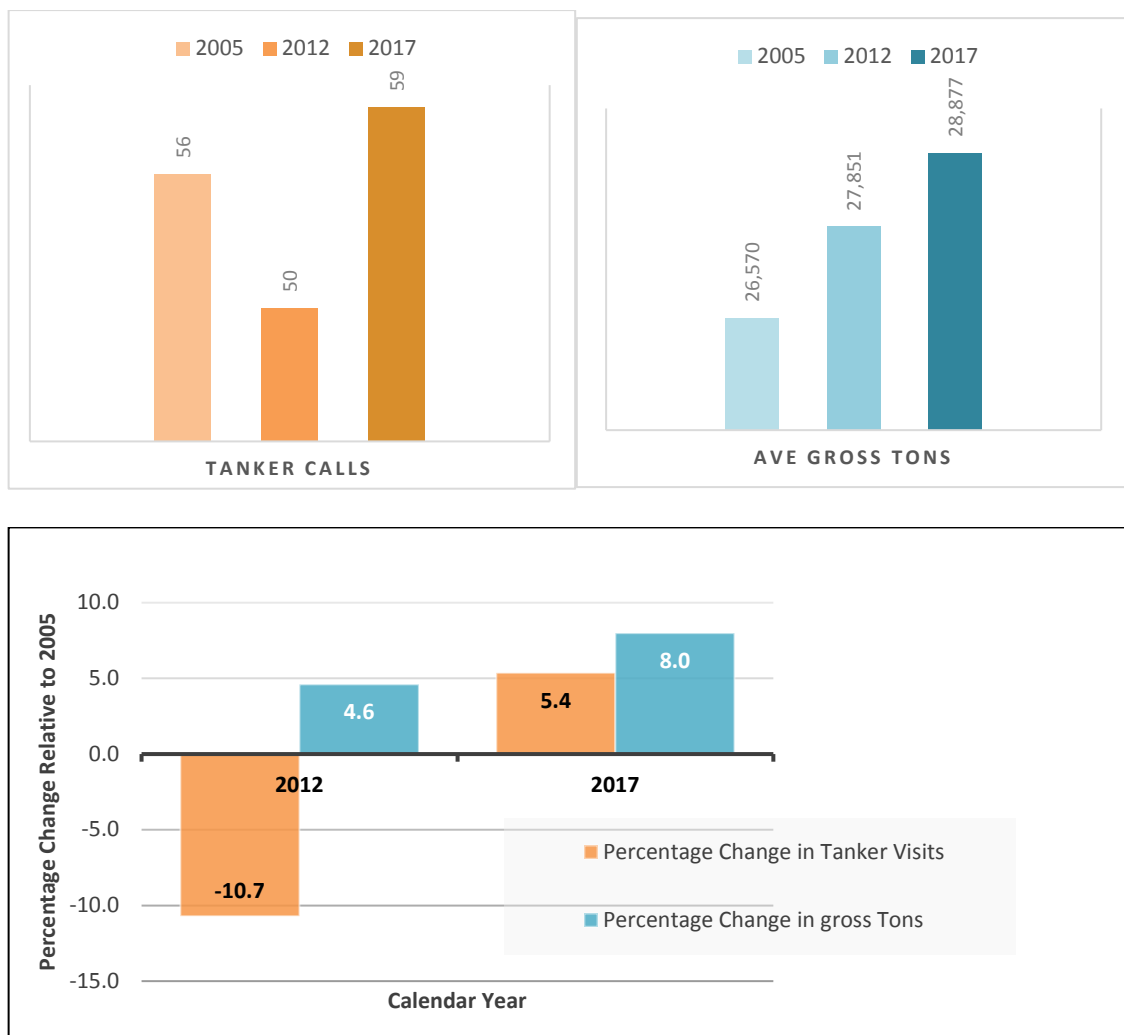
Figure 26: Changes in Tanker Traffic 2012 and 2017 Relative to 2005

Tanker movement analysis has also used 2005 as the baseline, with sample years of 2012 and 2017 being analysed. **Figure 26** shows this in 3 separate images, with number of tanker calls and average Gross Tons, with percentage changes below. Tanker visits have varied with a fall during 2012, but by 2017, there is a marginal growth overall in the number of tanker visits of 5.4%. However, the size of tankers visiting (Gross Tons) has increased almost year on year, with an average increase of 2000 gross tons between 2005 and 2017. Although this is a marginal increase of 5.4%, reflecting international trends, there examples of larger vessels, such as *Stena Provence* at 36,168GT. It is clear that both visit numbers and the size of cargo parcels delivered have increased.

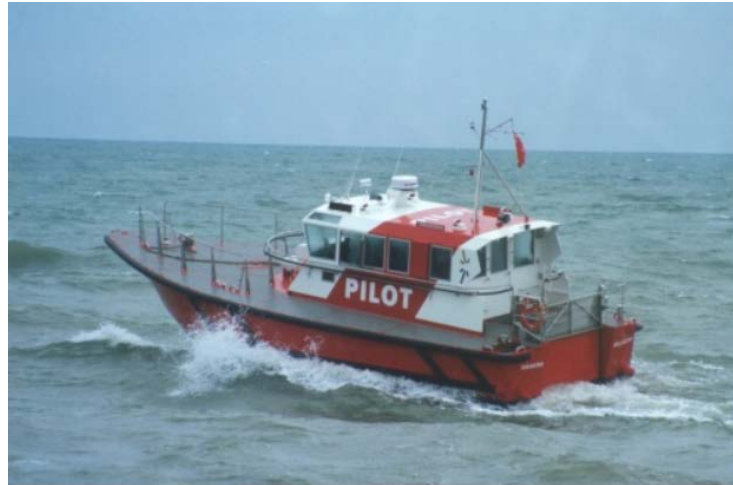
**Figure 40 :Wellington Pilot Boat, Tarakena.**

A significant damage incident when *Tarakena* was alongside occurred in 2011, placing this main pilot launch in a unexpectedly long period of repair. The port company subsequently used a RHIB<sup>37</sup> as a back-up pilot launch, which they share with a local charity, where it has a potentially useful role in marine search and rescue.

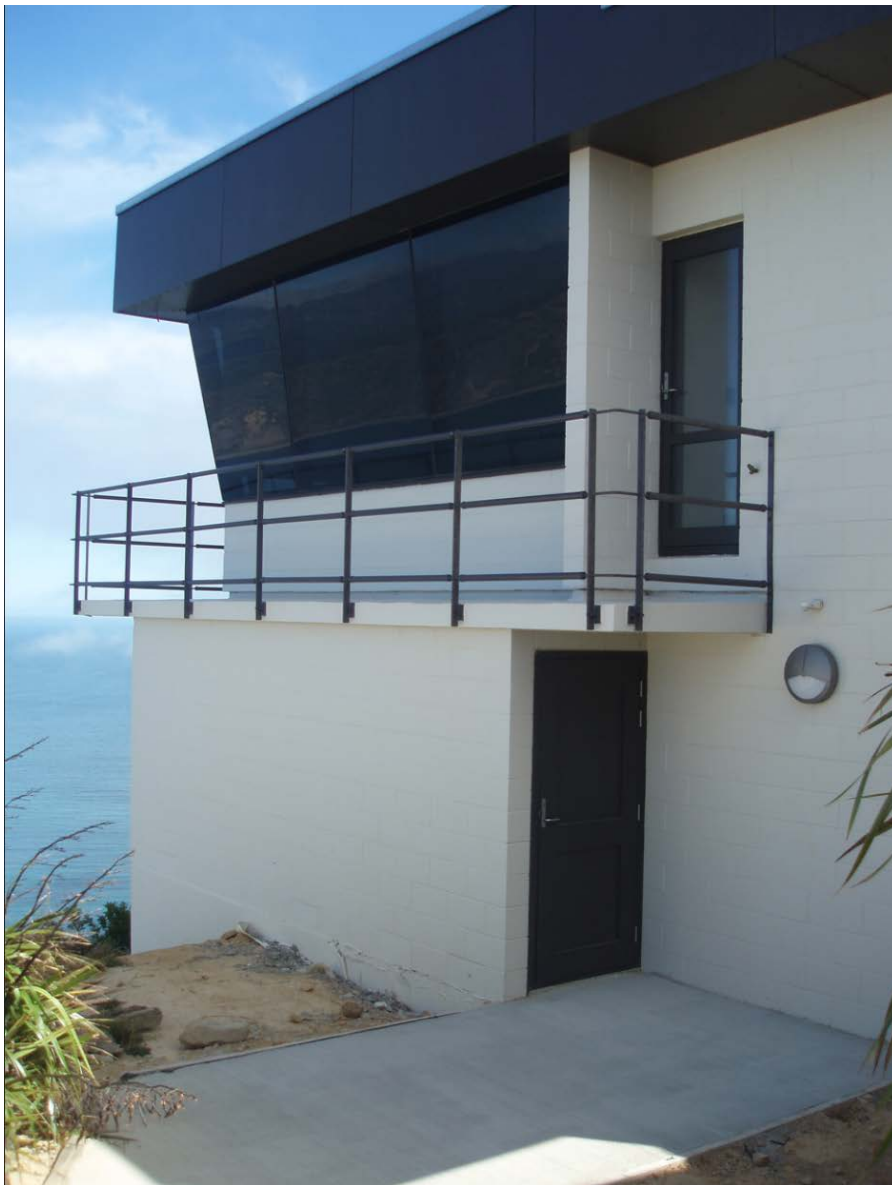
**Figure 42 :**  
**Beacon Hill Signal**  
**Station**

The 2006 risk assessment recognised the importance to Wellington Harbour of Beacon Hill, given harbour topography and large volume of PEC passenger RoRo vessels that represent the Cook Strait passenger services. Recommendations were made to upgrade the systems and services at the Beacon Hill traffic monitoring station, such that it could take a role in providing a modern traffic interface to the then developing VTS standard<sup>40</sup>. Council not only subsequently invested in both hardware and ship tracking software, by 2010 a whole new Beacon Hill operating station was designed and built, with an upgrade of all hardware and software facilities. This included the installation of a new radar, monitoring the approaches and entrance channel, AIS data reception and upgrading of the weather information system. The existing radar equipment was replaced with a

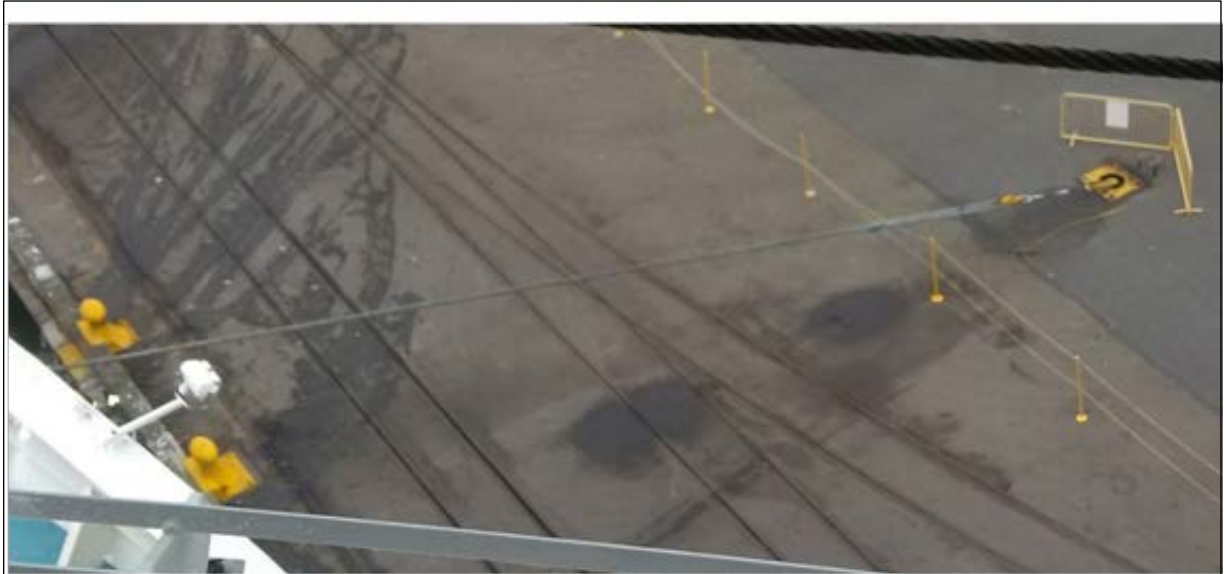
**Figure 45: Aotea Quay Improvements to Mooring Systems - Cruise vessels**

In recent years, a mooring breakout has occurred at Aotea Quay, involving a vehicle carrier with high hull area (windage). The mooring system has also undergone an important upgrade to accommodate the rise in cruise vessel visits and sizes. Cruise vessels provide large slab side and surface areas. Balconies also act as sails, especially when vessels are swinging<sup>51</sup>. The loads created by wind can be hundreds of tonnes (which changes with the angle of incidence to the wind). With a rising number of cruise vessel visits and a rapid increase in size, additional sunken mooring points, inboard from the quay face, were installed at the cruise vessel berths along Aotea Quay (see **Figure 44**), providing increased capability to withstand the high loads possible when large cruise vessels are berthed. The arrangement provides purchase at right angle to the vessel alignment alongside, which traditional mooring systems cannot achieve. Fenders on this wharf have also been renewed. The new bollards and fenders have significantly improved safety for cruise ship berthing and staying alongside. This is

a substantial improvement for this vessel type, but it means that flexibility of use is limited to the location where the new mooring sockets are fitted.

Tankers also berth adjacent to the section of Aotea Quay designated for cruise vessels and the improvements to mooring security also benefit this ship type. Positive feedback about the improvements has been provided by Tanker masters serving on the NZ coastal service.
