Preliminary Design Philosophy Statement

10 November 2021

Thorndon Quay Hutt Road

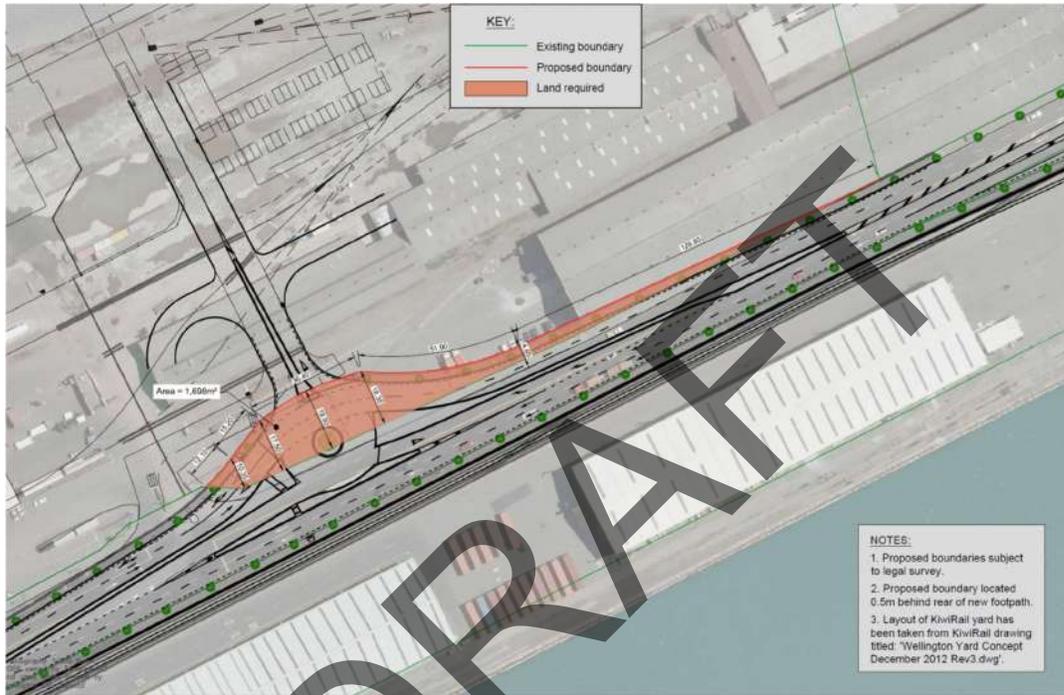
Figure 7: Aotea Quay Roundabout (Spiire Design for Wellington City Council)

A roundabout on Aotea Quay is proposed to provide a turnaround location for vehicles/freight as a result of restricting turning movements on Hutt Road. A design was carried out by (Spiire, circa 2014). This is shown in Figure 7 below. The design was reviewed by the project team for issues

that may impact upon the integration into the preliminary design for TQHR. The following key issues were raised:

- There is no space to provide the footpath on the seaward side of the road / roundabout as the fenceline is hard up to the existing road with rail sidings on the other side
- The 'Seagull' configuration raises safety concerns due to the nature of the vehicles that will be pulling into the fast through lane. HCV's will be exiting the roundabout at low speed and then merging into the fast lane of the through traffic on Aotea Quay. From a safety point of view this manoeuvre is considered problematic due to the differences in road speeds and limited visibility on the blind side of HCV's as they pull out.

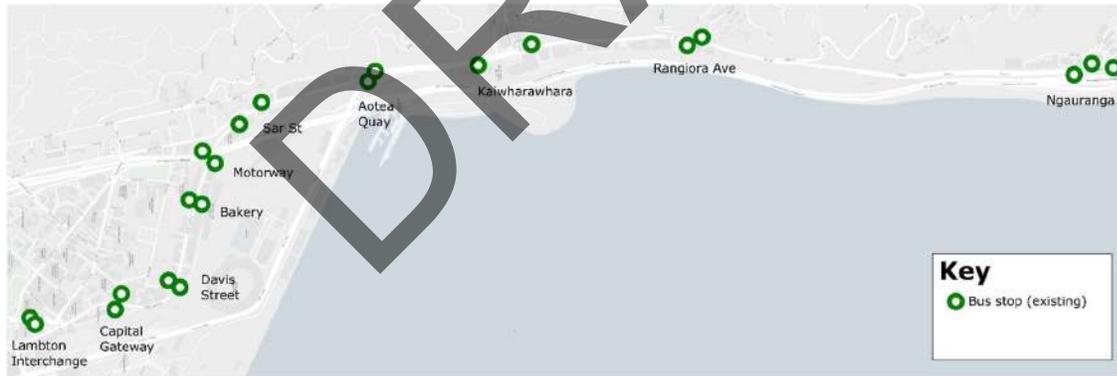
Figure 9: Current Bus Stop Locations

Figures 9 and 10 show the current bus stop locations as well as the indicative new bus stop locations as part of rebalancing proposed in Stage 1. The relocation of bus stops have been explored further with GWRC and the operators and adopted in the preliminary design. One area where the final location may need to be further considered is the stops near Moore Street intersection (Capital Gateway). From an urban design perspective, the driver is to have the stop near to the Marae area. Whereas from a purely spatial perspective (distances between stops) it is located the other side of Moore Street. The final locations will be developed during the detailed design phase.

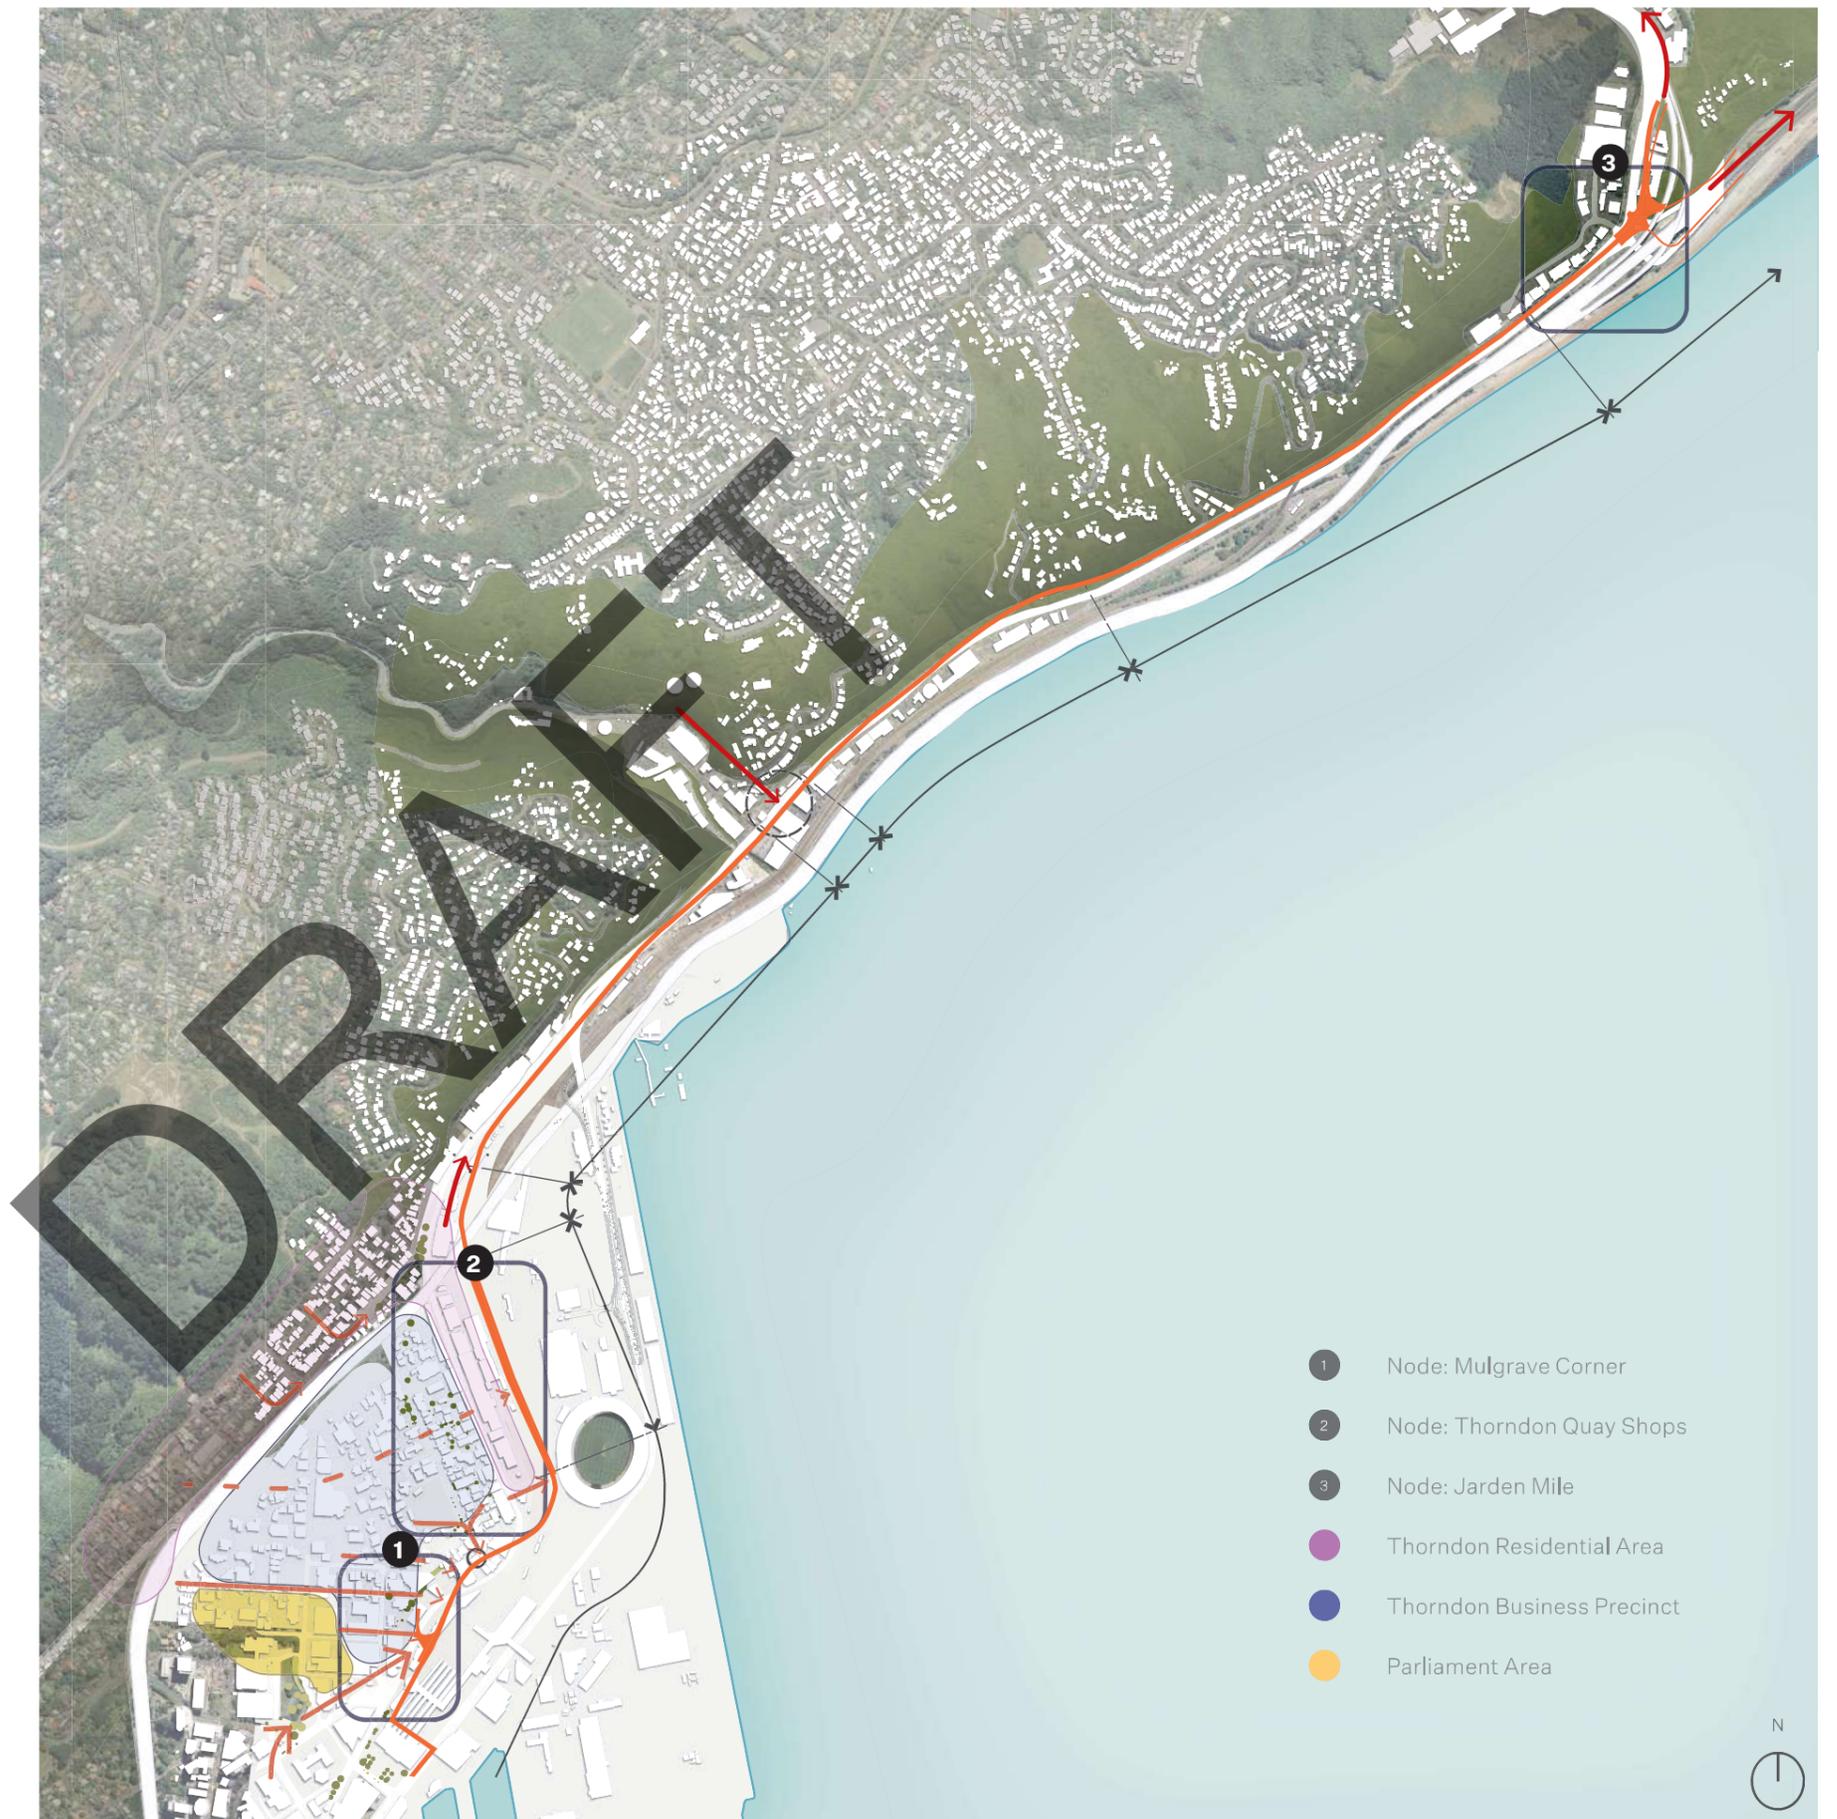
Node 01

The extent of the node expands to include an opportunity to tie together Old St Paul's Church, the Pipitea Marae and their open spaces. The opportunity to create a 'cultural precinct' within this node by strengthening permeability via landscape pathways and open spaces to connect to Mulgrave St, Thorndon Quay and Moore St. The node is looking to the whole extent of the block where we would foresee the redevelopment of the existing Archives building and other properties in the near future turn into mixed use residential. The injection of people and activity will support the adjacent Wellington Girl's College. The node also not only strengthen Thorndon Quay but it enables Mulgrave Street to activate more and be a feeder into Thorndon and later connect back into the second node Thorndon Quay Shops.

- 1 Railway Station: Peak time 8am & 5pm
- 2 VUW Campus/Bus Exchange: Peak time 8am & 5pm
- 3 Stadium Platform: Event on
- 4 Potential pause spot
- 5 Potential Commercial/Mixed use development
- 6 Potential Commercial/ Retail Extension
- 7 Urban landscaping. Pedestrian oriented street: Peak time Students 8am & 5pm
- 8 Potential low green space or Commercial development
- 9 Cultural Precinct Walkway

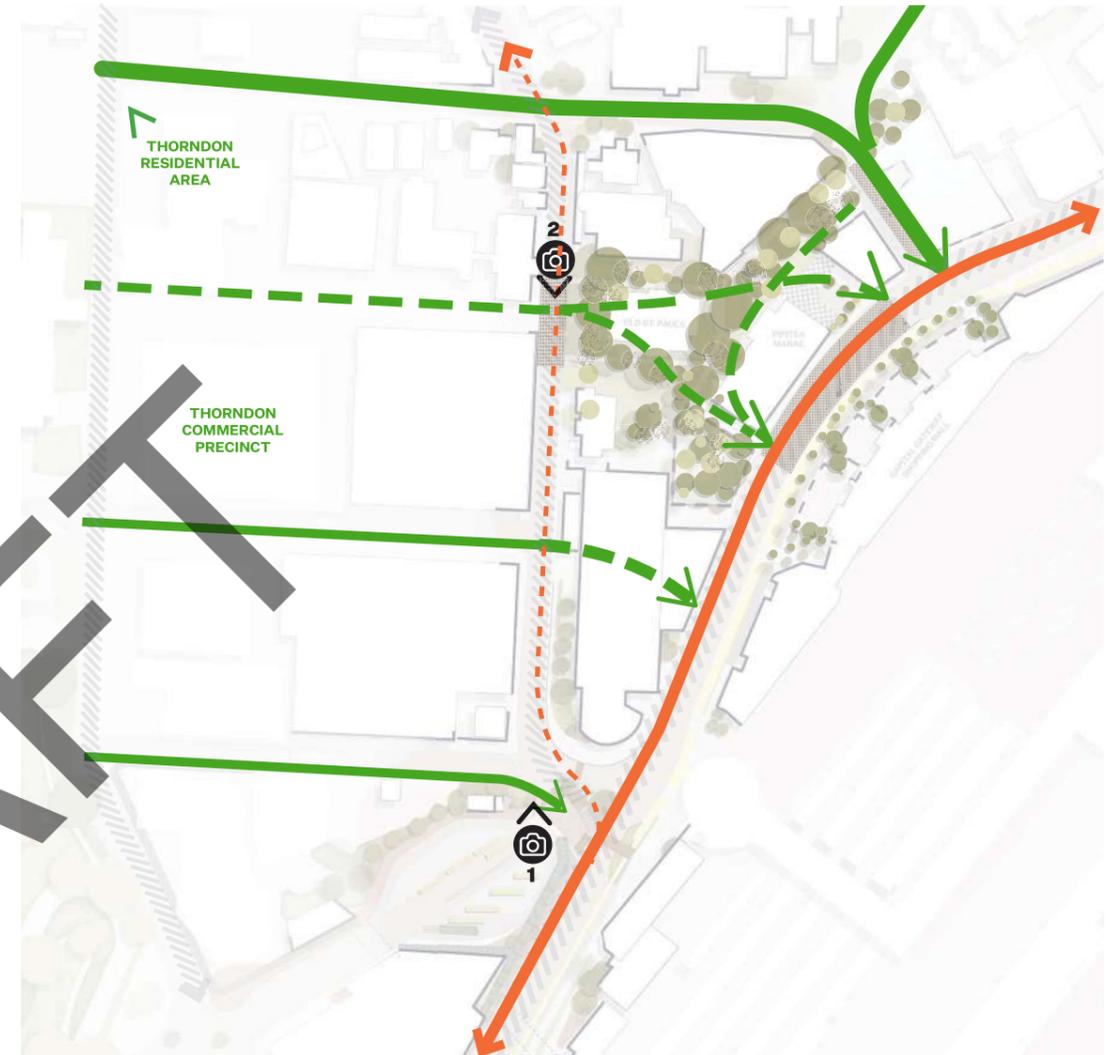
Streetscape

The streetscape is instrumental to bind the railway, university, cultural, and business precincts together. Strengthening the Thorndon Quay arterial circulation route and secondary routes such as Mulgrave, Aitken and Pipitea Street connects the node with a strong weave of streets.

- Primary Road
- Secondary Road
- Developed Potential Link

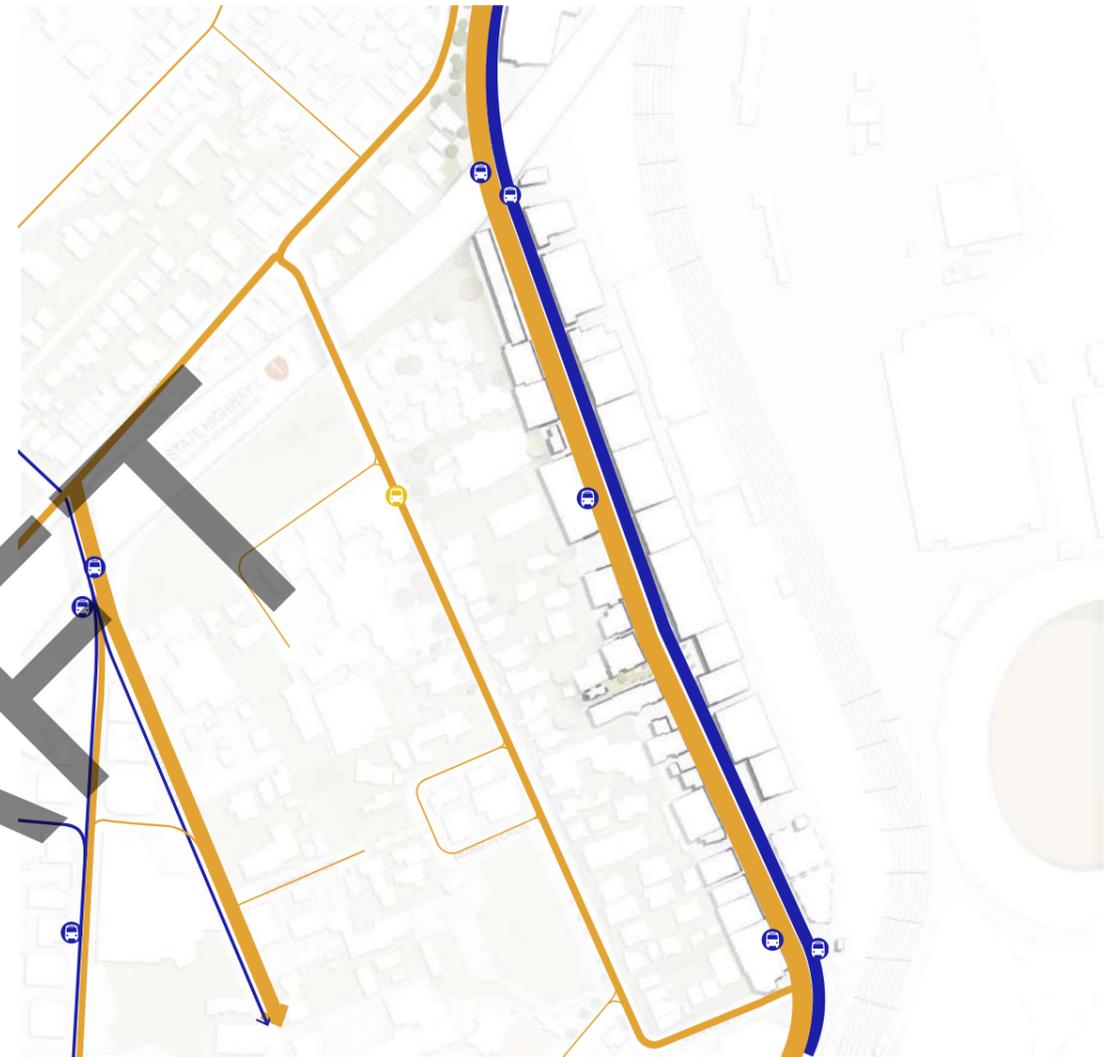
Vehicle Movement

High volumes of private vehicles and public bus routes dominate the Thorndon Quay Shops node. To create a safer more pedestrian oriented space with more public engagement, the vehicles are required to reduce speed or stop at proposed pause points. Giving some more presence to pedestrians and cyclists will enable the node to shift away from a vehicle dominant street.

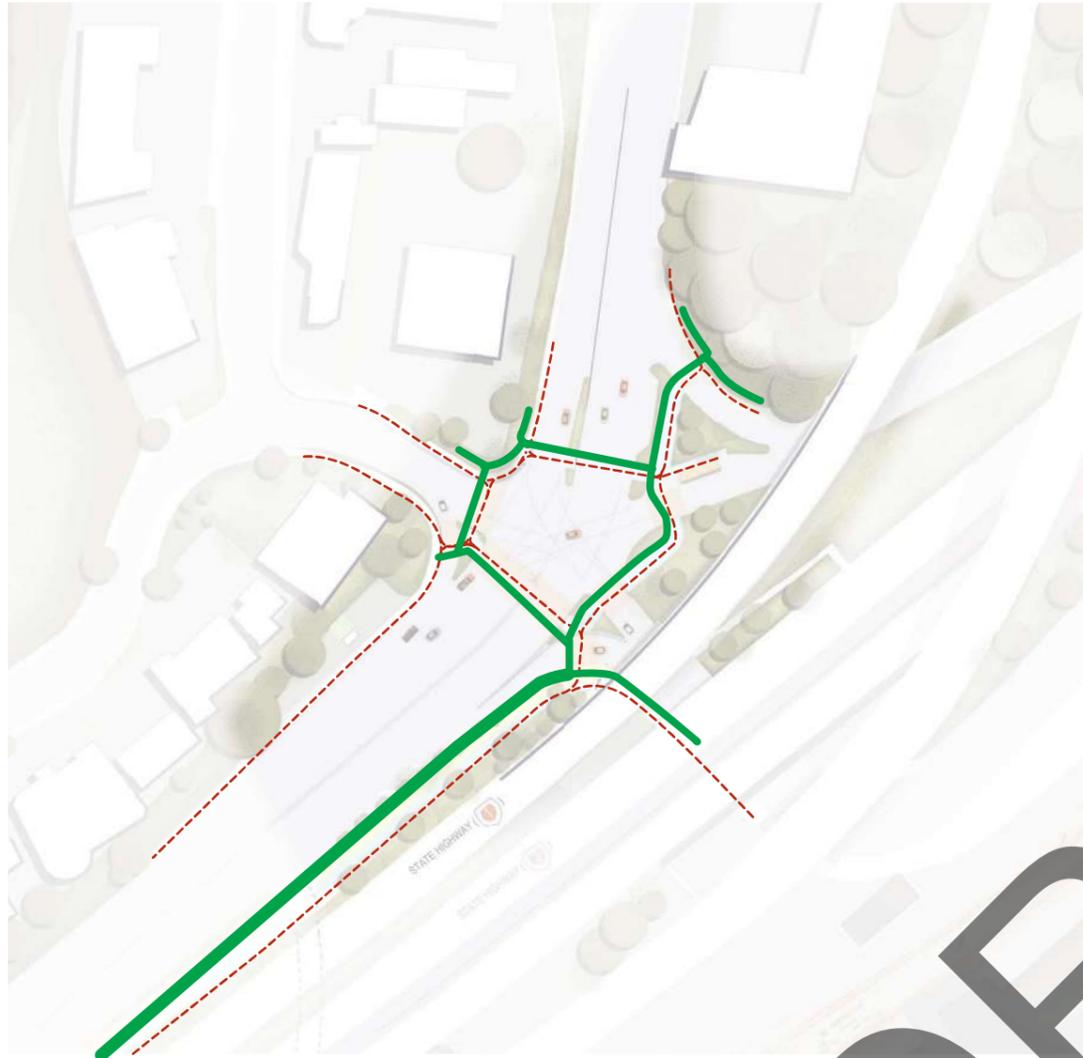
Pedestrian & Cyclist Movement

Highly legible pedestrians and cycling routes and crossing will be required in this node. It is envisioned that with the gateway proposal it will visually make vehicles aware of the other modes of transport in this area and slow down.

- High Pedestrian movement
- - - Low Pedestrian movement/ Off peak
- - - - Developed Potential Pedestrian Movement
- Multi-Modal
- - - - Pedestrian - Vehicle Conflict

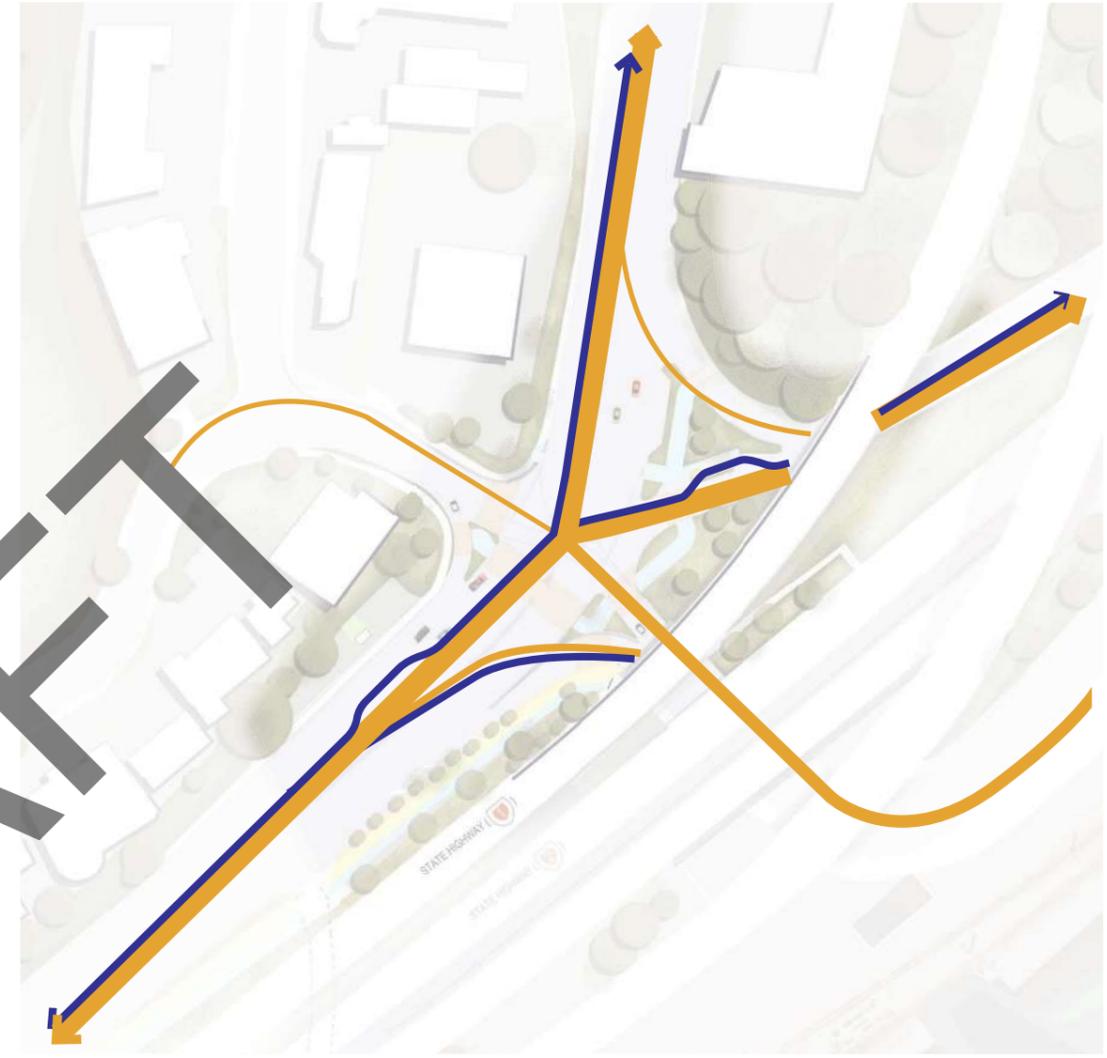
Vehicle Movement

Through the realignment of vehicle lanes and increase in pedestrian points the area is more enclosed forcing greater awareness for vehicles thus improving safety.

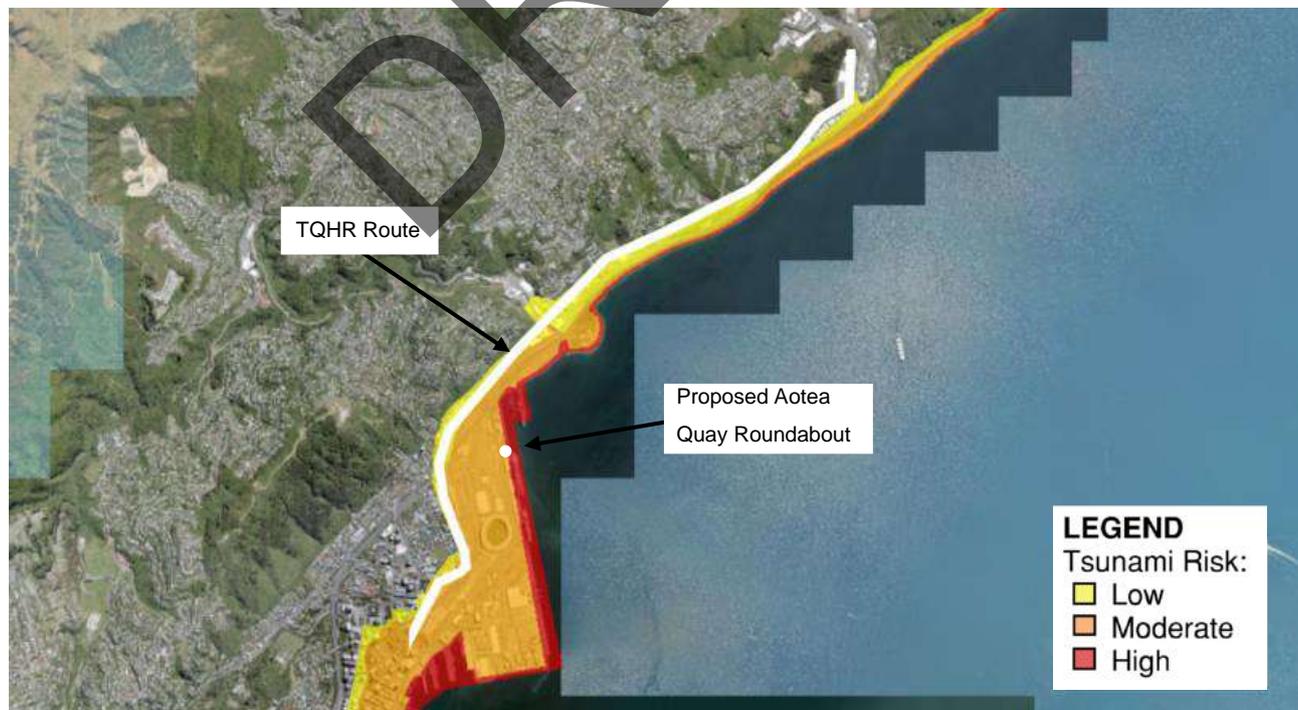
Figure 3. Tsunami Evacuation Zones Map (ESRI, 2021).

Due to the low-lying nature of the TQHR area, the entirety of the route will be subject to tsunami risk. Figure 3 identifies evacuation zones depending on the risk level, according to GWRC.

The project area is predominately located in the yellow evacuation area, with the southern end of Thorndon Quay, the Kaiwharawhara intersection and the Aotea Quay Roundabout located in the orange area.

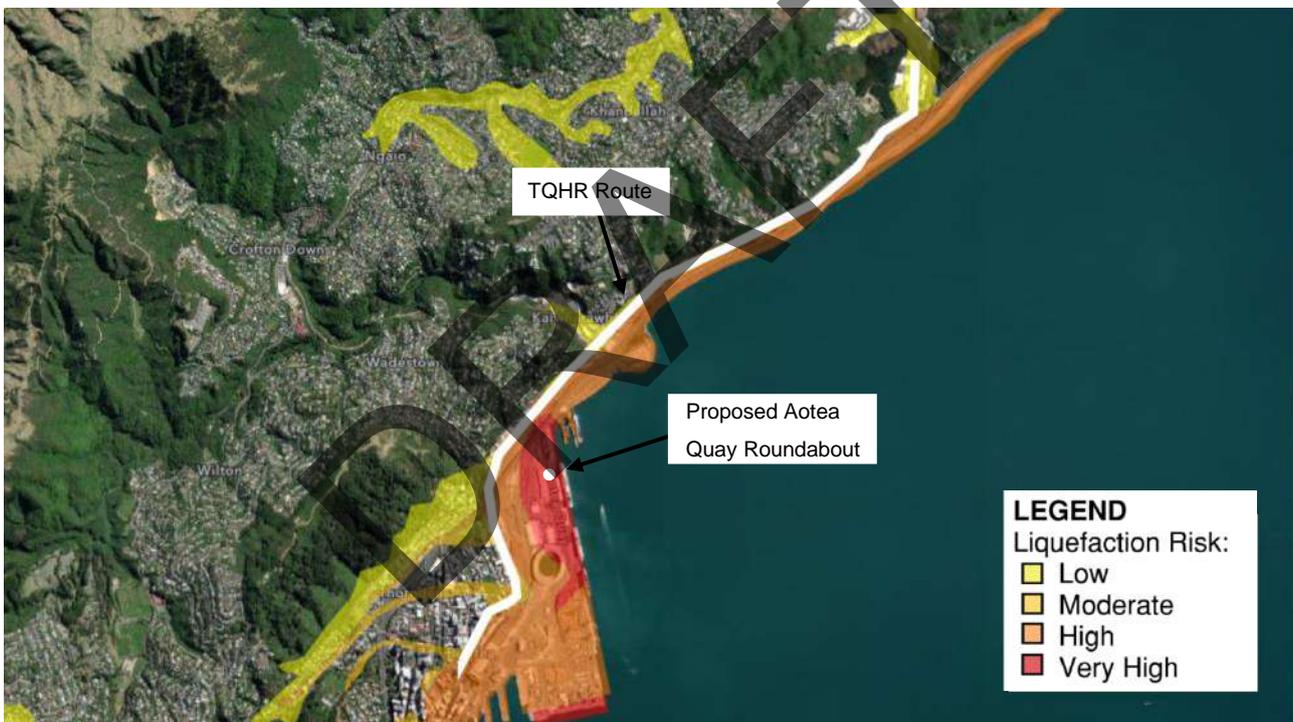
Figure 4. Liquefaction Hazard Zoning Map (ESRI, 2021).

Zones of potential liquefaction risk along TQHR has been evaluated by GWRC and is presented in Figure 4. The risk for TQHR varies from low to very high, with the southern end being exposed to higher risk.

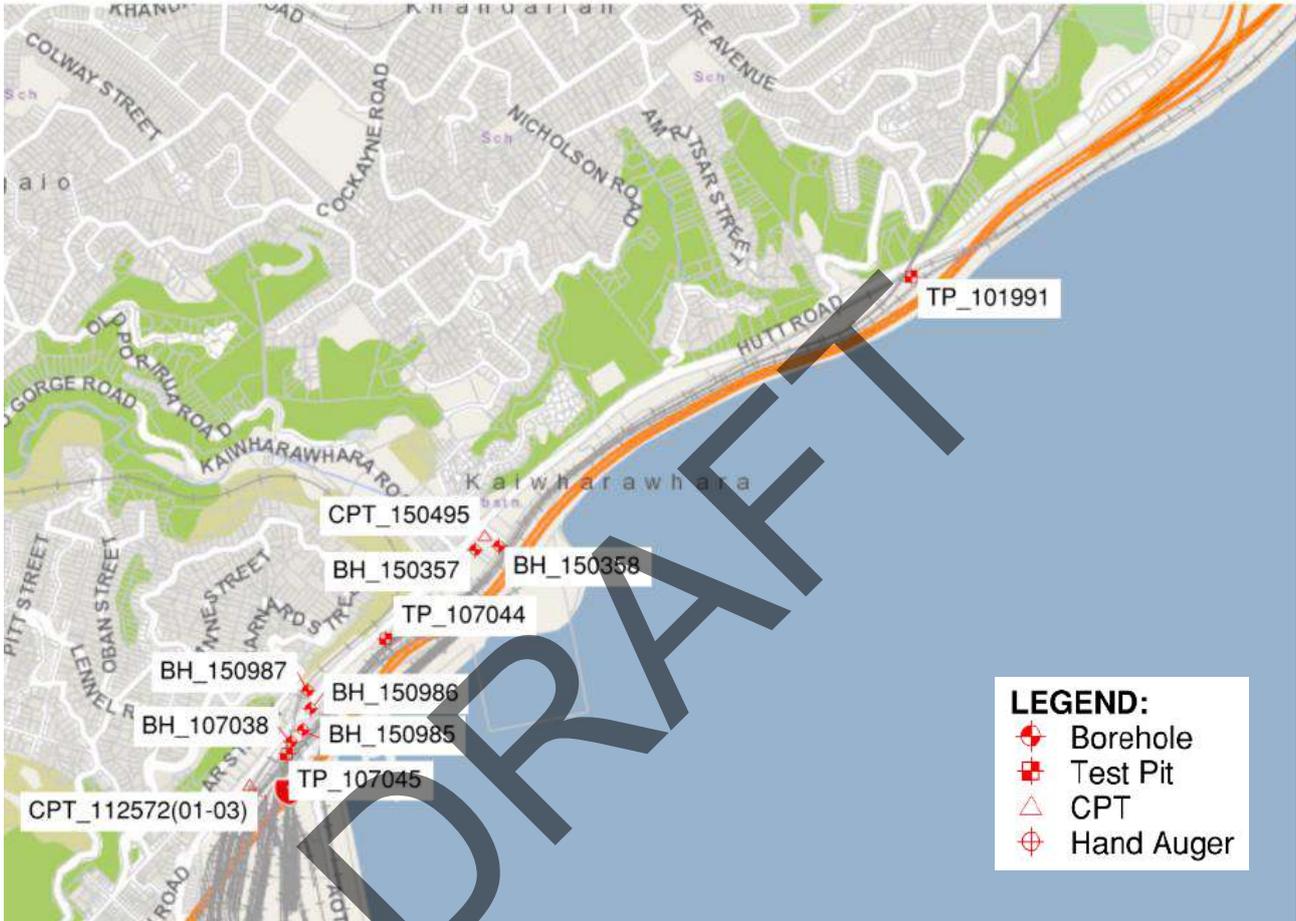
Figure 7. Historical Investigations along Hutt Road Section of TQHR.

The reclaimed fill beneath Hutt Road is expected to extend 3-4 metres bgl and is underlain by marine and alluvial deposits. Greywacke was generally encountered at depths ranging from 23-27 metres bgl, with the exception of BH_150986 where it was encountered at 15 metres bgl.

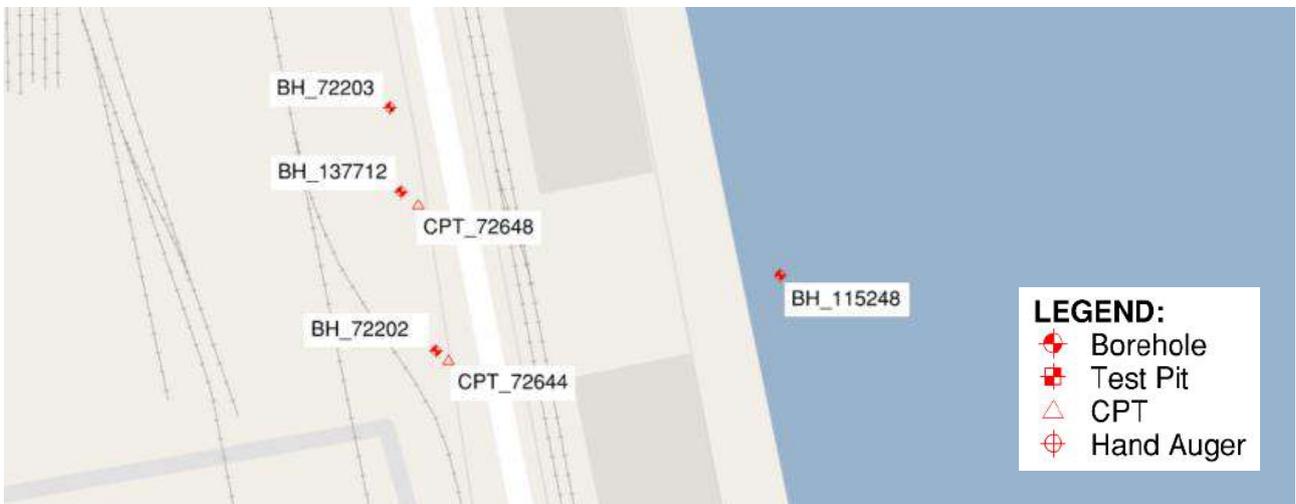
Figure 9. Historical Investigations along Aotea Quay Roundabout section of TQHR.

The Aotea Quay roundabout area is expected to have reclaimed fill extending to approximately 5.5-8.5 metres bgl. Marine deposits and alluvium is then identified as underlying this material. Greywacke was not encountered in boreholes, so can be expected to be present at depths greater than 25 metres bgl.

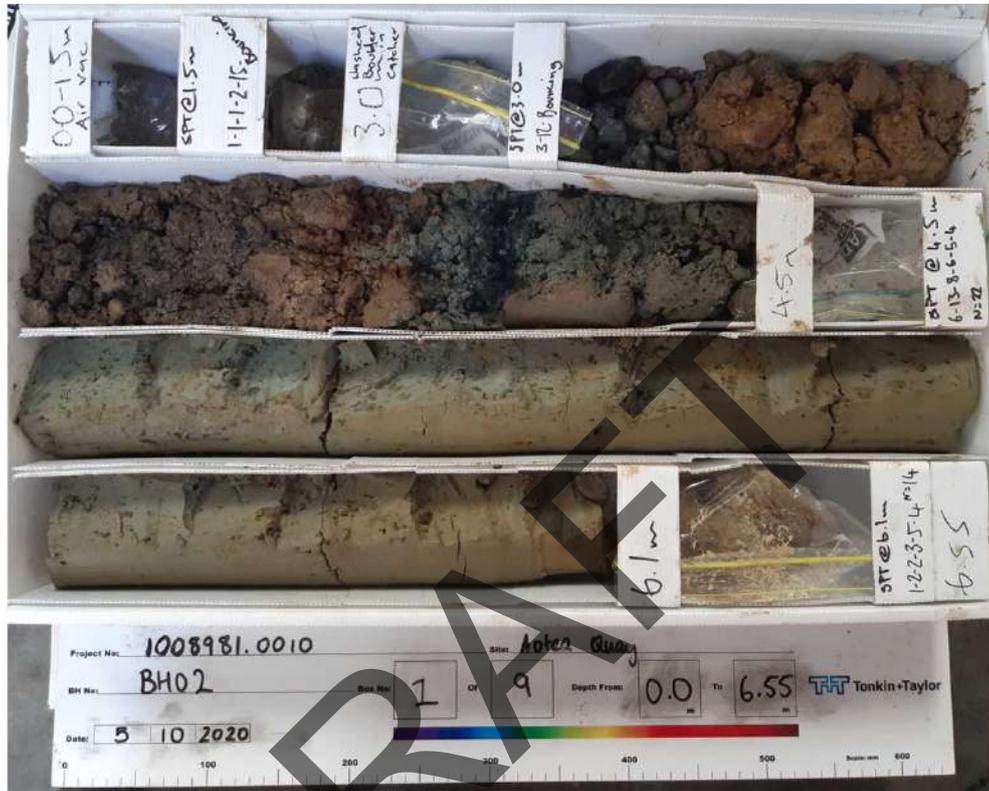
0.00-6.55m

BOREHOLE No.: **BH2**
Hole Location: To the west of Aotea Quay bridge, north of railway lines.
 SHEET: 1 OF 5

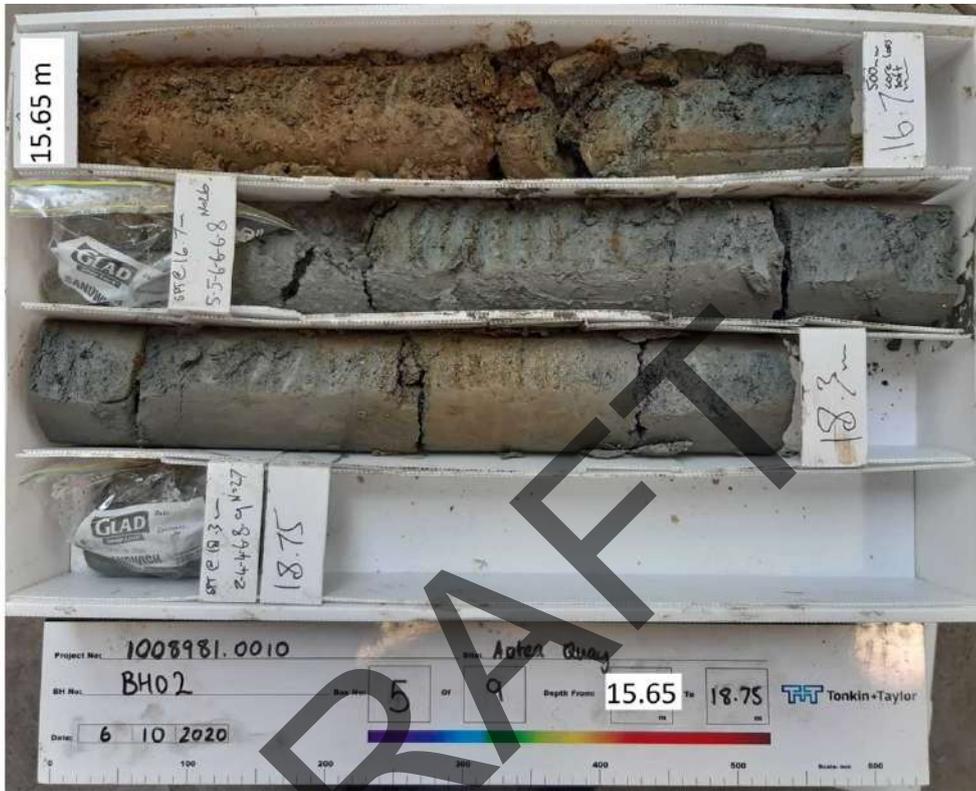
15.65-18.75m

BOREHOLE No.: **BH2**
Hole Location: To the west of Aotea Quay bridge, north of railway lines.
 SHEET: 3 OF 5

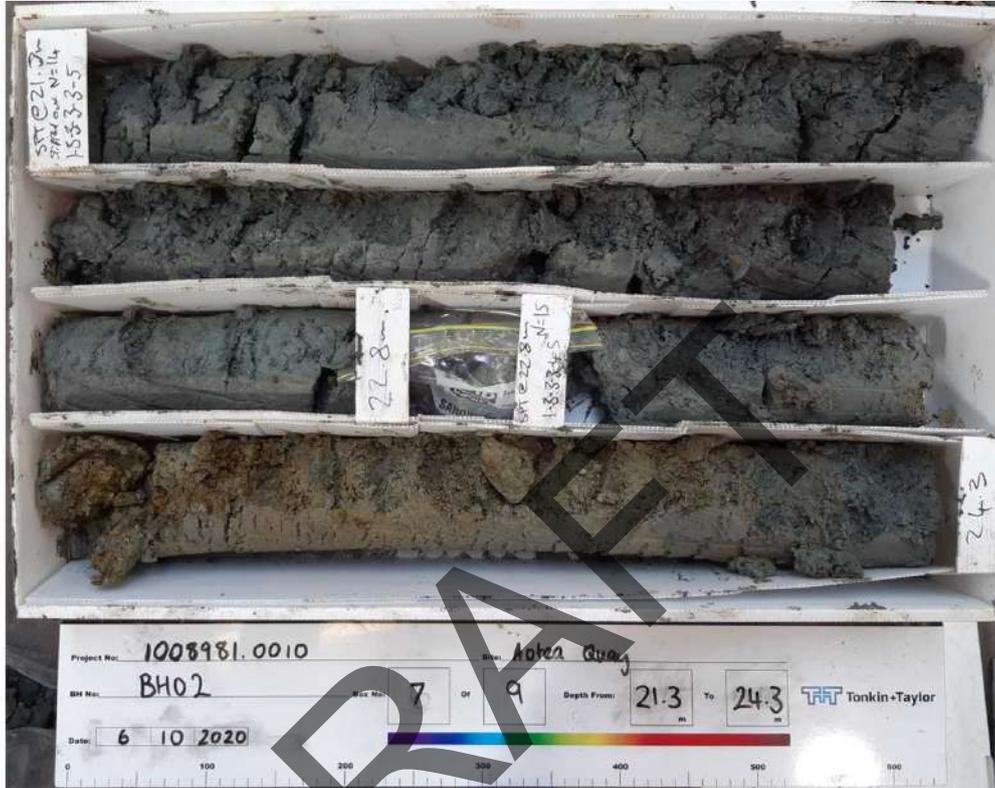
21.30-24.30m

BOREHOLE No.: BH2
Hole Location: To the west of Aotea Quay bridge, north of railway lines.
SHEET: 4 OF 5

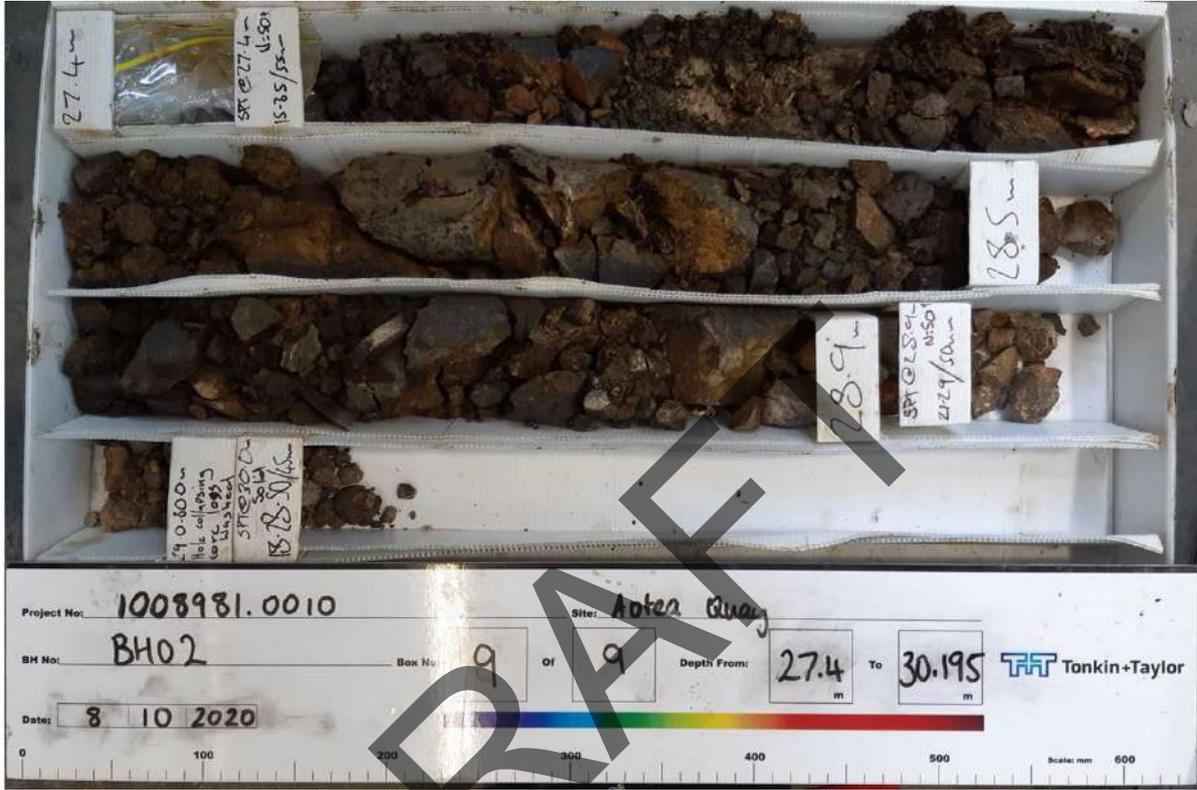
27.40-30.20m

BOREHOLE No.: **BH2**
Hole Location: To the west of Aotea Quay bridge, north of railway lines.
 SHEET: 5 OF 5

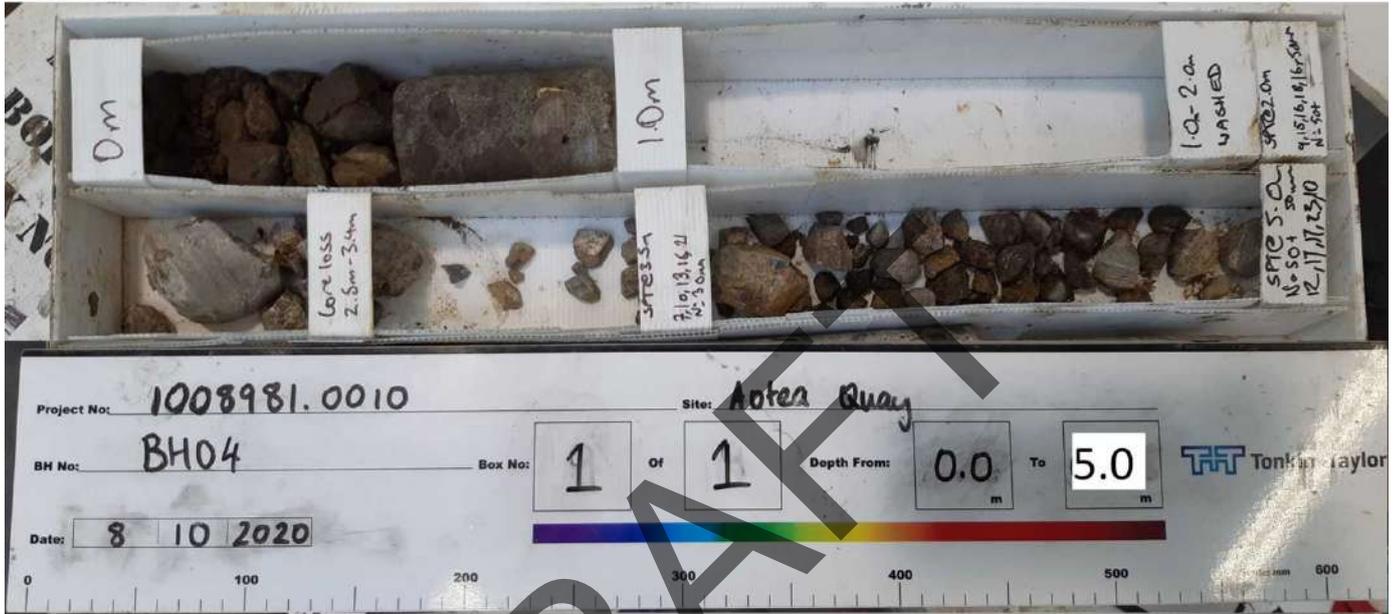
0.00-5.35m

BOREHOLE No.: **BH4**
Hole Location: Beneath the northern end of Aotea Quay bridge off ramp, north of the railway tracks.
 SHEET: 1 OF 1

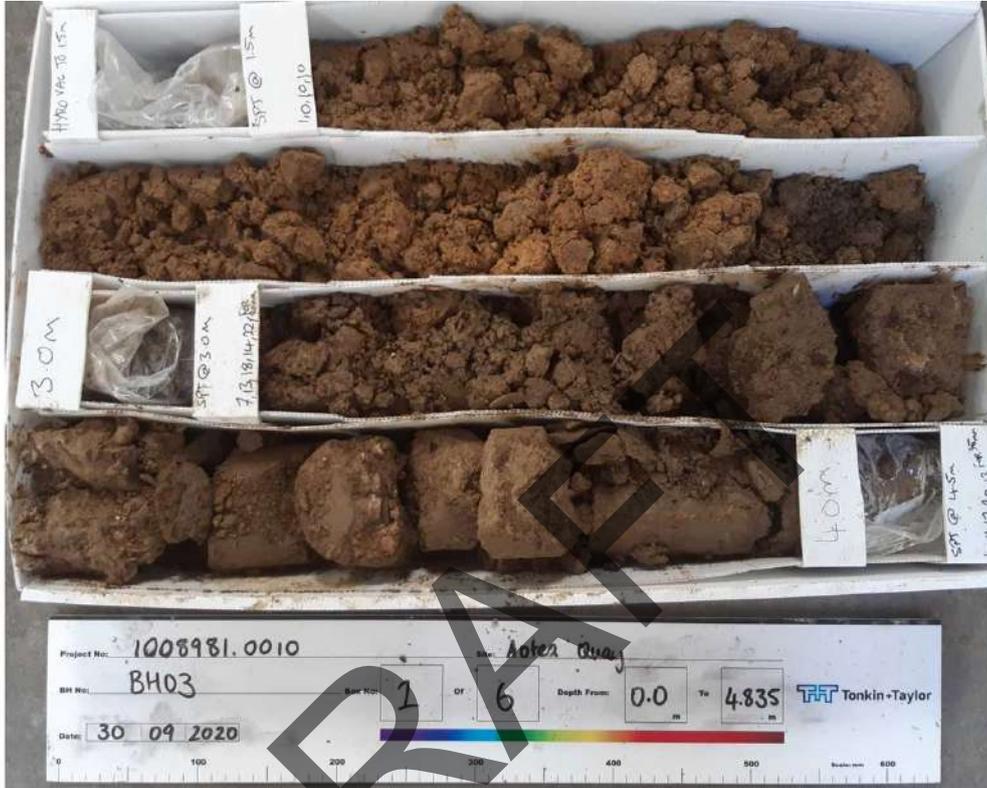
0.00-4.84m

BOREHOLE No.: **BH3**
 Hole Location: Near Hutt Road bus stop to the east of Aotea Quay bridge.
 SHEET: 1 OF 3

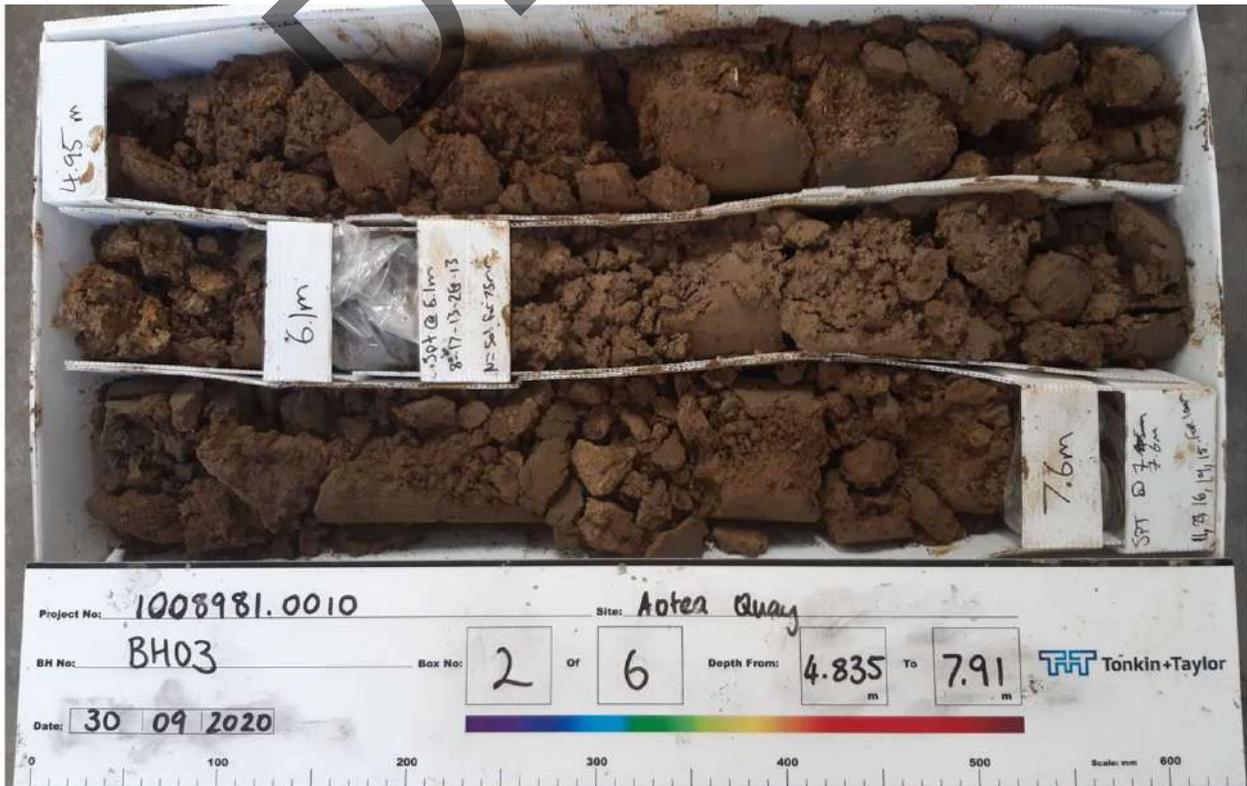
CORE PHOTOS

BOREHOLE No.: **BH3**
Hole Location: Near Hutt Road bus stop to the east of Aotea Quay bridge.
 SHEET: 2 OF 3

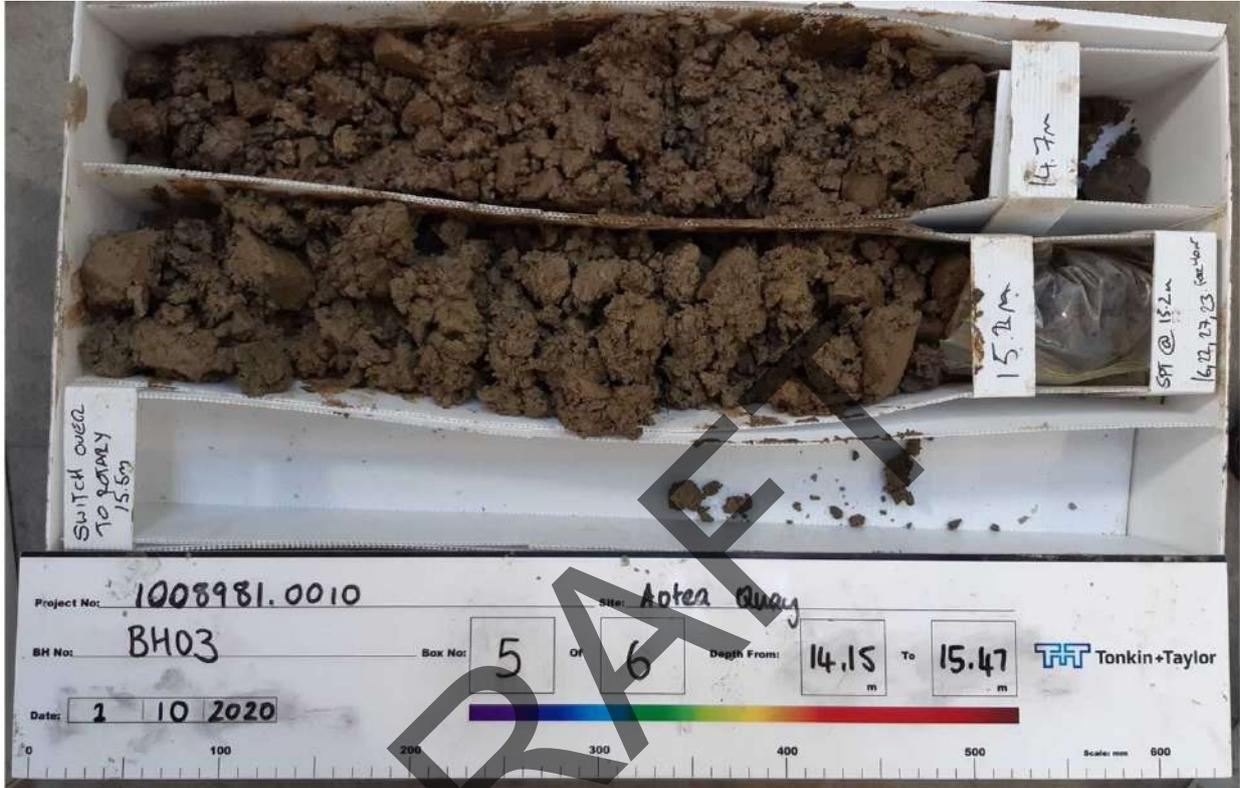
14.15-15.47m

BOREHOLE No.: **BH3**
 Hole Location: Near Hutt Road bus stop to the east of Aotea Quay bridge.
 SHEET: 3 OF 3
