Preliminary Design Philosophy Statement

10 November 2021

Thorndon Quay Hutt Road

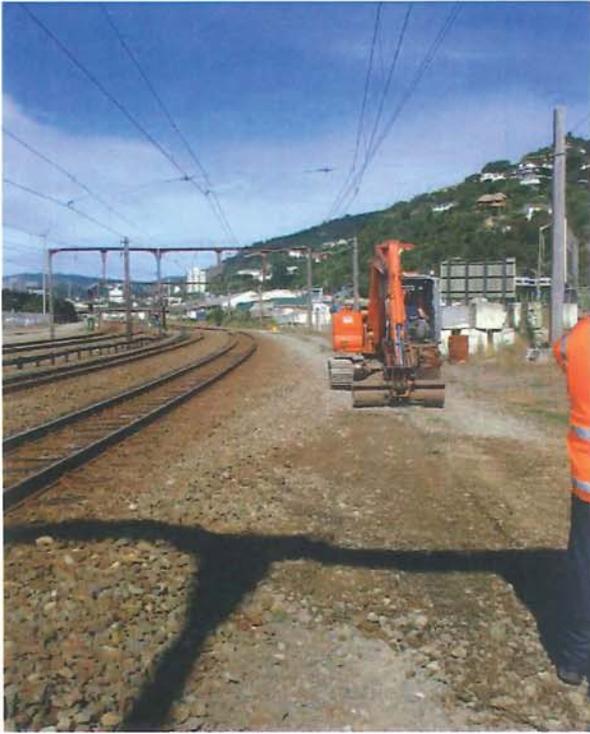
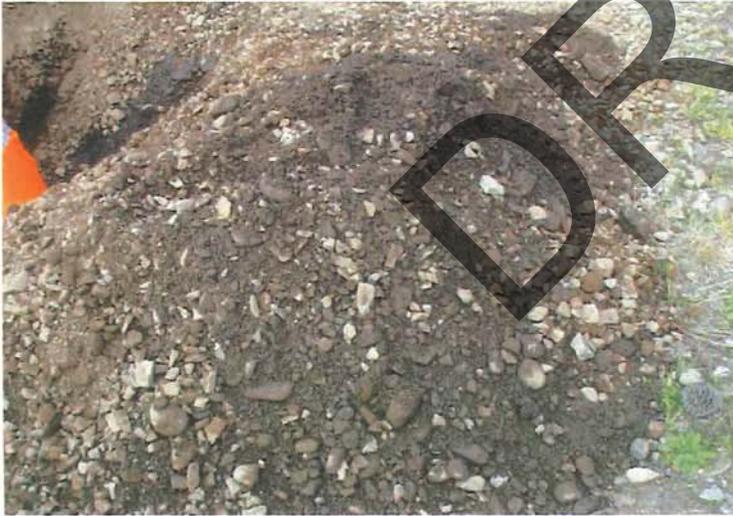
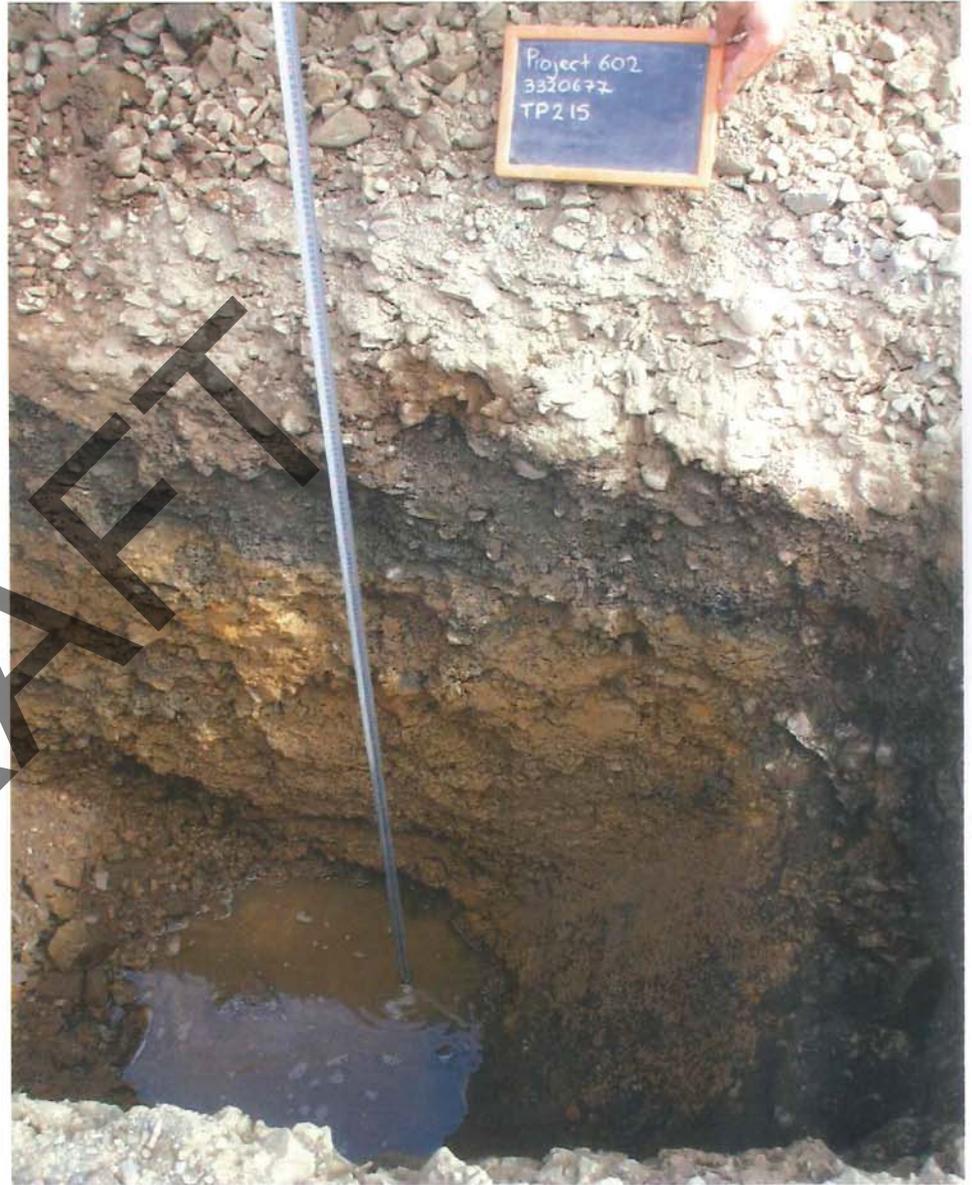
Test Pit Photos

Wellington Station Entry
Project 602

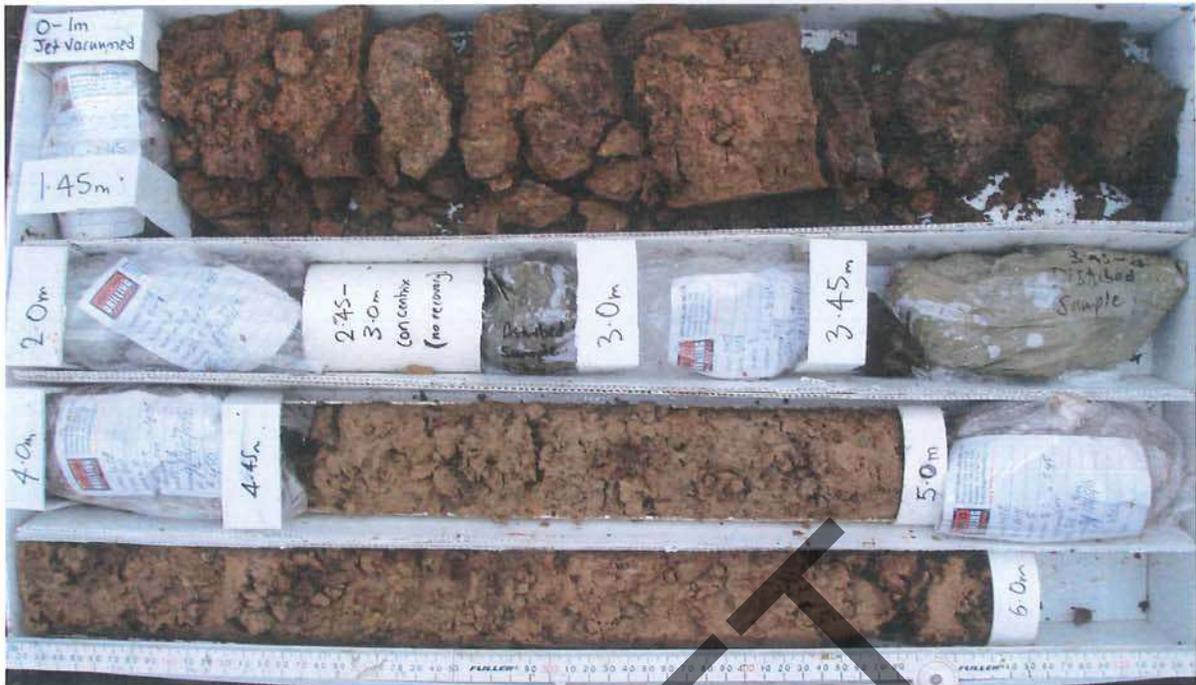
BOX: 1

DEPTH: 1.0 to 6.0m

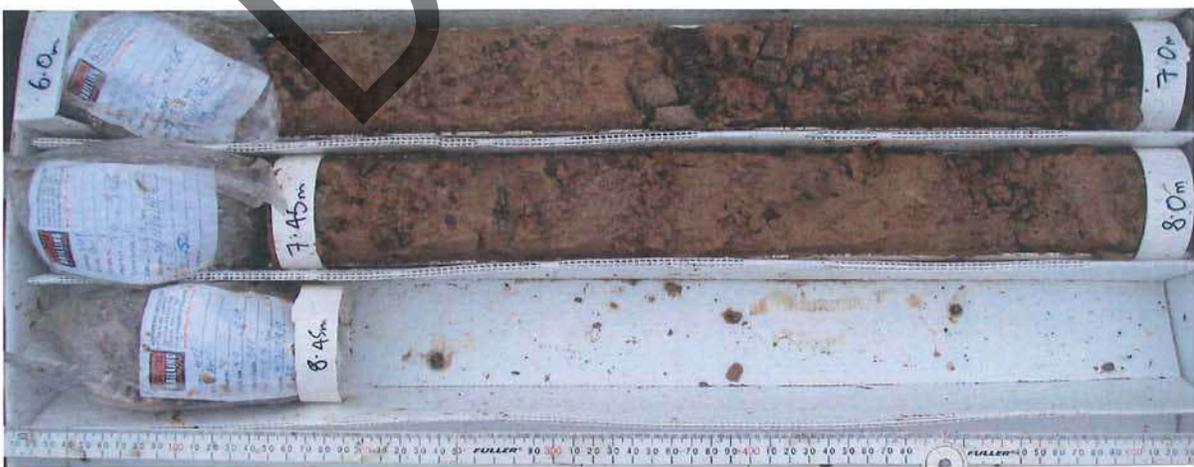
BOX: 2

DEPTH: 6.0 to 8.45m

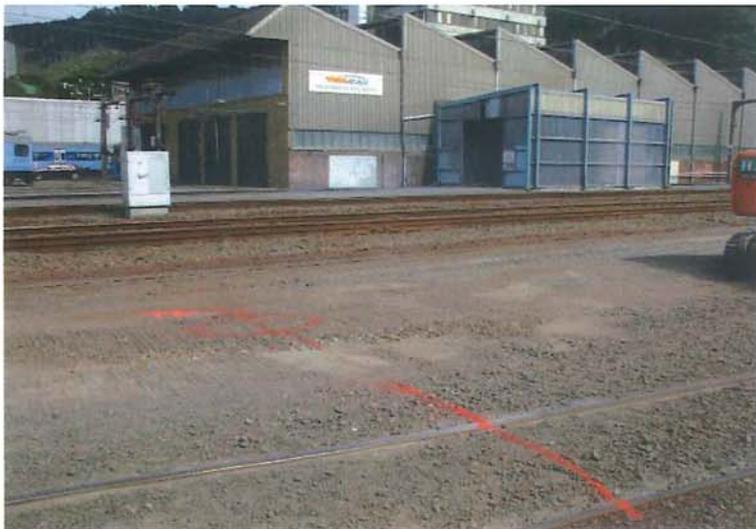
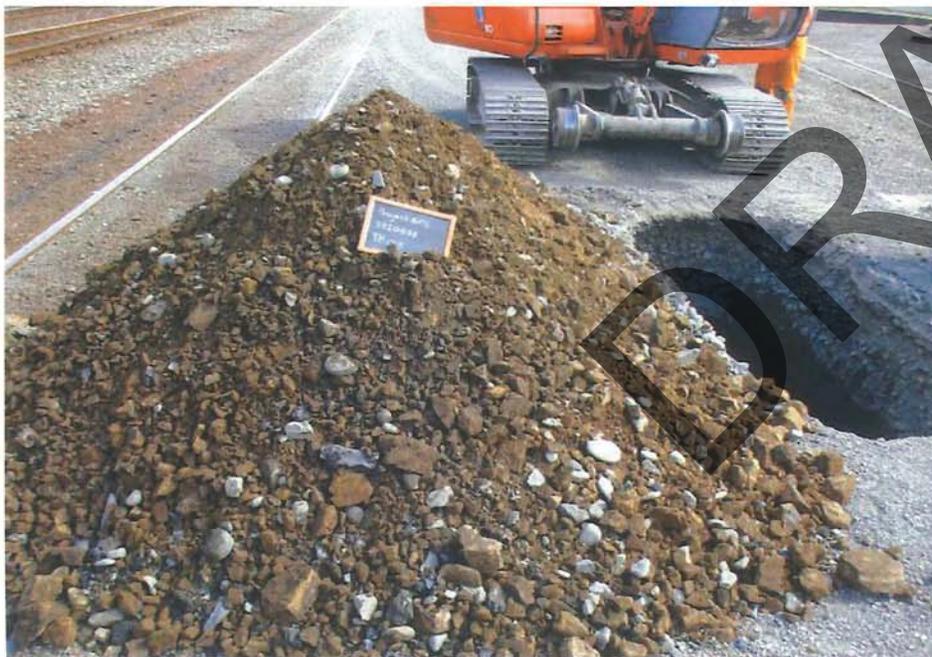
Test Pit Photos

Wellington Station Entry
Project 602

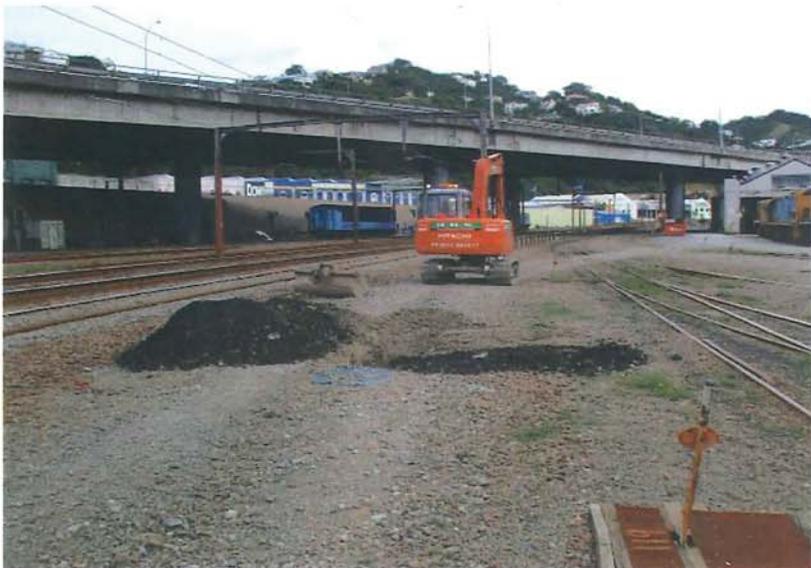
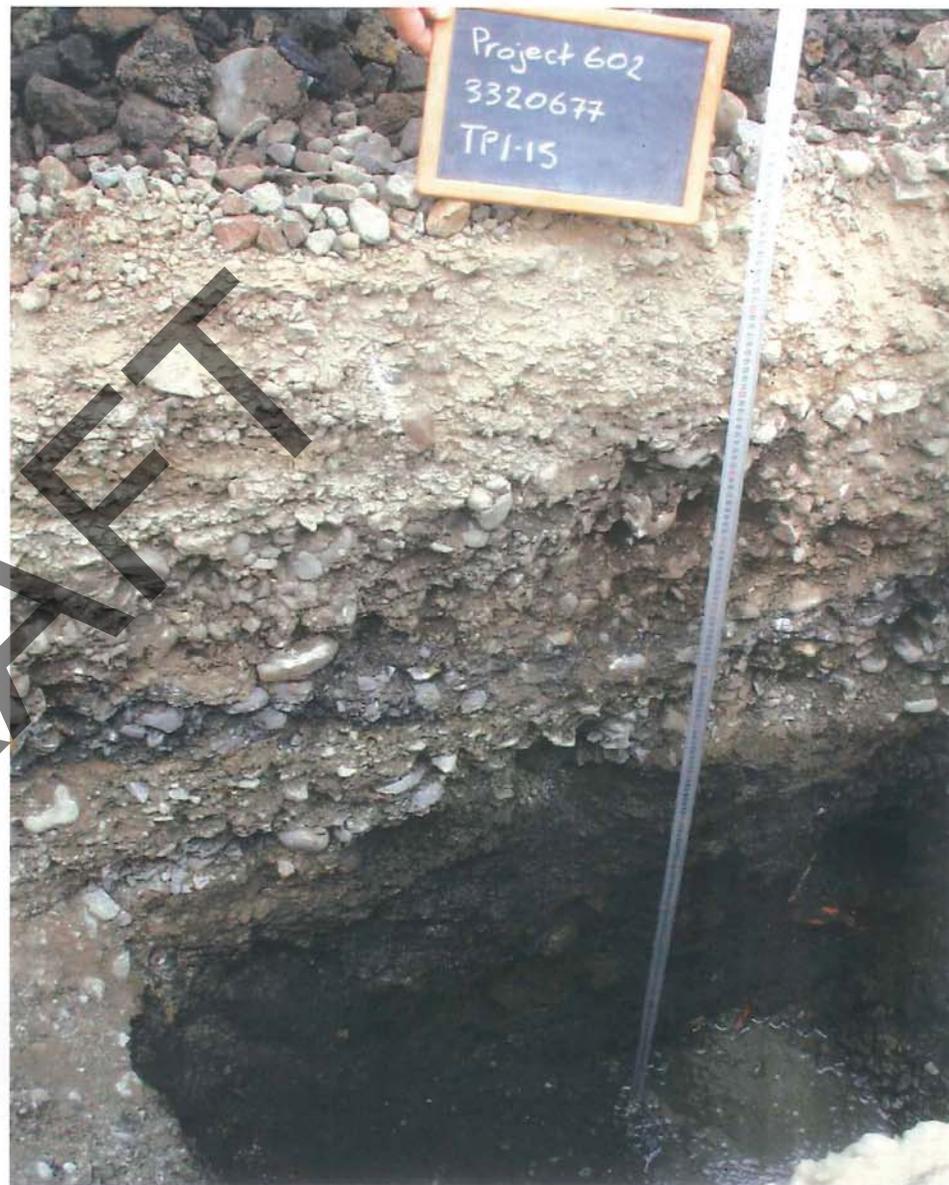
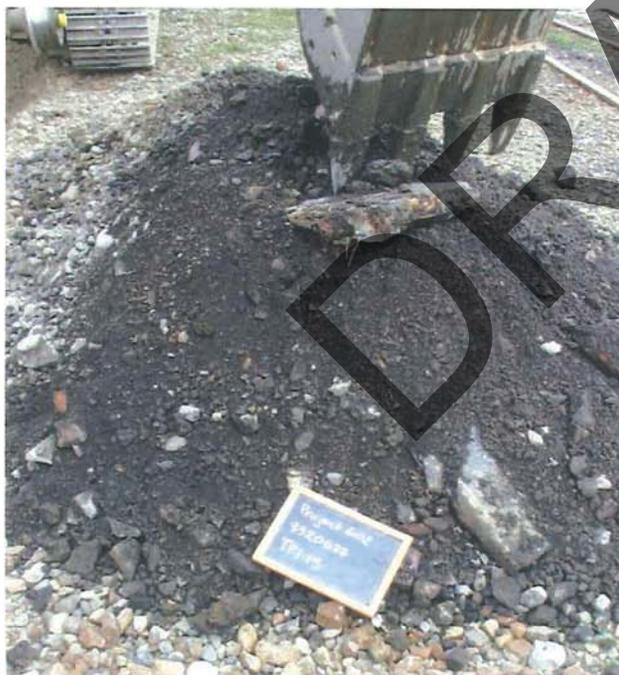
Test Pit Photos

Wellington Station Entry
Project 602
